# CHISEL POINT DEV 995 1069 PR – EUTECTOID TO HYPEREUTECTOID STEEL – EARLY MEDIEVAL TIMES – SWITZERLAND

**Artefact name** Chisel point DEV 995 1069 PR

**Authors** Marianne. Senn (Empa, Dübendorf, Zurich, Switzerland) & Christian. Degriigny (HE-Arc CR, Neuchâtel, Neuchâtel, Switzerland)

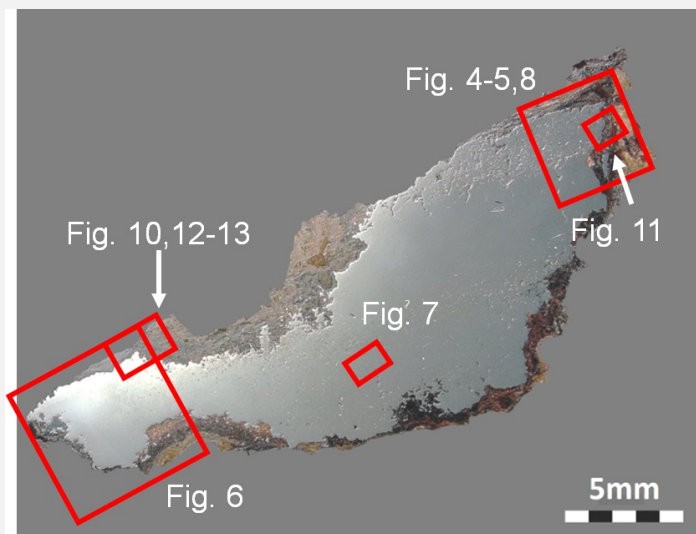
Fig. 3: Micrograph of the cross-section of the chisel point showing the location of Figs. 4 to 8 and 10 to 13.

<b>Description of sample</b>	A longitudinal cut from a chisel point (Figs. 2 and 3) after restoration. Dimensions: L = 30mm; W = 11mm (approximately).
<b>Alloy</b>	Eutectoid to hypereutectoid steel
<b>Technology</b>	Quench hardened
<b>Lab number of sample</b>	DEV1069
<b>Sample location</b>	HE-Arc CR, Neuchâtel, Neuchâtel
<b>Responsible institution</b>	Office de la Culture, Porrentruy, Jura
<b>Date and aim of sampling</b>	2000, metallography and chemical composition of the metal

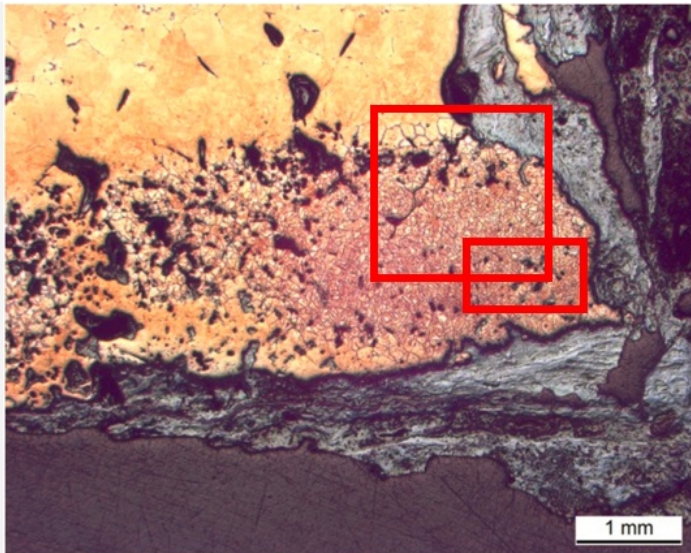
The remaining metal is a eutectoid to hypereutectoid steel (C 0.8-1 mass%) with cracks and porosity (Figs. 4 and 5). Its composition is given in Table 1 (except Fe). Of the trace elements, only Ni reaches a medium concentration (Ni 0.07 mass%). The composition and the high Ni/Co ratio are atypical for iron worked in smithies of the settlement at Develier-Courtételle JU, CH. The few slag inclusions and their chemical composition confirm this (Table 2). The slag is rich in CaO whereas the pisolithic or bean ore worked in the Central Jura smelting district is rich in Al<sub>2</sub>O<sub>3</sub>. The slag inclusions cannot be smithing slag because the artefact is formed from one piece of metal. The slag probably incorporated while refining the bloom or during the bloom smelting process. The ore from which this metal was smelted cannot yet be identified. Intergranular corrosion has developed, penetrating into the metal structure (Fig. 5). The etched metal shows a dominant martensitic structure, typical of quench hardened steel (Figs. 4, 6, 7 and 8). The characteristic forms of the martensite are non-organised needles (Fig. 7). In restricted areas bainite nodules occur (Figs. 6 and 7). In the centre of the point, hypereutectoid steel is composed of cementite in the grain boundaries and in needle like shapes within the grains (Fig. 9). Hypereutectoid regions also occur in the centre of the shaft and on its left surface (Fig. 4). Here the hypereutectoid steel is composed of martensite and cementite in the grain boundaries and in needle form within the grains (Figs. 5 and 8). Nevertheless, most of the chisel is dominated by eutectoid steel. The average hardness of the quench hardened eutectoid steel is about HV1 690. In the bainite nodules the average hardness drops to about HV1 350, the martensite has an average hardness of HV1 750.

Fig. 4: Micrograph of the metal sample from Fig. 3 (inverted picture, detail), etched, bright field. The metal contains porosity and cracks (in black). The micrographs of Figs. 5 and 8 are marked by the top and bottom rectangles respectively,

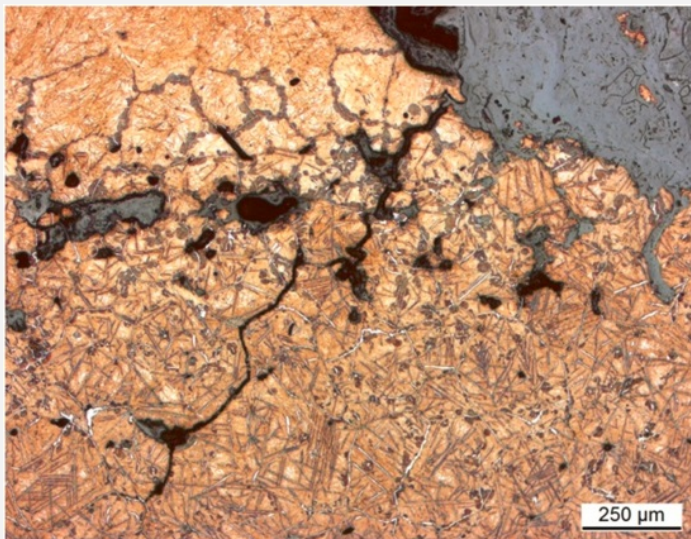
Fig. 5: Micrograph of the metal sample, detail from Fig. 4, etched, bright field. We observe martensite (in orange), cementite (in grey), porosity and intergranular cracks (in black) and corrosion,

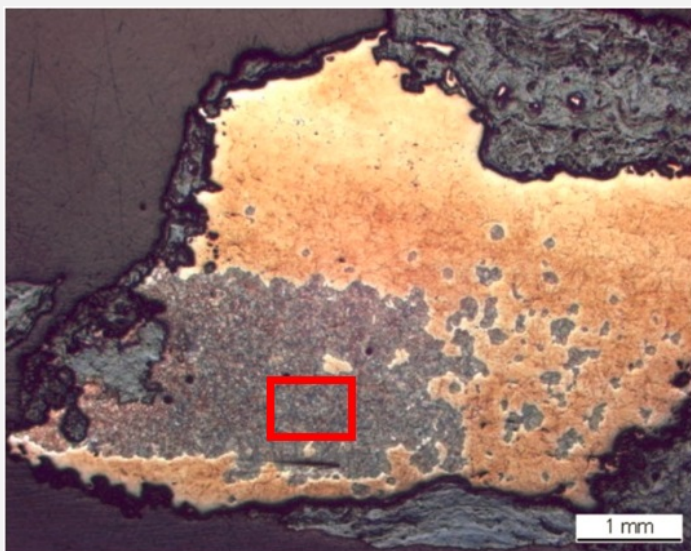
Fig. 6: Micrograph of the metal sample from Fig. 3 (inverted picture, detail), etched, bright field. We observe the metal with martensite (orange) and bainite nodules (blue). The micrograph of Fig. 9 is marked by a rectangle,

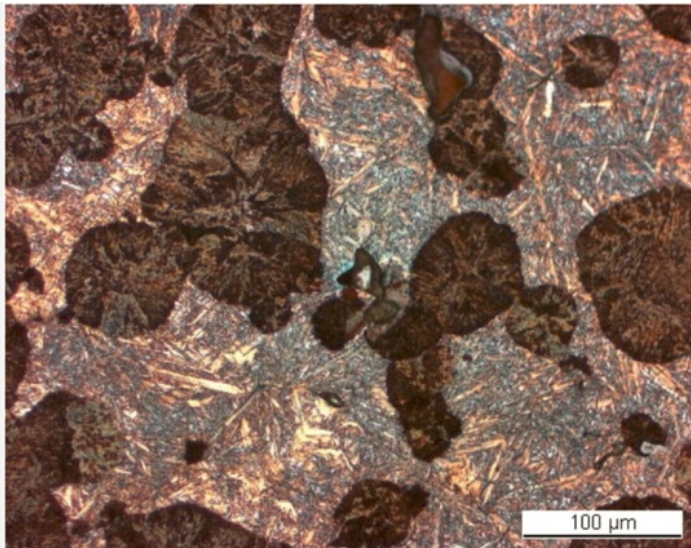
Fig. 7: Micrograph of the metal sample from Fig. 3 (detail), etched, bright field. We observe dark bainite nodules combined with martensite needles,

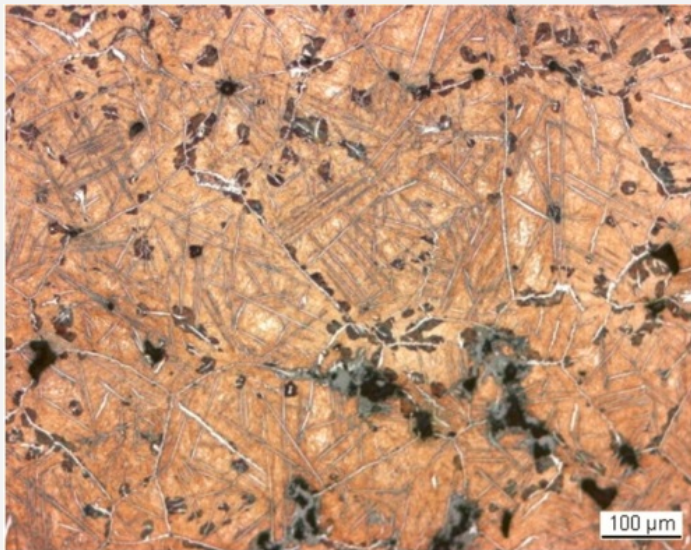
Fig. 8: Micrograph of the metal sample, detail from Fig. 4, etched, bright field. Hypereutectoid steel with a structure of cementite in white in the grain boundaries and in needle form combined with martensite (pink). Some bainite occurs around the grain boundaries.

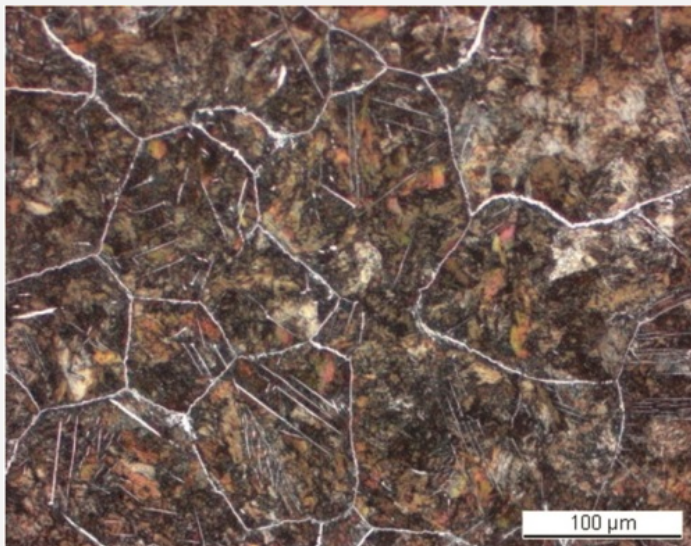
Fig. 9: Micrograph of the metal sample, detail from Fig. 6, etched, bright field. Hypereutectoid steel with a structure of cementite in white in the grain boundaries and in needle form combined with bainite (dark).

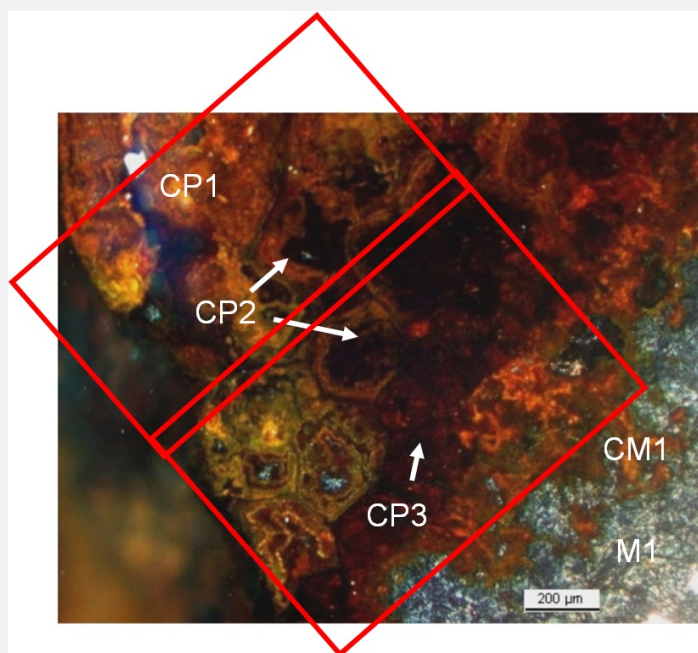
The metal is heavily corroded and the thickness of the corrosion crust is irregular, but averages about 0.5mm. The corrosion products enclose different ghost structures: the corrosion crust has preserved the shape of polygonal grains (Figs. 10 and 12) and cementite needles (Fig. 11). Under polarised light, the corrosion products at the metal - corrosion crust interface are dark-red and form an inner S-rich layer (CP3, Figs. 10 and 12). Cl occurs locally (CP3) and C is present in layers CP2 and CP3 (Fig. 12). The outer layer of the corrosion products (CP1) is orange and contains more O than the inner layer CP3 (Figs. 10 and 13).

Fig. 10: Micrograph showing the metal - corrosion crust interface from Fig. 3 (rotated by 270°, detail) and corresponding to the stratigraphy of Fig. 14, unetched, polarised light. Polygonal grains are visible as ghost structure in the corrosion crust. The selected areas for elemental chemical distribution (Figs. 12 and 13) are marked by two rectangles (bottom: Fig. 12 and top: Fig. 13),

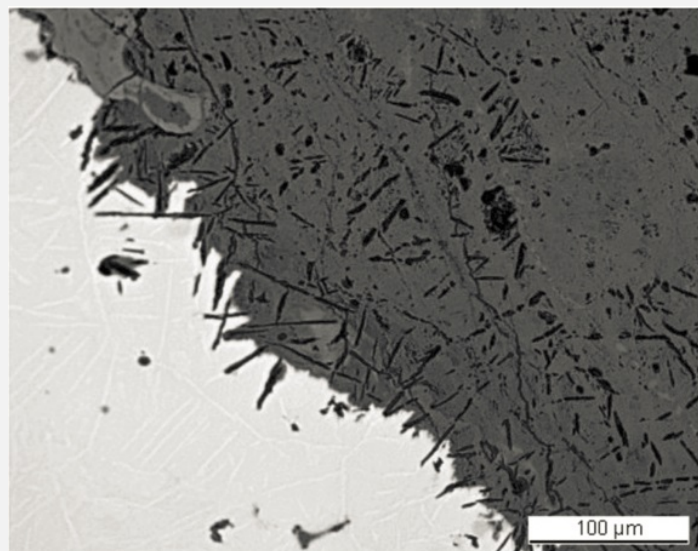
Fig. 11: Micrograph showing the metal - corrosion crust interface from Fig. 3 (detail), unetched, bright field. The cementite is visible as white needles in the metal and its ghost structure as black needles in the corrosion crust,

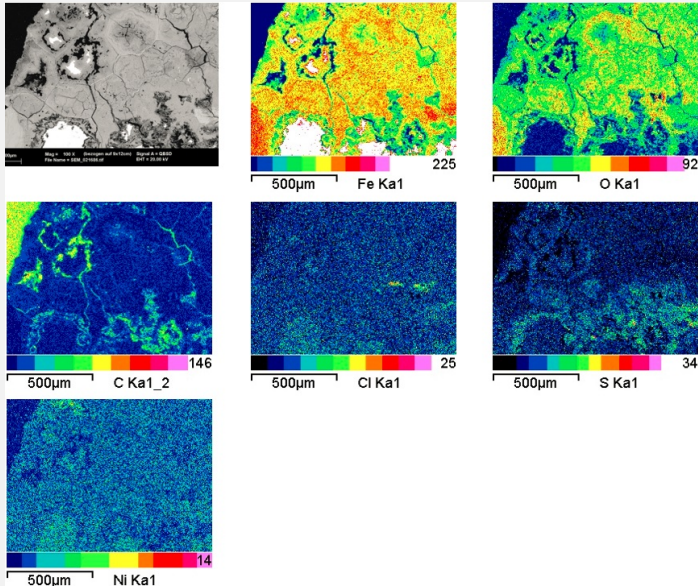
Fig. 12: SEM image, BSE-mode, and elemental chemical distribution of the selected area from Fig. 10 (rotated by 45°). Method of examination: SEM/EDS, Laboratory of Analytical Chemistry, Empa,

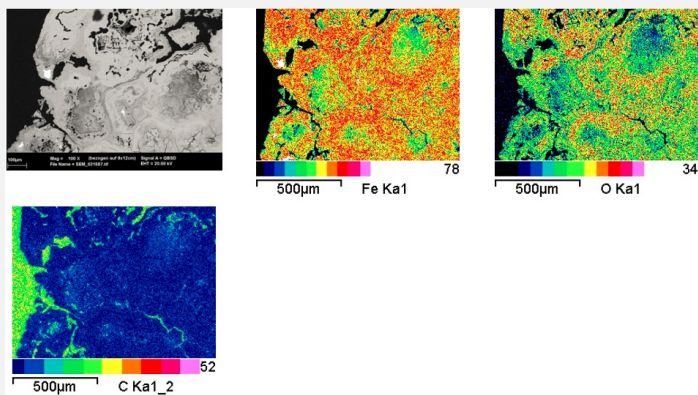
Fig. 13: SEM image, BSE-mode, and elemental chemical distribution of the selected area from Fig. 10 (rotated by 45°). Method of examination: SEM/EDS, Laboratory of Analytical Chemistry, Empa,

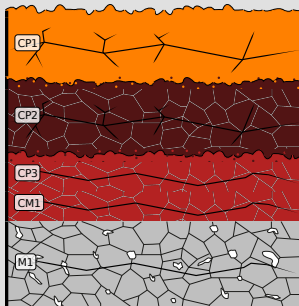
Fig. 14: Stratigraphic representation of the chisel point in cross-section (dark field) using the MiCorr application. The characteristics of the strata are only accessible by clicking on the drawing that redirects you to the search tool by stratigraphy representation. This representation can be compared to Fig. 10, Credit HE-Arc CR.
