# CHISEL POINT DEV 995 1069 PR – EUTECTOID TO HYPEREUTECTOID STEEL – EARLY MEDIEVAL TIMES – SWITZERLAND

**Artefact name** Chisel point DEV 995 1069 PR

**Authors** Marianne. Senn (Empa, Dübendorf, Zurich, Switzerland) & Christian. Degriigny (HE-Arc CR, Neuchâtel, Neuchâtel, Switzerland)

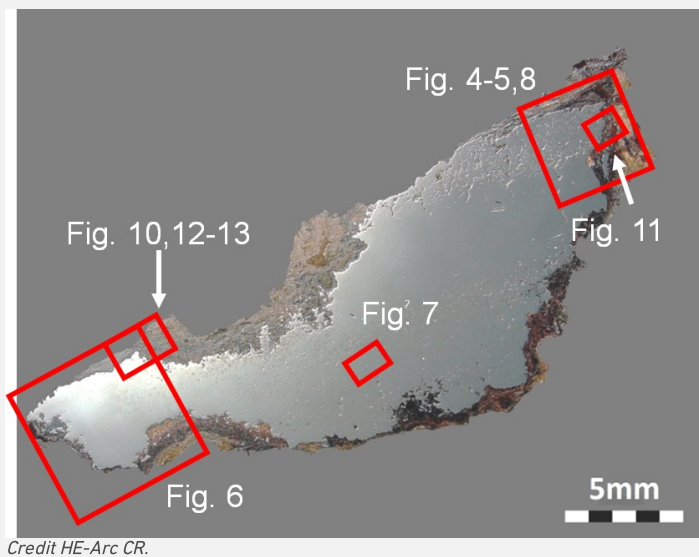
Fig. 3: Micrograph of the cross-section of the chisel point showing the location of Figs. 4 to 8 and 10 to 13.

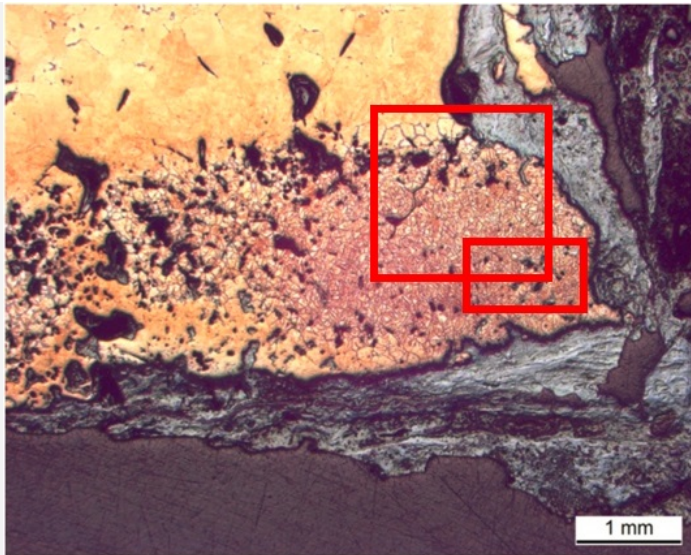
The remaining metal is a eutectoid to hypereutectoid steel (C 0.8-1 mass%) with cracks and porosity (Figs. 4 and 5). Its composition is given in Table 1 (except Fe). Of the trace elements, only Ni reaches a medium concentration (Ni 0.07 mass%). The composition and the high Ni/Co ratio are atypical for iron worked in smithies of the settlement at Develier-Courtételle JU, CH. The few slag inclusions and their chemical composition confirm this (Table 2). The slag is rich in CaO whereas the pisolithic or bean ore worked in the Central Jura smelting district is rich in Al<sub>2</sub>O<sub>3</sub>. The slag inclusions cannot be smithing slag because the artefact is formed from one piece of metal. The slag probably incorporated while refining the bloom or during the bloom smelting process. The ore from which this metal was smelted cannot yet be identified. Intergranular corrosion has developed, penetrating into the metal structure (Fig. 5). The etched metal shows a dominant martensitic structure, typical of quench hardened steel (Figs. 4, 6, 7 and 8). The characteristic forms of the martensite are non-organised needles (Fig. 7). In restricted areas bainite nodules occur (Figs. 6 and 7). In the centre of the point, hypereutectoid steel is composed of cementite in the grain boundaries and in needle like shapes within the grains (Fig. 9). Hypereutectoid regions also occur in the centre of the shaft and on its left surface (Fig. 4). Here the hypereutectoid steel is composed of martensite and cementite in the grain boundaries and in needle form within the grains (Figs. 5 and 8). Nevertheless, most of the chisel is dominated by eutectoid steel. The average hardness of the quench hardened eutectoid steel is about HV1 690. In the bainite nodules the average hardness drops to about HV1 350, the martensite has an average hardness of HV1 750.

Fig. 4: Micrograph of the metal sample from Fig. 3 (inverted picture, detail), etched, bright field. The metal contains porosity and cracks (in black). The micrographs of Figs. 5 and 8 are marked by the top and bottom rectangles respectively,

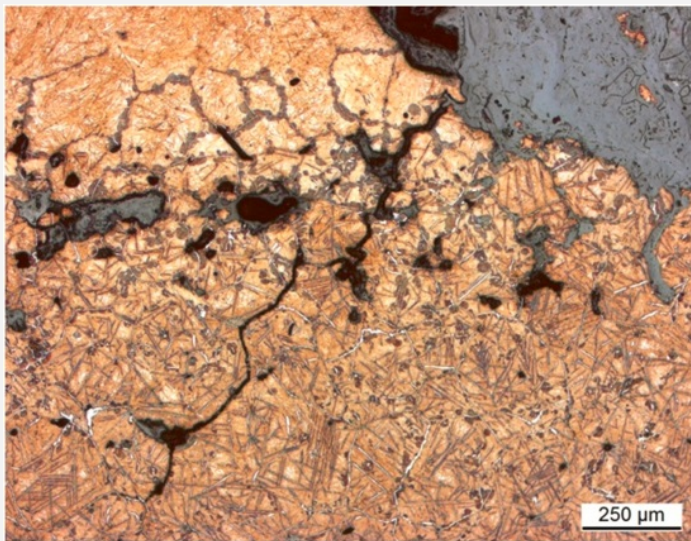
Fig. 5: Micrograph of the metal sample, detail from Fig. 4, etched, bright field. We observe martensite (in orange), cementite (in grey), porosity and intergranular cracks (in black) and corrosion,

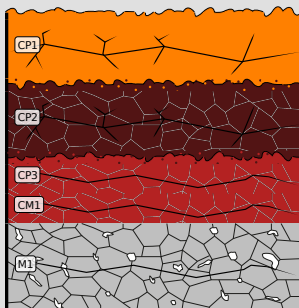
Fig. 14: Stratigraphic representation of the chisel point in cross-section (dark field) using the MiCorr application. The characteristics of the strata are only accessible by clicking on the drawing that redirects you to the search tool by stratigraphy representation. This representation can be compared to Fig. 10, Credit HE-Arc CR.
