SHINGLE OF A ROOF – CU ALLOY – MODERN TIMES – SWITZERLAND

Artefact name	Shingle of a roof
Authors	Marianne. Senn (EMPA, Dübendorf, Zurich, Switzerland) & Christian. Degriigny (HE-Arc CR, Neuchâtel, Neuchâtel, Switzerland)
Url	/artefacts/1244/

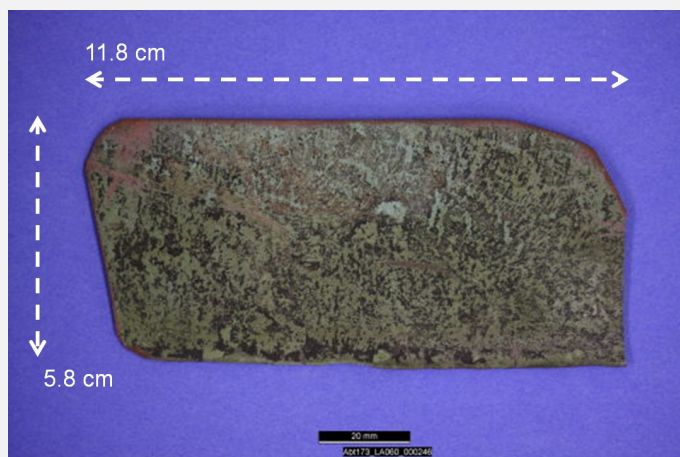
Fig. 1: Shingle of a roof, internal side,

Description of the artefact	Shingle, slightly curved, the internal side is covered with heterogeneously distributed green and black corrosion products (Fig. 1). The external side shows a regular dark green corrosion crust. Dimensions: L = 11.8cm; W = 5.8cm.
Type of artefact	Architectural element
Origin	Roof of the Abbey of St Gallen, Sankt Gallen, Saint Gallen, Switzerland
Recovering date	None
Chronology category	Modern Times
chronology tpq	1780 A.D. ▼
chronology taq	----- ▼
Chronology comment

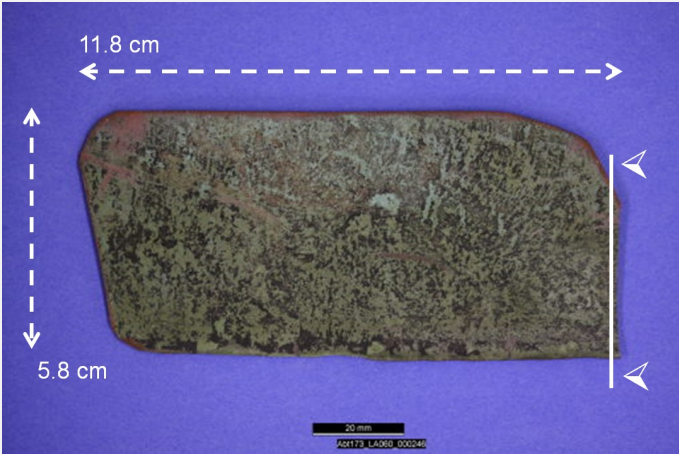
Fig. 2: Location of sampling area,

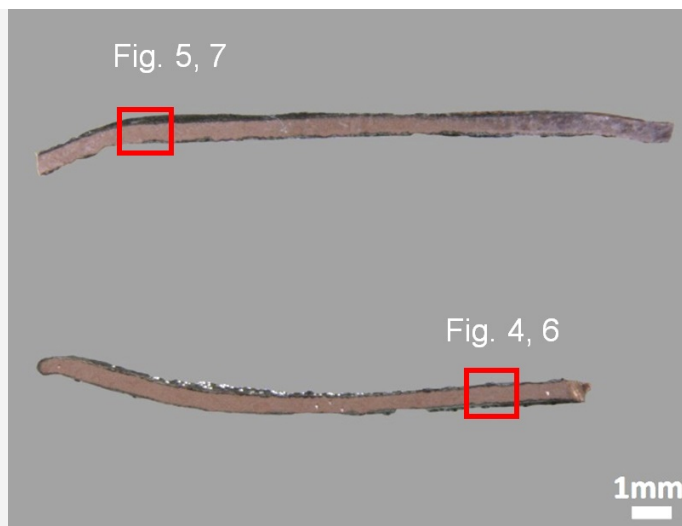
Fig. 3: Micrograph of the cross-sections of the sample taken from the shingle showing the location of Figs. 4 to 7,

Description of sample	Two samples were taken (Fig. 3). The polished samples show a well-preserved metal surface with a thin corrosion crust. T = 0.5mm.
Alloy	Cu Alloy
Technology	Rolled (probably hot rolling) and annealed
Lab number of sample	MAH-98-257
Sample location	HE-Arc CR (Degrigny Christian), Neuchâtel, Neuchâtel
Responsible institution	Conservation Department of the Musées d'art et d'histoire, Genève, Geneva
Date and aim of sampling	2009, integration of sample to the MIFAC-Metal project (Degrigny, 2016)

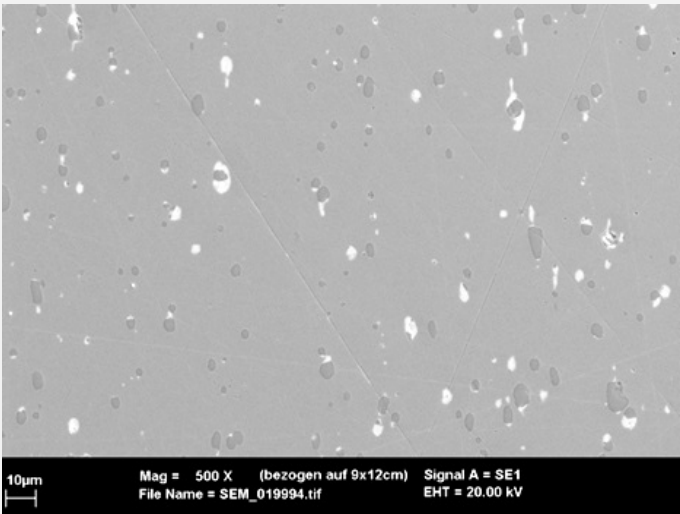
The remaining metal is a copper alloy (Table 1). The evenly distributed inclusions observed under SEM, SE-mode, are either light-grey or white (Fig. 4). The oval shape of the light-grey inclusions is due to deformation, probably by hot rolling (a common technique in the 18th century). Under polarised light they look red (Fig. 6) and their analysis reveals a composition similar to cuprite/Cu₂O (Table 2). The white inclusions are rich in Pb and are remnants of the refining process (Table 2). The etched copper shows a structure of polygonal and twinned grains (Fig. 5). The grain size is variable. The average hardness of the metal is about HV1 70.

Fig. 4: SEM image, SE-mode, of the metal sample from Fig. 3 (detail). Light-grey and white inclusions are distributed evenly,

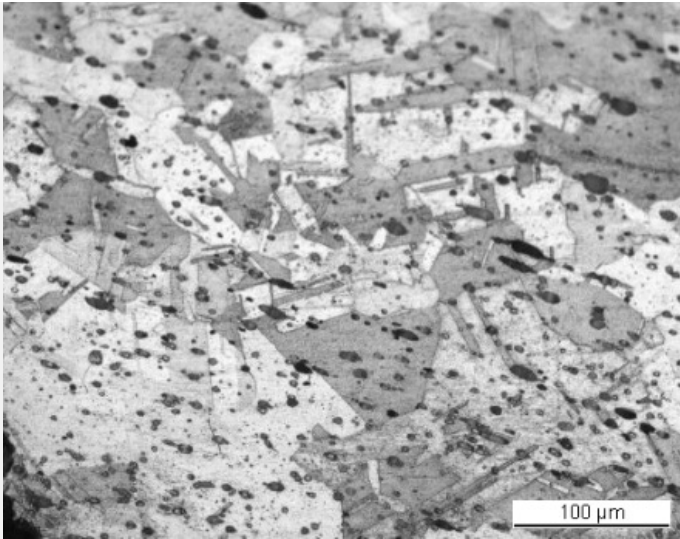
Fig. 5: Micrograph of the metal sample from Fig. 3 (detail), etched, bright field. The metal shows a structure of polygonal and twinned grains. Cuprite inclusions appear as dark spots,

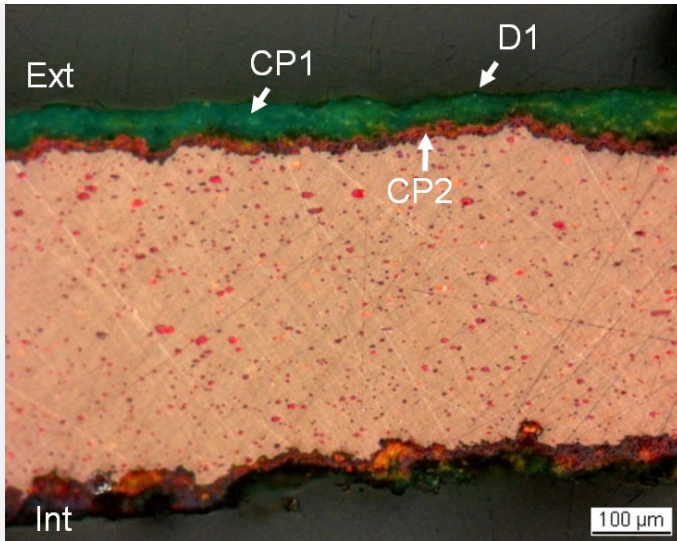
The corrosion crusts of the external and internal sides are distinctively different (Fig. 6). On the internal side an irregular reddish-orange corrosion layer has developed, and pitting corrosion has occurred. The more uniform corrosion layers on the external side consist of a reddish-orange layer, with a thicker green layer above. In some areas, dark-red corrosion products can be observed between the green and reddish-orange sub-layers. The same dark-red sub-layer can be seen in areas on the internal side covering the reddish-orange corrosion products. The reddish-orange corrosion layer on both sides (CP2) has a chemical composition similar to cuprite/Cu₂O, while the green layer on the external side (CP1) contains Cu, S and O and is enriched on its upper surface with Si (Table 3 and Fig. 7). XRD analysis of the corrosion products on the external side of another shingle fragment from the same roof identified brochantite/Cu₄SO₄(OH)₆ and cuprite as corrosion products (Rapport d'analyse no. MAH 98-257). These results are confirmed by Raman spectroscopy of the external side of this sample where the same compounds were clearly identified (Figs. 8 and 9).

Fig. 6: Micrograph of the metal sample from Fig. 3 and corresponding to the stratigraphy of Fig. 10, polarised light. External side: the regular corrosion crust with outer green,

inner red-orange corrosion products and intermediate dark-red corrosion products. Internal side: the irregular corrosion crust with inner red-orange and outer dark-red corrosion products,

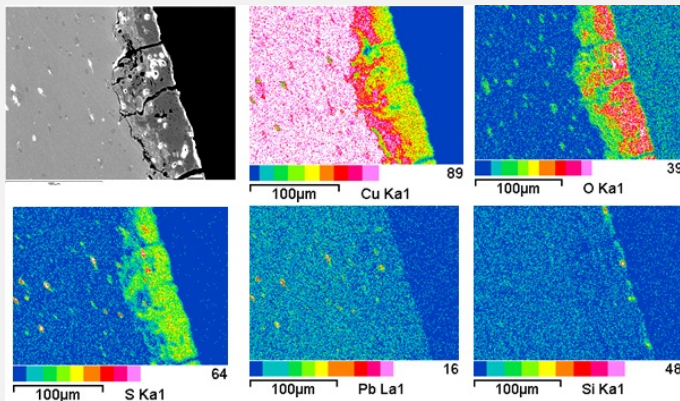
Fig. 7: SEM image, SE-mode, and elemental chemical distribution of a selected area on the external side (rotated image, detail of Fig. 3). Method of examination: SEM/EDS, Laboratory of Analytical Chemistry, Empa,

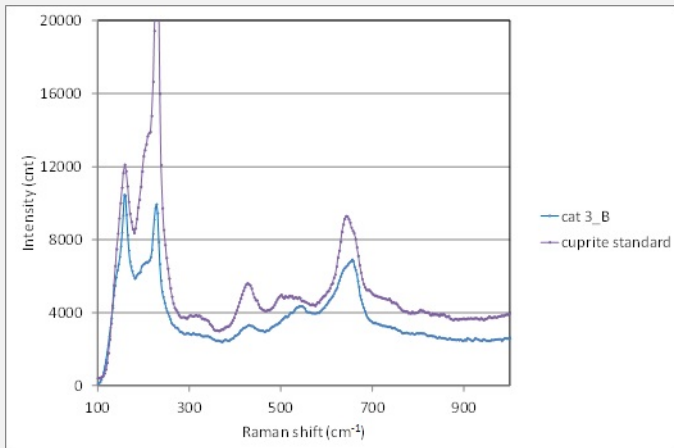
Fig. 8: Raman spectrum of the red-orange inner corrosion layer (CP2) of the external side (cat3_B) compared to a cuprite standard spectrum. Settings: laser wavelength 532nm, acquisition time 100s, one accumulation, filter D2 (0.75-0.8 mW), hole 500, slit 80, grating 600. Method of analysis: Raman spectroscopy, Lab Swiss National Museum, Affoltern a. Albis ZH,

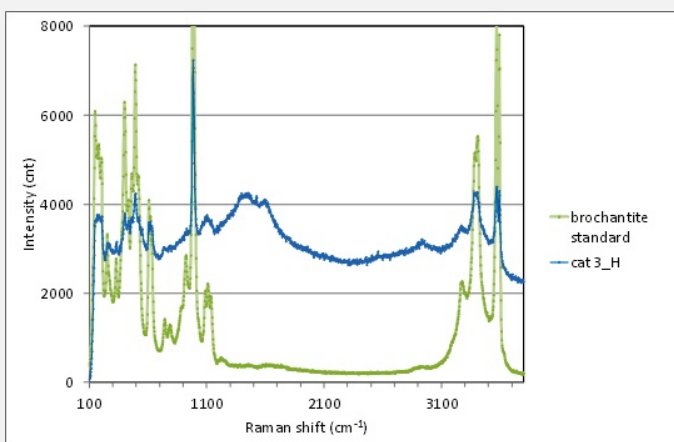
Fig. 9: Raman spectrum of the green outer corrosion layer (CP1) of the external side (cat3_H) compared to a brochantite standard spectrum. Settings: laser wavelength 532nm, acquisition time 100s, one accumulation, filter D2 (0.75-0.8 mW), hole 500, slit 80, grating 600. The peak indicated with an arrow on the cat3_H spectrum is due to fluorescence. Method of analysis: Raman spectroscopy, Lab Swiss National Museum, Affoltern a. Albis ZH,

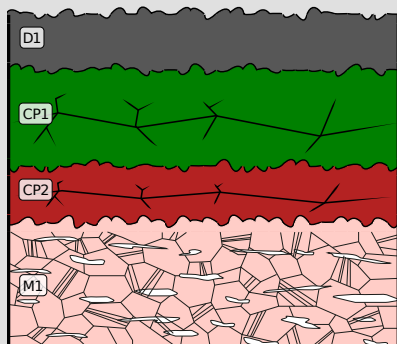
Fig. 10: Stratigraphic representation of the sample taken from the shingle in cross-section (dark field) using the MiCorr application. The characteristics of the strata are only accessible by clicking on the drawing that redirects you to the search tool by stratigraphy representation. This representation can be compared to Fig. 6, Credit HE-Arc CR.
