# SHINGLE OF A ROOF – CU ALLOY – MODERN TIMES – SWITZERLAND

**Artefact name** Shingle of a roof

**Authors** Marianne. Senn (EMPA, Dübendorf, Zurich, Switzerland) & Christian. Degriigny (HE-Arc CR, Neuchâtel, Neuchâtel, Switzerland)

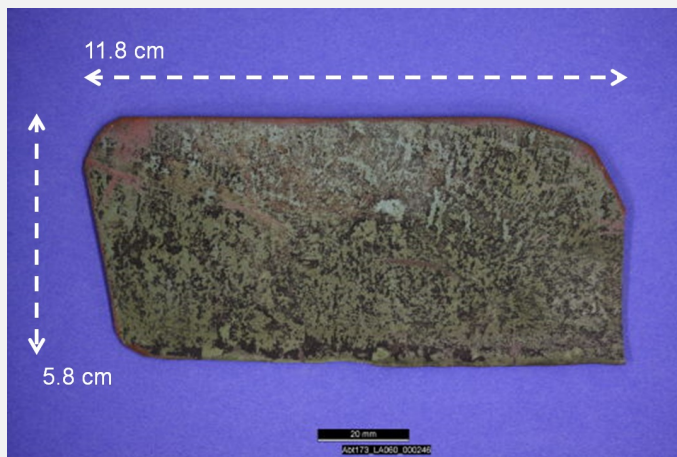
Fig. 1: Shingle of a roof, internal side,

<b>Description of the artefact</b>	Shingle, slightly curved, the internal side is covered with heterogeneously distributed green and black corrosion products (Fig. 1). The external side shows a regular dark green corrosion crust. Dimensions: L = 11.8cm; W = 5.8cm.
<b>Type of artefact</b>	Architectural element
<b>Origin</b>	Roof of the Abbey of St Gallen, Sankt Gallen, Saint Gallen, Switzerland
<b>Recovering date</b>	None
<b>Chronology category</b>	Modern Times
<b>chronology tpq</b>	<input type="text" value="1780"/> A.D. ▾
<b>chronology taq</b>	<input type="text" value=""/> ---- ▾
<b>Chronology comment</b>

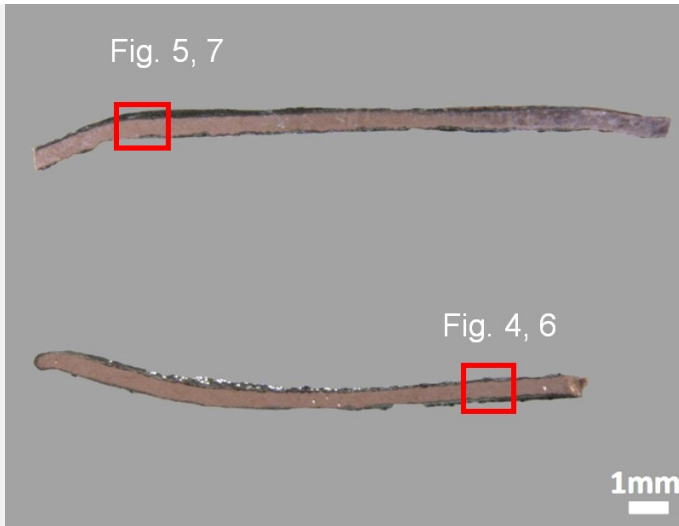
Fig. 3: Micrograph of the cross-sections of the sample taken from the shingle showing the location of Figs. 4 to 7,

<b>Description of sample</b>	Two samples were taken (Fig. 3). The polished samples show a well-preserved metal surface with a thin corrosion crust. T = 0.5mm.
<b>Alloy</b>	Cu Alloy
<b>Technology</b>	Rolled (probably hot rolling) and annealed
<b>Lab number of sample</b>	MAH-98-257
<b>Sample location</b>	HE-Arc CR (Degrigny Christian), Neuchâtel, Neuchâtel
<b>Responsible institution</b>	Conservation Department of the Musées d'art et d'histoire, Genève, Geneva
<b>Date and aim of sampling</b>	2009, integration of sample to the MIFAC-Metal project (Degrigny, 2016)

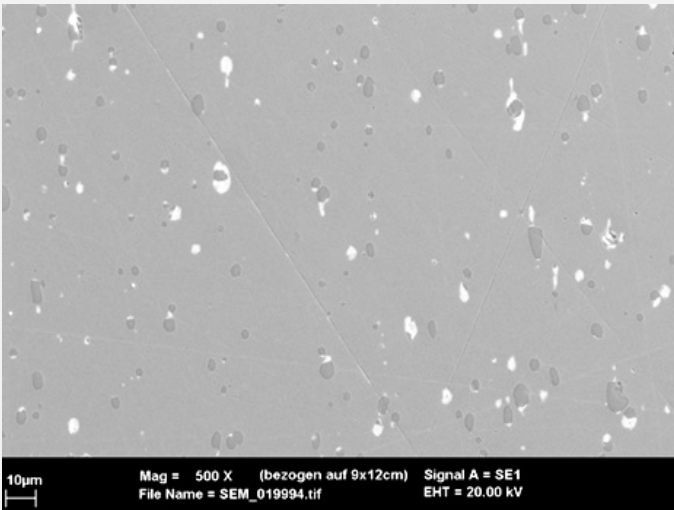
The remaining metal is a copper alloy (Table 1). The evenly distributed inclusions observed under SEM, SE-mode, are either light-grey or white (Fig. 4). The oval shape of the light-grey inclusions is due to deformation, probably by hot rolling (a common technique in the 18th century). Under polarised light they look red (Fig. 6) and their analysis reveals a composition similar to cuprite/Cu<sub>2</sub>O (Table 2). The white inclusions are rich in Pb and are remnants of the refining process (Table 2). The etched copper shows a structure of polygonal and twinned grains (Fig. 5). The grain size is variable. The average hardness of the metal is about HV1 70.

Table 2: Chemical composition (mass %, <: below the detection limit) of the inclusions in the metal (from Fig. 4). Method of analysis: SEM/EDS, Laboratory of Analytical Chemistry, Empa.

Fig. 4: SEM image, SE-mode, of the metal sample from Fig. 3 (detail). Light-grey and white inclusions are distributed evenly,

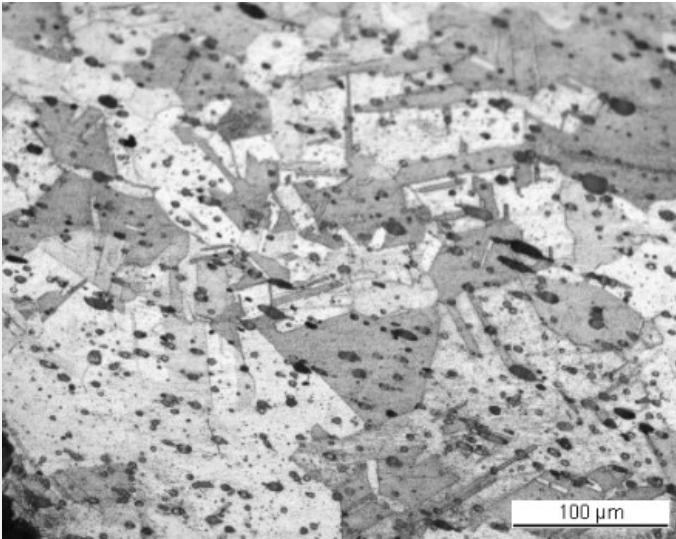
Fig. 5: Micrograph of the metal sample from Fig. 3 (detail), etched, bright field. The metal shows a structure of polygonal and twinned grains. Cuprite inclusions appear as dark spots,

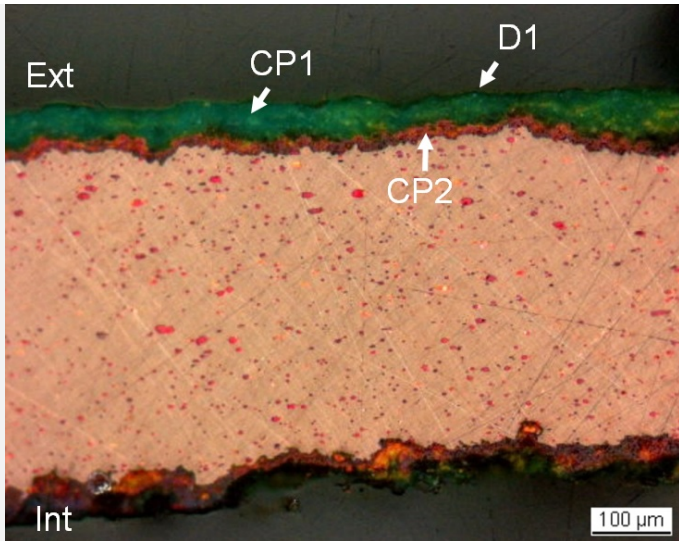
The corrosion crusts of the external and internal sides are distinctively different (Fig. 6). On the internal side an irregular reddish-orange corrosion layer has developed, and pitting corrosion has occurred. The more uniform corrosion layers on the external side consist of a reddish-orange layer, with a thicker green layer above. In some areas, dark-red corrosion products can be observed between the green and reddish-orange sub-layers. The same dark-red sub-layer can be seen in areas on the internal side covering the reddish-orange corrosion products. The reddish-orange corrosion layer on both sides (CP2) has a chemical composition similar to cuprite/Cu<sub>2</sub>O, while the green layer on the external side (CP1) contains Cu, S and O and is enriched on its upper surface with Si (Table 3 and Fig. 7). XRD analysis of the corrosion products on the external side of another shingle fragment from the same roof identified brochantite/Cu<sub>4</sub>SO<sub>4</sub>(OH)<sub>6</sub> and cuprite as corrosion products (Rapport d'analyse no. MAH 98-257). These results are confirmed by Raman spectroscopy of the external side of this sample where the same compounds were clearly identified (Figs. 8 and 9).

Fig. 6: Micrograph of the metal sample from Fig. 3 and corresponding to the stratigraphy of Fig. 10, polarised light. External side: the regular corrosion crust with outer green,

inner red-orange corrosion products and intermediate dark-red corrosion products. Internal side: the irregular corrosion crust with inner red-orange and outer dark-red corrosion products,

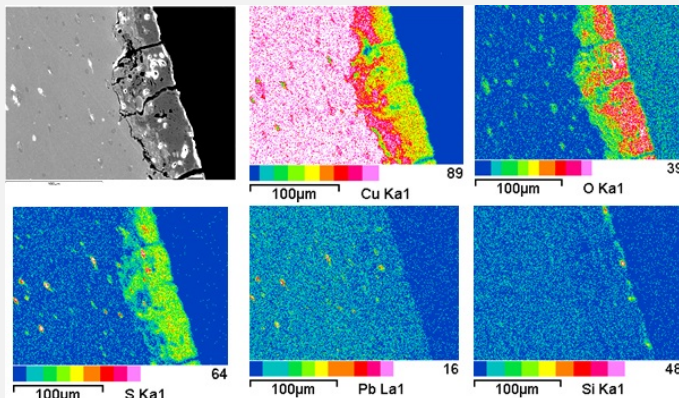
Table 3: Chemical composition (mass %, <: below the detection limit) of the corrosion layers of the external side. Method of analysis: SEM/EDS, Laboratory of Analytical Chemistry, Empa.

Fig. 7: SEM image, SE-mode, and elemental chemical distribution of a selected area on the external side (rotated image, detail of Fig. 3). Method of examination: SEM/EDS, Laboratory of Analytical Chemistry, Empa,

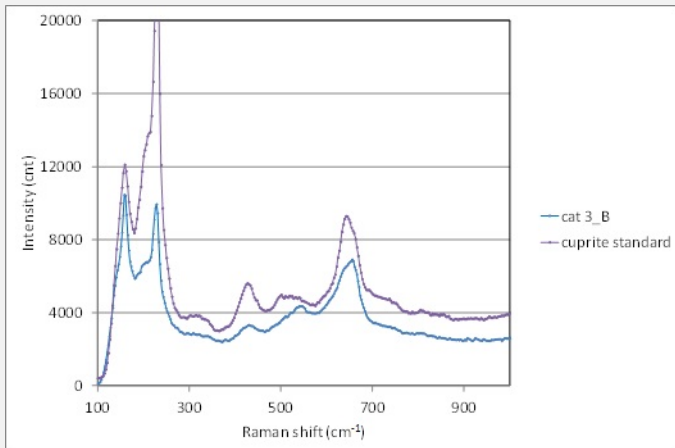
Fig. 8: Raman spectrum of the red-orange inner corrosion layer (CP2) of the external side (cat3\_B) compared to a cuprite standard spectrum. Settings: laser wavelength 532nm, acquisition time 100s, one accumulation, filter D2 (0.75-0.8 mW), hole 500, slit 80, grating 600. Method of analysis: Raman spectroscopy, Lab Swiss National Museum, Affoltern a. Albis ZH,

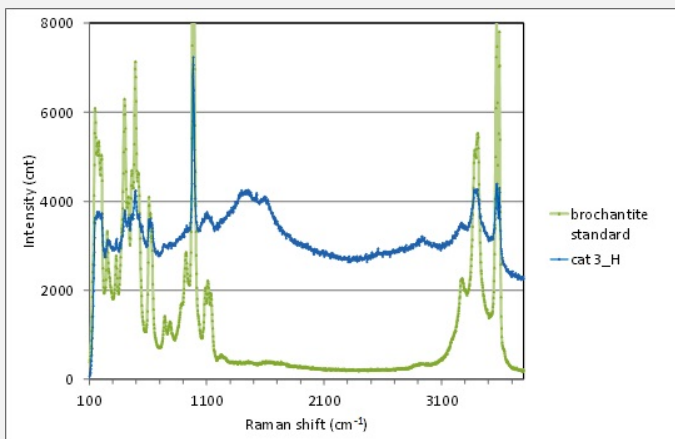
Fig. 9: Raman spectrum of the green outer corrosion layer (CP1) of the external side (cat3\_H) compared to a brochantite standard spectrum. Settings: laser wavelength 532nm, acquisition time 100s, one accumulation, filter D2 (0.75-0.8 mW), hole 500, slit 80, grating 600. The peak indicated with an arrow on the cat3\_H spectrum is due to fluorescence. Method of analysis: Raman spectroscopy, Lab Swiss National Museum, Affoltern a. Albis ZH,

The copper shingle was rolled (probably hot rolling) and annealed to recover the ductility of the original material. The metal is covered on its external side by a typical "urban outdoor" patina consisting of copper sulphate (brochantite/ $\text{Cu}_4(\text{OH})_6\text{SO}_4$ ) formed on top of a cuprite/ $\text{Cu}_2\text{O}$  layer. The surface of the internal side, protected from the dilute sulphuric acid present in urban rainwater, has mainly developed a layer of cuprite. The silica present in the brochantite on the external side is due to airborne particle pollution. The corrosion is probably of type 1 after Robbiola et al. 1998.

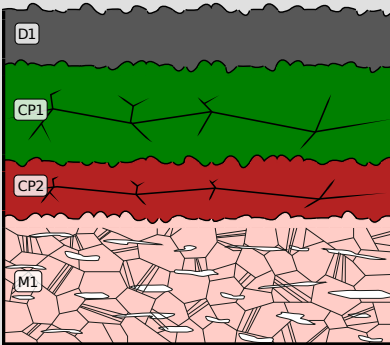
Fig. 10: Stratigraphic representation of the sample taken from the shingle in cross-section (dark field) using the MiCorr application. The characteristics of the strata are only accessible by clicking on the drawing that redirects you to the search tool by stratigraphy representation. This representation can be compared to Fig. 6, Credit HE-Arc CR.
