SHINGLE OF A ROOF – CU ALLOY – MODERN TIMES – SWITZERLAND

Artefact name Shingle of a roof

Authors Marianne. Senn (EMPA, Dübendorf, Zurich, Switzerland) & Christian. Degrygn (HE-Arc CR, Neuchâtel, Neuchâtel, Switzerland)

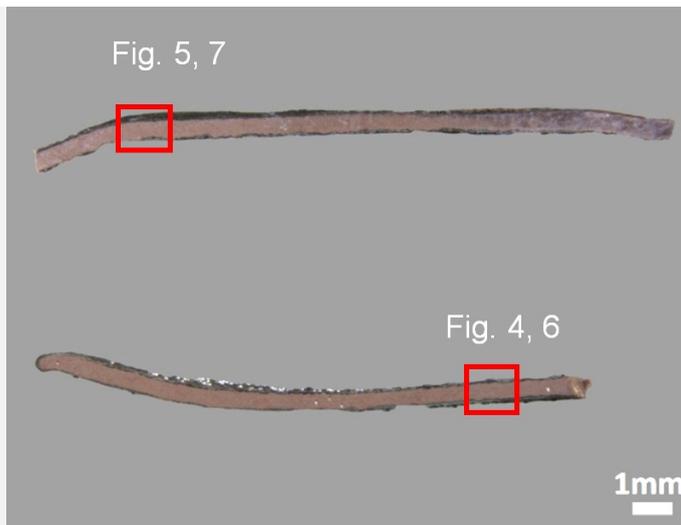
Fig. 3: Micrograph of the cross-sections of the sample taken from the shingle showing the location of Figs. 4 to 7,

Description of sample	Two samples were taken (Fig. 3). The polished samples show a well-preserved metal surface with a thin corrosion crust. T = 0.5mm.
Alloy	Cu Alloy
Technology	Rolled (probably hot rolling) and annealed
Lab number of sample	MAH-98-257
Sample location	HE-Arc CR (Degrigny Christian), Neuchâtel, Neuchâtel
Responsible institution	Conservation Department of the Musées d'art et d'histoire, Genève, Geneva
Date and aim of sampling	2009, integration of sample to the MIFAC-Metal project (Degrigny, 2016)

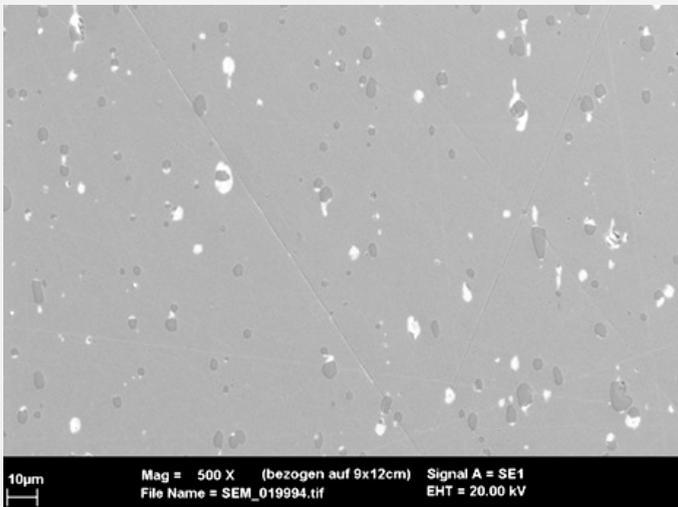
The remaining metal is a copper alloy (Table 1). The evenly distributed inclusions observed under SEM, SE-mode, are either light-grey or white (Fig. 4). The oval shape of the light-grey inclusions is due to deformation, probably by hot rolling (a common technique in the 18th century). Under polarised light they look red (Fig. 6) and their analysis reveals a composition similar to cuprite/Cu₂O (Table 2). The white inclusions are rich in Pb and are remnants of the refining process (Table 2). The etched copper shows a structure of polygonal and twinned grains (Fig. 5). The grain size is variable. The average hardness of the metal is about HV1 70.

Elements	O	Cu	Pb	As	Sb	Total
Light-grey inclusion	10	86	<	<	<	96
White inclusion	9	9	68	5	3	94

Fig. 4: SEM image, SE-mode, of the metal sample from Fig. 3 (detail). Light-grey and white inclusions are distributed evenly,

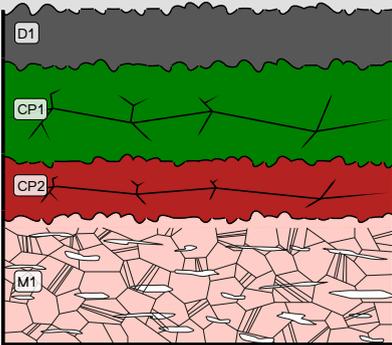
Fig. 10: Stratigraphic representation of the sample taken from the shingle in cross-section (dark field) using the MiCorr application. The characteristics of the strata are only accessible by clicking on the drawing that redirects you to the search tool by stratigraphy representation. This representation can be compared to Fig. 6, Credit HE-Arc CR.

The copper shingle was rolled (probably hot rolling) and annealed to recover the ductility of the original material. The metal is covered on its external side by a typical “urban outdoor” patina consisting of copper sulphate (brochantite/ $\text{Cu}_4(\text{OH})_6\text{SO}_4$) formed on top of a cuprite/ Cu_2O layer. The surface of the internal side, protected from the dilute sulphuric acid present in urban rainwater, has mainly developed a layer of cuprite. The silica present in the brochantite on the external side is due to airborne particle pollution. The corrosion is probably of type 1 after Robbiola et al. 1998.
