SHINGLE OF A ROOF – CU ALLOY – MODERN TIMES – SWITZERLAND

Artefact name Shingle of a roof

Authors Marianne. Senn (EMPA, Dübendorf, Zurich, Switzerland) & Christian. Degriigny (HE-Arc CR, Neuchâtel, Neuchâtel, Switzerland)

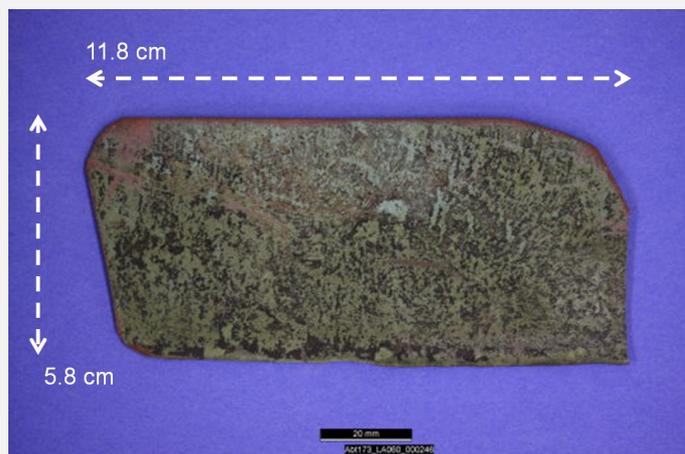
Fig. 1: Shingle of a roof, internal side,

Description of the artefact	Shingle, slightly curved, the internal side is covered with heterogeneously distributed green and black corrosion products (Fig. 1). The external side shows a regular dark green corrosion crust. Dimensions: L = 11.8cm; W = 5.8cm.
Type of artefact	Architectural element
Origin	Roof of the Abbey of St Gallen, Sankt Gallen, Saint Gallen, Switzerland
Recovering date	None
Chronology category	Modern Times
chronology tpq	<input type="text" value="1780"/> A.D. ▼
chronology taq	<input type="text" value="----"/> ▼
Chronology comment

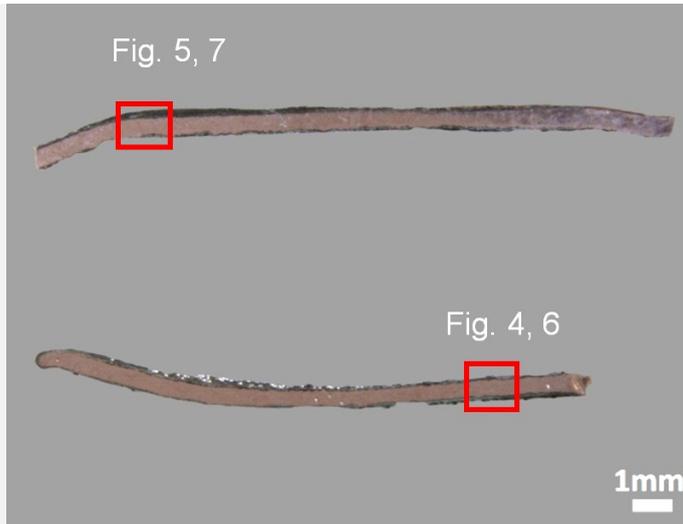
Fig. 3: Micrograph of the cross-sections of the sample taken from the shingle showing the location of Figs. 4 to 7,

Description of sample	Two samples were taken (Fig. 3). The polished samples show a well-preserved metal surface with a thin corrosion crust. T = 0.5mm.
Alloy	Cu Alloy
Technology	Rolled (probably hot rolling) and annealed
Lab number of sample	MAH-98-257
Sample location	HE-Arc CR (Degrigny Christian), Neuchâtel, Neuchâtel
Responsible institution	Conservation Department of the Musées d'art et d'histoire, Genève, Geneva
Date and aim of sampling	2009, integration of sample to the MIFAC-Metal project (Degrigny, 2016)

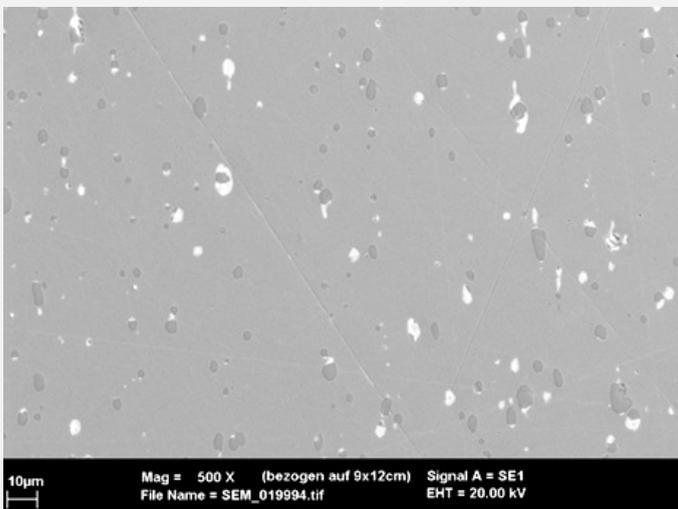
The remaining metal is a copper alloy (Table 1). The evenly distributed inclusions observed under SEM, SE-mode, are either light-grey or white (Fig. 4). The oval shape of the light-grey inclusions is due to deformation, probably by hot rolling (a common technique in the 18th century). Under polarised light they look red (Fig. 6) and their analysis reveals a composition similar to cuprite/Cu₂O (Table 2). The white inclusions are rich in Pb and are remnants of the refining process (Table 2). The etched copper shows a structure of polygonal and twinned grains (Fig. 5). The grain size is variable. The average hardness of the metal is about HV1 70.

Table 2: Chemical composition (mass %, <: below the detection limit) of the inclusions in the metal (from Fig. 4). Method of analysis: SEM/EDS, Laboratory of Analytical Chemistry, Empa.

Fig. 4: SEM image, SE-mode, of the metal sample from Fig. 3 (detail). Light-grey and white inclusions are distributed evenly,

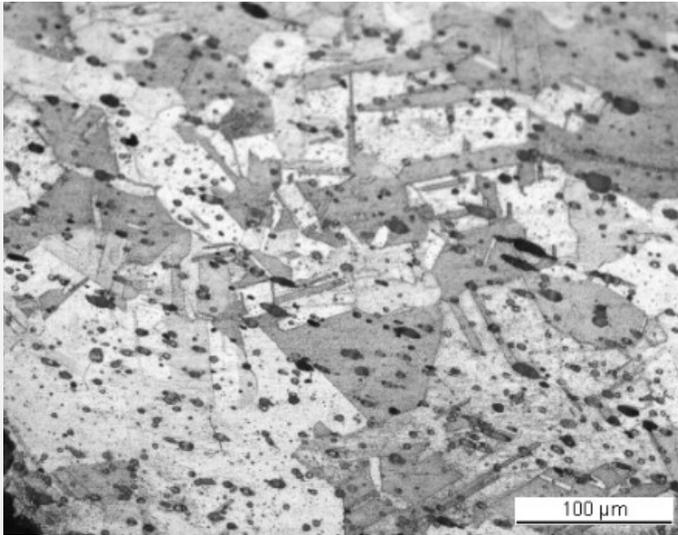
Fig. 5: Micrograph of the metal sample from Fig. 3 (detail), etched, bright field. The metal shows a structure of polygonal and twinned grains. Cuprite inclusions appear as dark spots,

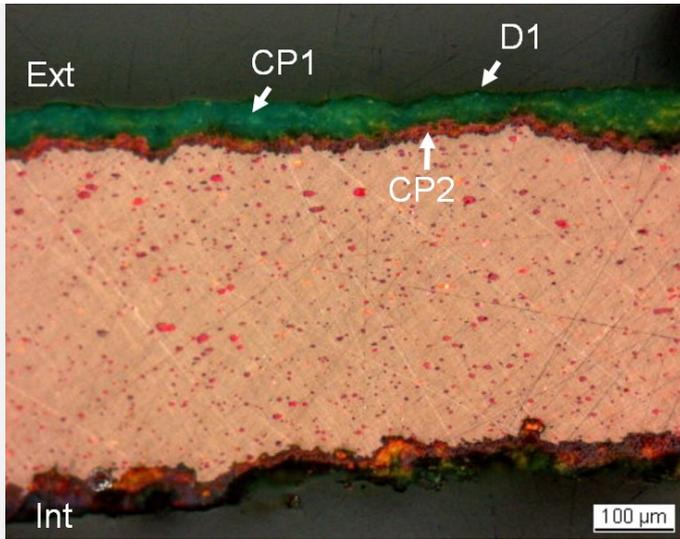
The corrosion crusts of the external and internal sides are distinctively different (Fig. 6). On the internal side an irregular reddish-orange corrosion layer has developed, and pitting corrosion has occurred. The more uniform corrosion layers on the external side consist of a reddish-orange layer, with a thicker green layer above. In some areas, dark-red corrosion products can be observed between the green and reddish-orange sub-layers. The same dark-red sub-layer can be seen in areas on the internal side covering the reddish-orange corrosion products. The reddish-orange corrosion layer on both sides (CP2) has a chemical composition similar to cuprite/ Cu_2O , while the green layer on the external side (CP1) contains Cu, S and O and is enriched on its upper surface with Si (Table 3 and Fig. 7). XRD analysis of the corrosion products on the external side of another shingle fragment from the same roof identified brochantite/ $\text{Cu}_4\text{SO}_4(\text{OH})_6$ and cuprite as corrosion products (Rapport d'analyse no. MAH 98-257). These results are confirmed by Raman spectroscopy of the external side of this sample where the same compounds were clearly identified (Figs. 8 and 9).

Fig. 6: Micrograph of the metal sample from Fig. 3 and corresponding to the stratigraphy of Fig. 10, polarised light. External side: the regular corrosion crust with outer green, inner red-orange corrosion products and intermediate dark-red corrosion products. Internal side: the irregular corrosion crust with inner red-orange and outer dark-red corrosion products,

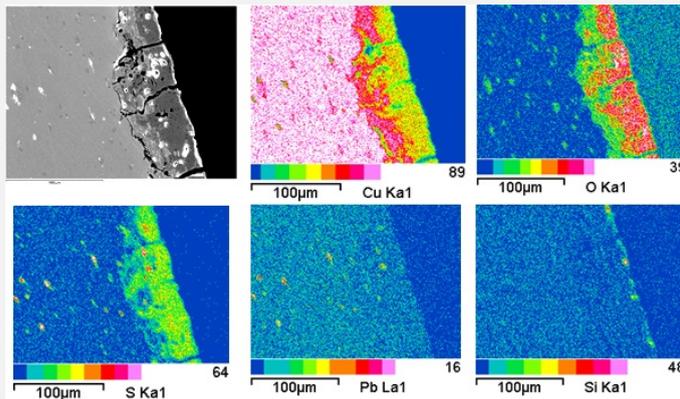
Table 3: Chemical composition (mass %, <: below the detection limit) of the corrosion layers of the external side. Method of analysis: SEM/EDS, Laboratory of Analytical Chemistry, Empa.

Fig. 7: SEM image, SE-mode, and elemental chemical distribution of a selected area on the external side (rotated image, detail of Fig. 3). Method of examination: SEM/EDS, Laboratory of Analytical Chemistry, Empa,

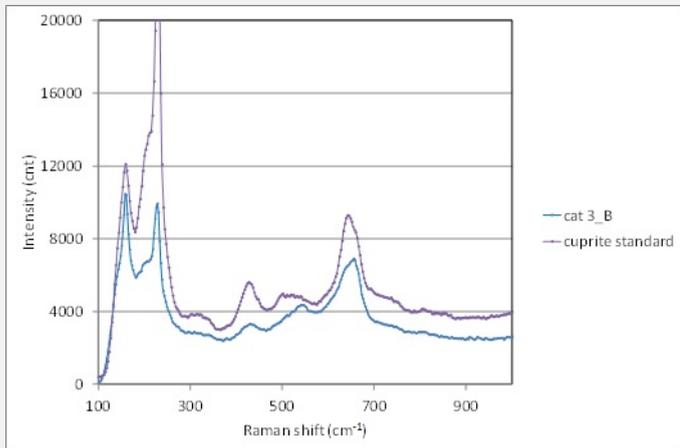
Fig. 8: Raman spectrum of the red-orange inner corrosion layer (CP2) of the external side (cat3_B) compared to a cuprite standard spectrum. Settings: laser wavelength 532nm, acquisition time 100s, one accumulation, filter D2 (0.75-0.8 mW), hole 500, slit 80, grating 600. Method of analysis: Raman spectroscopy, Lab Swiss National Museum, Affoltern a. Albis ZH,

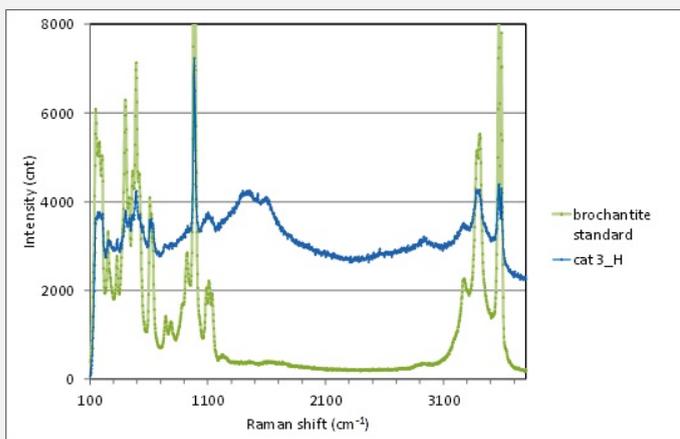
Fig. 9: Raman spectrum of the green outer corrosion layer (CP1) of the external side (cat3_H) compared to a brochantite standard spectrum. Settings: laser wavelength 532nm, acquisition time 100s, one accumulation, filter D2 (0.75-0.8 mW), hole 500, slit 80, grating 600. The peak indicated with an arrow on the cat3_H spectrum is due to fluorescence. Method of analysis: Raman spectroscopy, Lab Swiss National Museum, Affoltern a. Albis ZH,

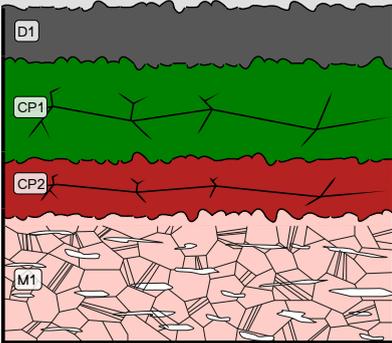
Fig. 10: Stratigraphic representation of the sample taken from the shingle in cross-section (dark field) using the MiCorr application. The characteristics of the strata are only accessible by clicking on the drawing that redirects you to the search tool by stratigraphy representation. This representation can be compared to Fig. 6, Credit HE-Arc CR.

The copper shingle was rolled (probably hot rolling) and annealed to recover the ductility of the original material. The metal is covered on its external side by a typical “urban outdoor” patina consisting of copper sulphate (brochantite/ $\text{Cu}_4(\text{OH})_6\text{SO}_4$) formed on top of a cuprite/ Cu_2O layer. The surface of the internal side, protected from the dilute sulphuric acid present in urban rainwater, has mainly developed a layer of cuprite. The silica present in the brochantite on the external side is due to airborne particle pollution. The corrosion is probably of type 1 after Robbiola et al. 1998.
