CIRCULAR DOOR KNOCKER STRIKING PLATE – CU ALLOY – MODERN TIMES – SWITZERLAND

Artefact name	Circular door knocker striking plate
Authors	Marianne. Senn (Empa, Dübendorf, Zurich, Switzerland) & Christian. Degriigny (HE-Arc CR, Neuchâtel, Neuchâtel, Switzerland)
Url	/artefacts/1245/

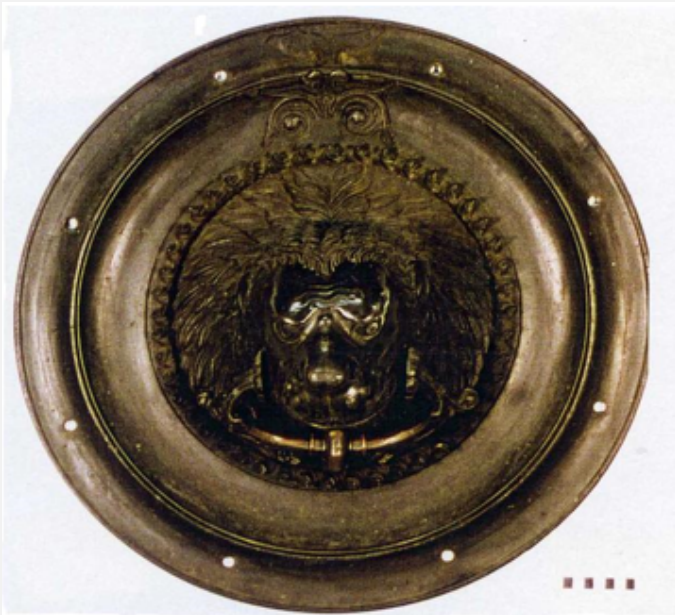
Fig. 1: Circular door knocker striking plate (after Benoît, 1994),

Description of the artefact	Circular striking plate no 2 (from a set of two) of a door knocker with a protruding lion head holding a hinge in his fangs, Ø.ext = 64cm. The circular base is said to be covered by a gilded decorative relief (Fig. 1, Benoît, 1994, 6).
Type of artefact	Architectural element
Origin	Door knocker of Lausanne cathedral, Lausanne, Vaud, Switzerland
Recovering date	Unknown

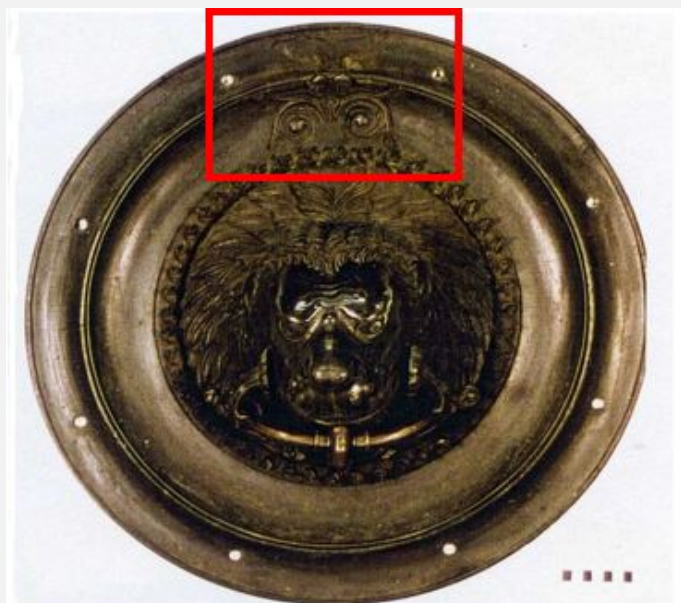
Fig. 2: Possible location of sampling area,

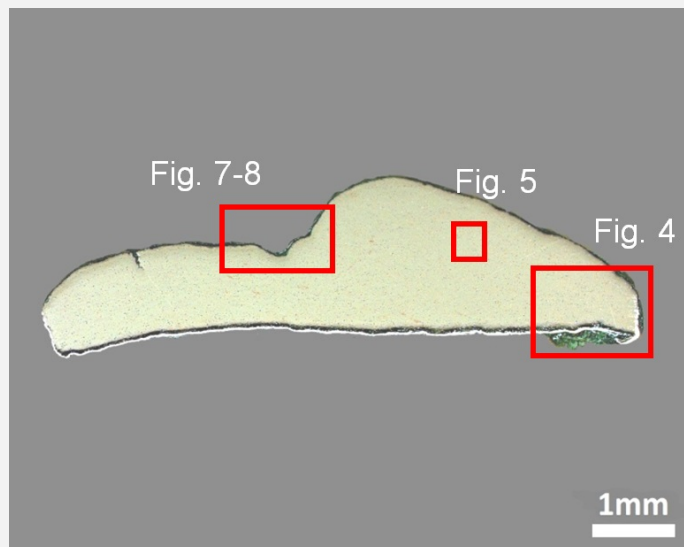
Fig. 3: Micrograph of the cross-section of the sample taken from the circular plate showing the location of Figs. 4 to 5 and 7 to 8,

Description of sample	No information is given on where the sample has been taken. A supposed location is however illustrated in Fig. 2. The polished sample shows a well preserved metal surface with some cracks covered by a thin corrosion crust (Fig. 3).
Alloy	Cu Alloy
Technology	Rolled, annealed after cold working
Lab number of sample	MAH 94-156-001
Sample location	Musées d'art et d'histoire, Genève, Geneva
Responsible institution	Musées d'art et d'histoire, Genève, Geneva
Date and aim of sampling	1994, metallography and presence or not of a gilding treatment

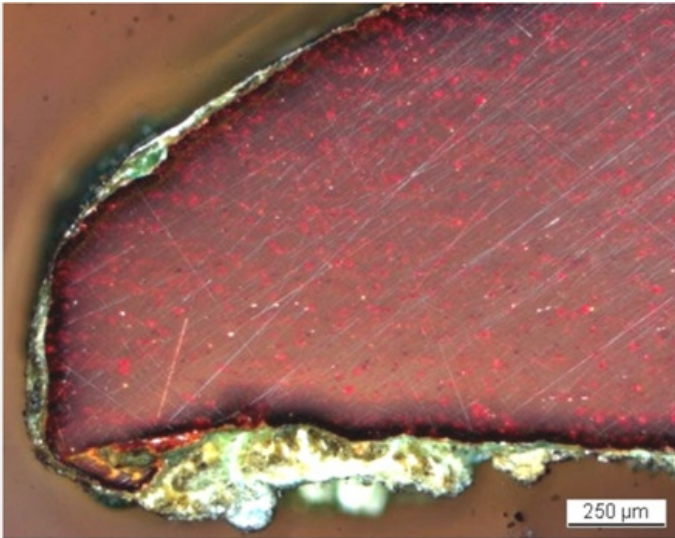
Fig. 4: Micrograph of the metal sample from Fig. 3 (reversed picture), unetched, polarised light. The red copper oxide inclusions form rows in the copper alloy matrix,

The average thickness of the corrosion crust is about 90µm, but may be thinner or thicker depending on the area of origin (Fig. 4). Under polarized light, we observe a multilayer system with a dense and thin inner red corrosion layer (CP2, probably cuprite/Cu₂O) on the metal (Fig. 7) containing chlorides (Fig. 8 and Table 3). This is followed by bands of heterogeneous green corrosion products (CP1, possibly copper chloride / sulphate / carbonate). This outer corrosion layer is contaminated with atmospheric components (Si, Al, Cl, C and O and perhaps gypsum particles (CaSO₄)) (Fig. 8).

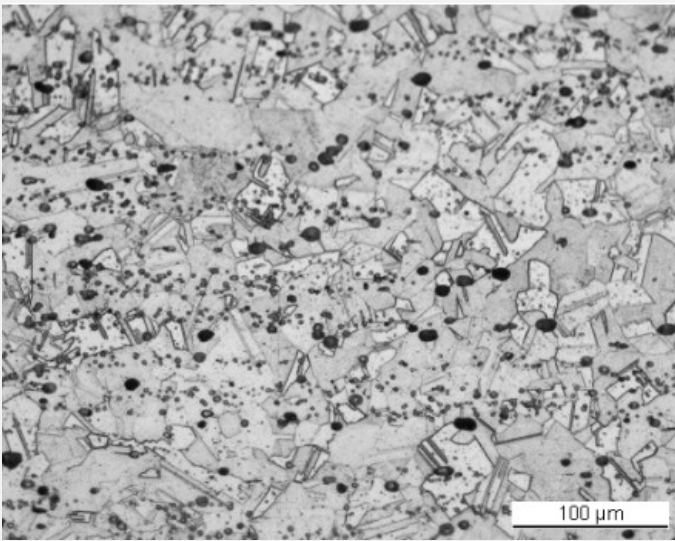
Fig. 5: Micrograph of the metal sample from Fig. 3 (detail), etched, bright field. The metal shows a structure of polygonal and twinned grains. Copper oxide inclusions are visible as dark spots,

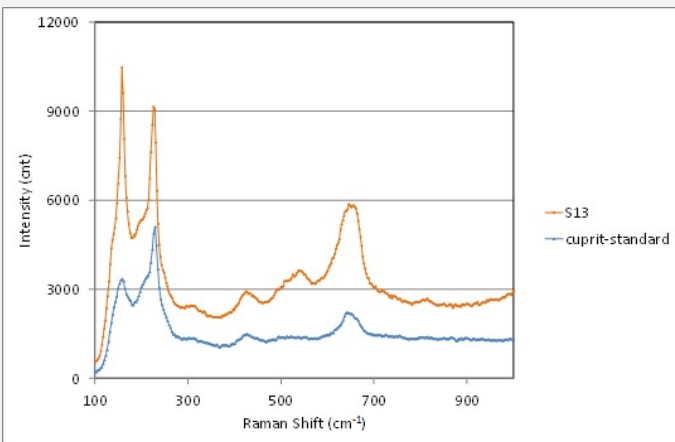
Fig. 6: Raman spectrum of a red inclusion (S13) of Fig. 4 compared to a cuprite standard spectrum. Settings: laser wavelength 532nm, acquisition time 100s, one accumulation, filter D2 (0.75-0.8mW), hole 500, slit 80, grating 600. Method of analysis: Raman spectroscopy. Lab of Swiss National Museum, Affoltern a. Albis ZH,

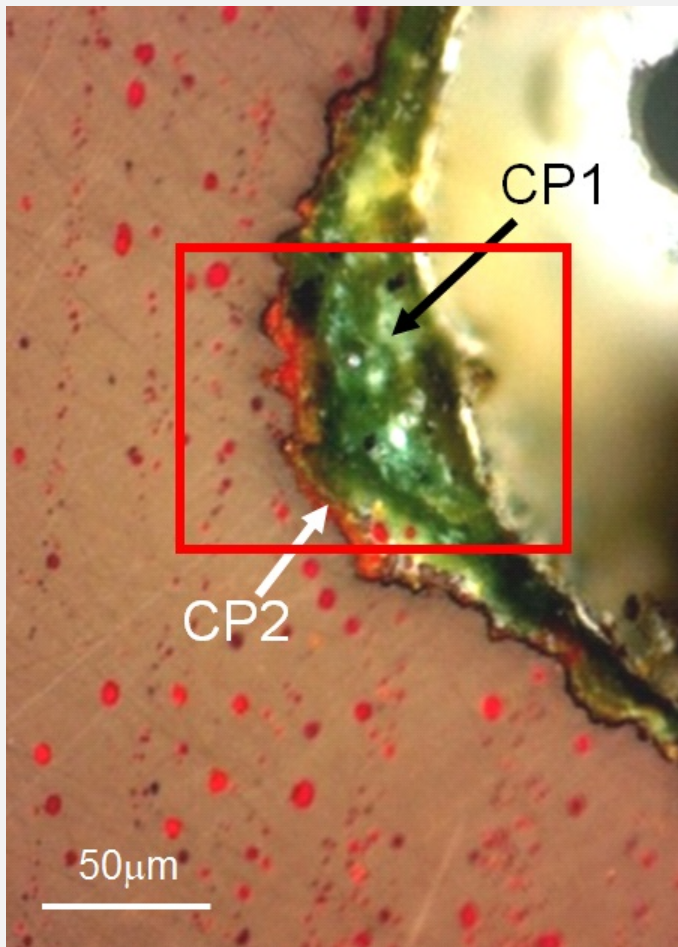
Fig. 7: Micrograph of the metal sample from Fig. 3 (rotated by 90°) and corresponding to the stratigraphy of Fig. 9, polarised light. Metal with red copper oxide inclusions. The black particles in the green corrosion layer are quartz inclusions. The area selected for elemental chemical distribution (Fig. 8) is marked by a red rectangle,

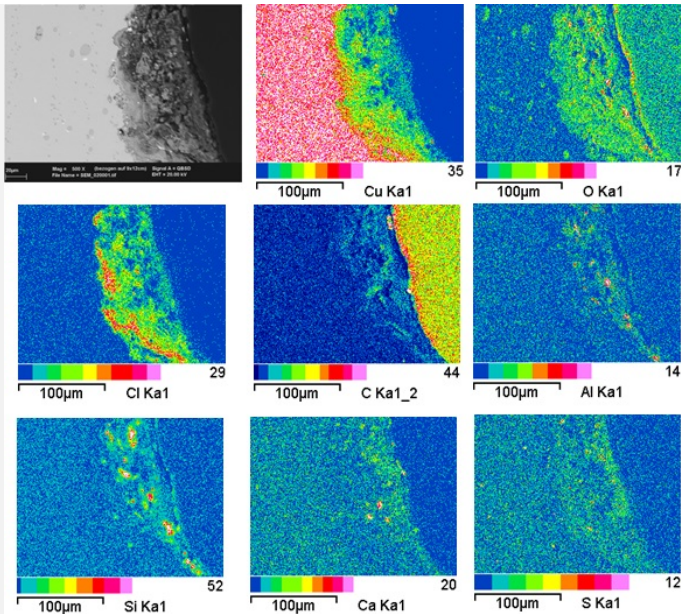
Table 2: Chemical composition (mass %, <: below the detection limit) of the inclusions (light-grey and white in Fig. 8) in the metal. Method of analysis: SEM/EDS, Laboratory of Analytical Chemistry, Empa.

Fig. 8: SEM image, BSE-mode, and elemental chemical distribution of the selected area of Fig. 7. Method of examination: SEM/EDS, Laboratory of Analytical Chemistry, Empa,
