CIRCULAR DOOR KNOCKER STRIKING PLATE – CU ALLOY – MODERN TIMES – SWITZERLAND

Artefact name	Circular door knocker striking plate
Authors	Marianne. Senn (Empa, Dübendorf, Zurich, Switzerland) & Christian. Degriigny (HE-Arc CR, Neuchâtel, Neuchâtel, Switzerland)
Url	/artefacts/1245/

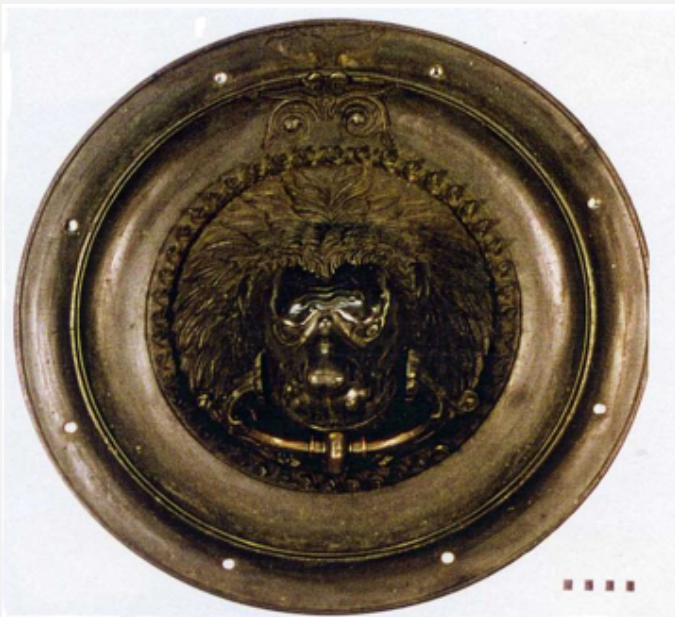
Fig. 1: Circular door knocker striking plate (after Benoît, 1994),

Description of the artefact	Circular striking plate no 2 (from a set of two) of a door knocker with a protruding lion head holding a hinge in his fangs, Ø.ext = 64cm. The circular base is said to be covered by a gilded decorative relief (Fig. 1, Benoit, 1994, 6).
Type of artefact	Architectural element
Origin	Door knocker of Lausanne cathedral, Lausanne, Vaud, Switzerland
Recovering date	Unknown

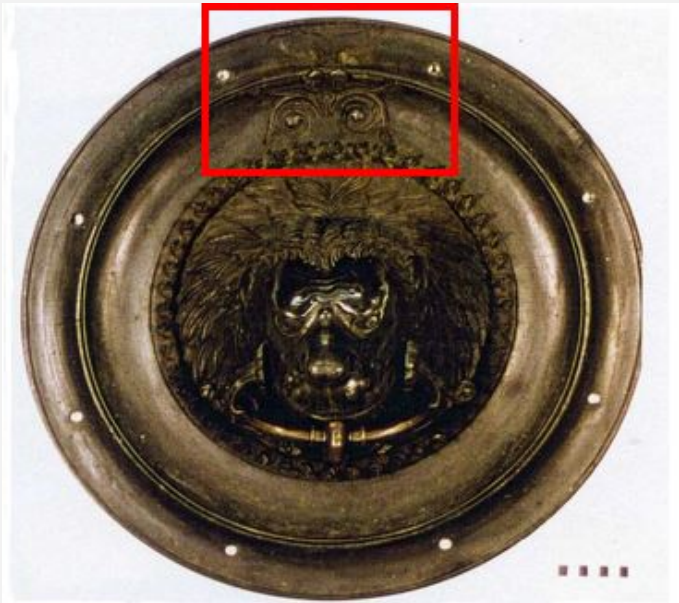
Fig. 2: Possible location of sampling area,

No information is given on where the sample has been taken. A supposed location is however illustrated in Fig. 2. The polished sample shows a well preserved metal surface with some cracks covered by a thin corrosion crust (Fig. 3).

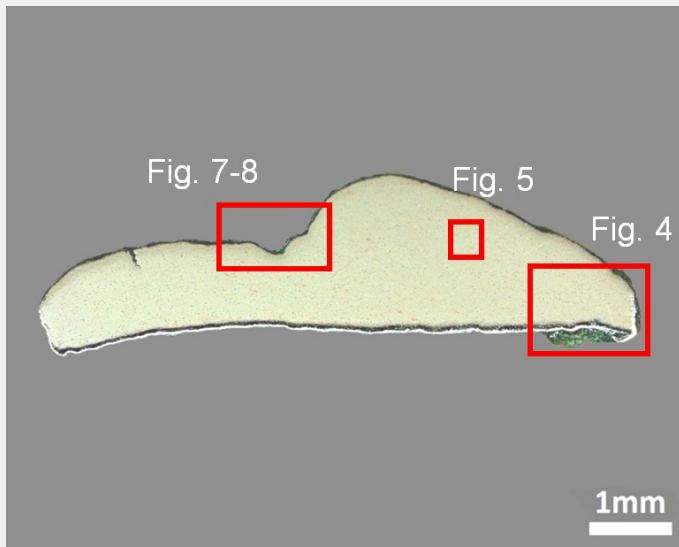
Fig. 3: Micrograph of the cross-section of the sample taken from the circular plate showing the location of Figs. 4 to 5 and 7 to 8,

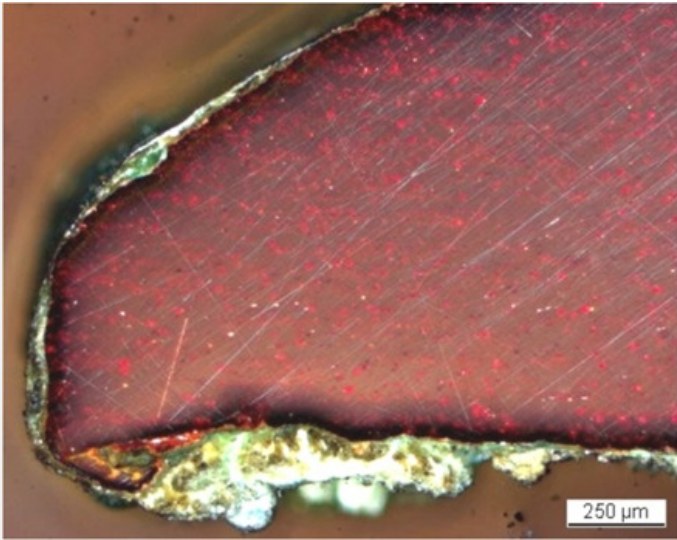
Fig. 4: Micrograph of the metal sample from Fig. 3 (reversed picture), unetched, polarised light. The red copper oxide inclusions form rows in the copper alloy matrix,

The average thickness of the corrosion crust is about 90µm, but may be thinner or thicker depending on the area of origin (Fig. 4). Under polarized light, we observe a multilayer system with a dense and thin inner red corrosion layer (CP2, probably cuprite/Cu₂O) on the metal (Fig. 7) containing chlorides (Fig. 8 and Table 3). This is followed by bands of heterogeneous green corrosion products (CP1, possibly copper chloride / sulphate / carbonate). This outer corrosion layer is contaminated with atmospheric components (Si, Al, Cl, C and O and perhaps gypsum particles (CaSO₄)) (Fig. 8).

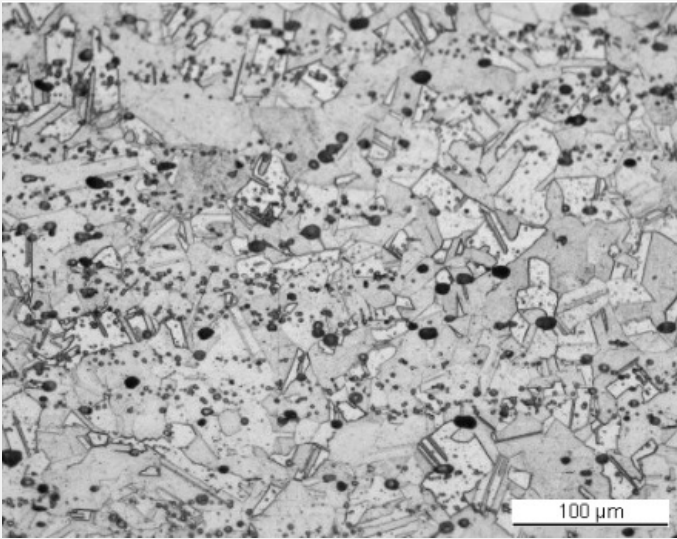
Fig. 5: Micrograph of the metal sample from Fig. 3 (detail), etched, bright field. The metal shows a structure of polygonal and twinned grains. Copper oxide inclusions are visible as dark spots,

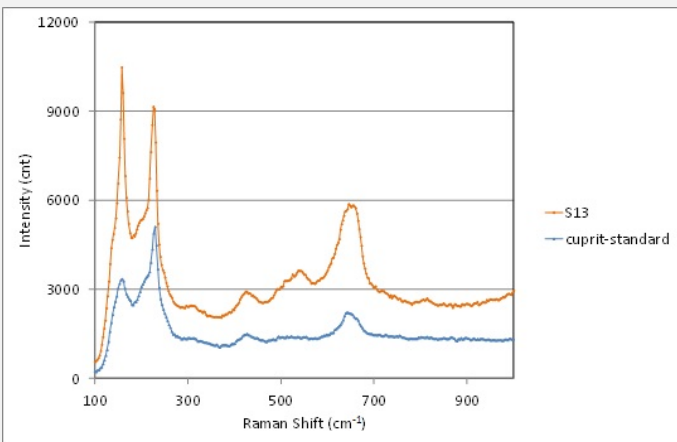
Fig. 6: Raman spectrum of a red inclusion (S13) of Fig. 4 compared to a cuprite standard spectrum. Settings: laser wavelength 532nm, acquisition time 100s, one accumulation, filter D2 (0.75-0.8mW), hole 500, slit 80, grating 600. Method of analysis: Raman spectroscopy. Lab of Swiss National Museum, Affoltern a. Albis ZH,

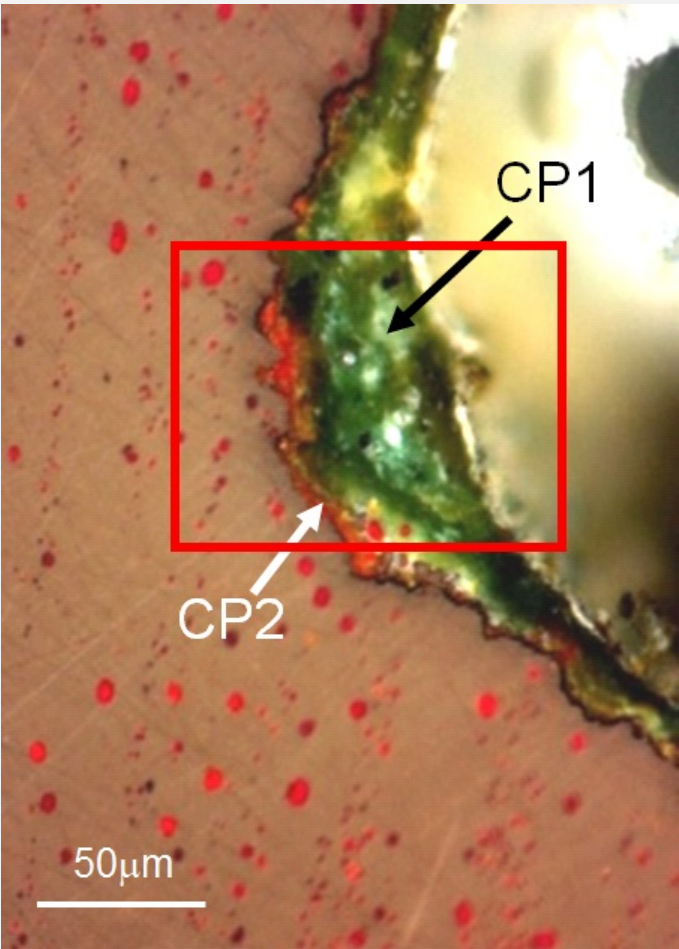
Fig. 7: Micrograph of the metal sample from Fig. 3 (rotated by 90°) and corresponding to the stratigraphy of Fig. 9, polarised light. Metal with red copper oxide inclusions. The black particles in the green corrosion layer are quartz inclusions. The area selected for elemental chemical distribution (Fig. 8) is marked by a red rectangle,

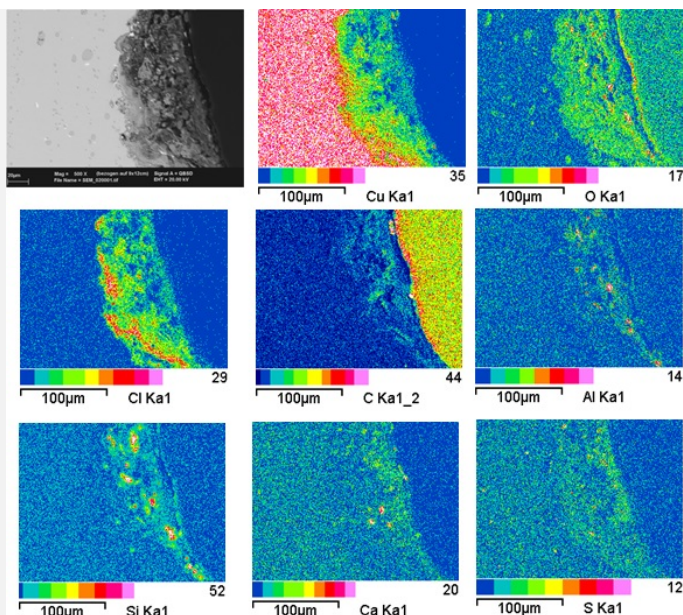
Table 2: Chemical composition (mass %, <: below the detection limit) of the inclusions (light-grey and white in Fig. 8) in the metal. Method of analysis: SEM/EDS, Laboratory of Analytical Chemistry, Empa.

Fig. 8: SEM image, BSE-mode, and elemental chemical distribution of the selected area of Fig. 7. Method of examination: SEM/EDS, Laboratory of Analytical Chemistry, Empa,
