CIRCULAR DOOR KNOCKER STRIKING PLATE – CU ALLOY – MODERN TIMES – SWITZERLAND

Artefact name	Circular door knocker striking plate
Authors	Marianne. Senn (Empa, Dübendorf, Zurich, Switzerland) & Christian. Degriigny (HE-Arc CR, Neuchâtel, Neuchâtel, Switzerland)
Url	/artefacts/1245/

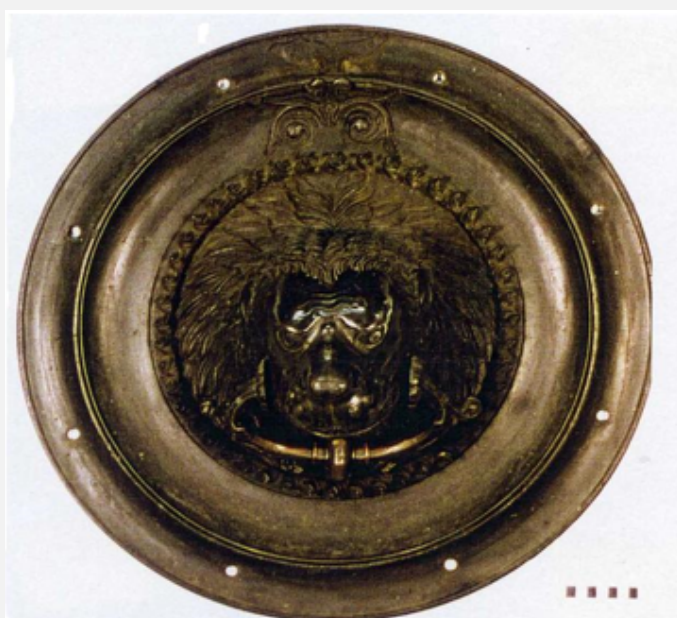
Fig. 1: Circular door knocker striking plate (after Benoît, 1994),

Description of the artefact	Circular striking plate no 2 (from a set of two) of a door knocker with a protruding lion head holding a hinge in his fangs, Ø.ext = 64cm. The circular base is said to be covered by a gilded decorative relief (Fig. 1, Benoît, 1994, 6).
Type of artefact	Architectural element
Origin	Door knocker of Lausanne cathedral, Lausanne, Vaud, Switzerland
Recovering date	Unknown
Chronology category	Modern Times

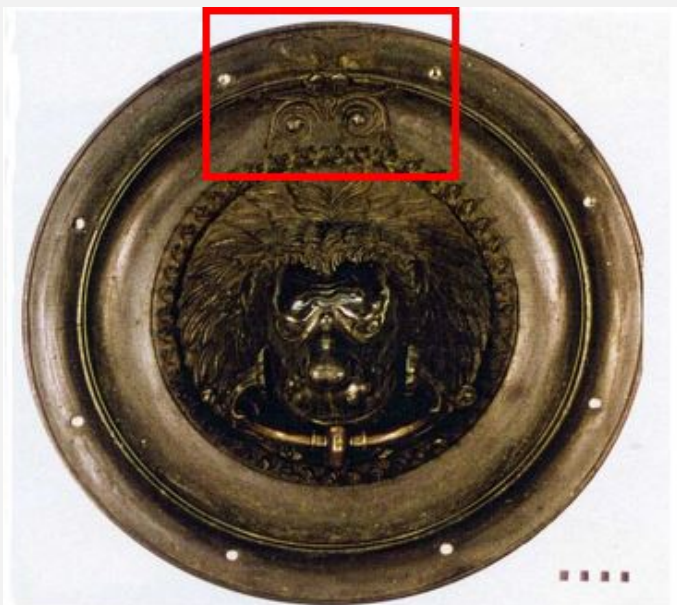
Fig. 2: Possible location of sampling area,

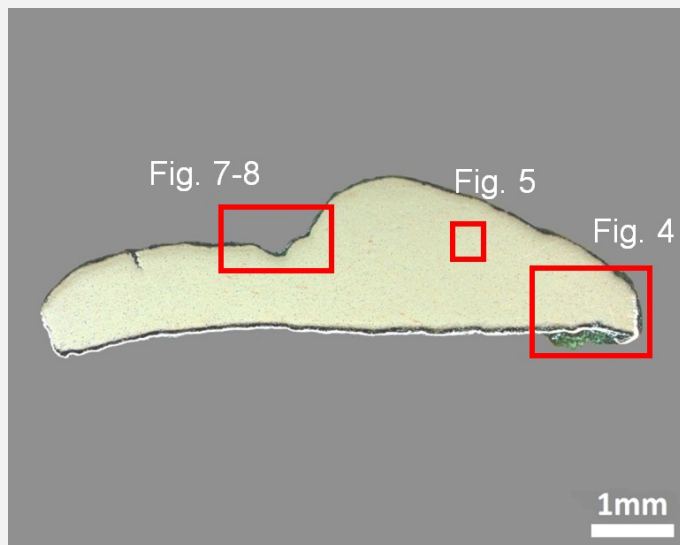
Fig. 3: Micrograph of the cross-section of the sample taken from the circular plate showing the location of Figs. 4 to 5 and 7 to 8,

Description of sample	No information is given on where the sample has been taken. A supposed location is however illustrated in Fig. 2. The polished sample shows a well preserved metal surface with some cracks covered by a thin corrosion crust (Fig. 3).
Alloy	Cu Alloy
Technology	Rolled, annealed after cold working
Lab number of sample	MAH 94-156-001
Sample location	Musées d'art et d'histoire, Genève, Geneva
Responsible institution	Musées d'art et d'histoire, Genève, Geneva
Date and aim of sampling	1994, metallography and presence or not of a gilding treatment

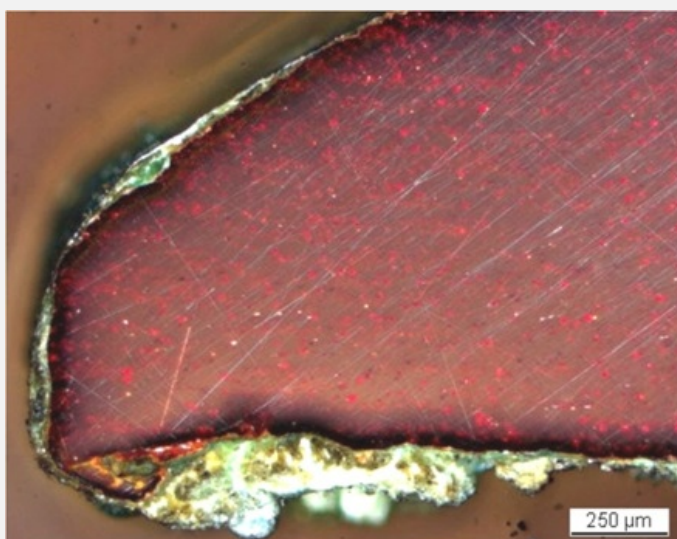
Fig. 4: Micrograph of the metal sample from Fig. 3 (reversed picture), unetched, polarised light. The red copper oxide inclusions form rows in the copper alloy matrix,

The average thickness of the corrosion crust is about 90µm, but may be thinner or thicker depending on the area of origin (Fig. 4). Under polarized light, we observe a multilayer system with a dense and thin inner red corrosion layer (CP2, probably cuprite/Cu₂O) on the metal (Fig. 7) containing chlorides (Fig. 8 and Table 3). This is followed by bands of heterogeneous green corrosion products (CP1, possibly copper chloride / sulphate / carbonate). This outer corrosion layer is contaminated with atmospheric components (Si, Al, Cl, C and O and perhaps gypsum particles (CaSO₄)) (Fig. 8).

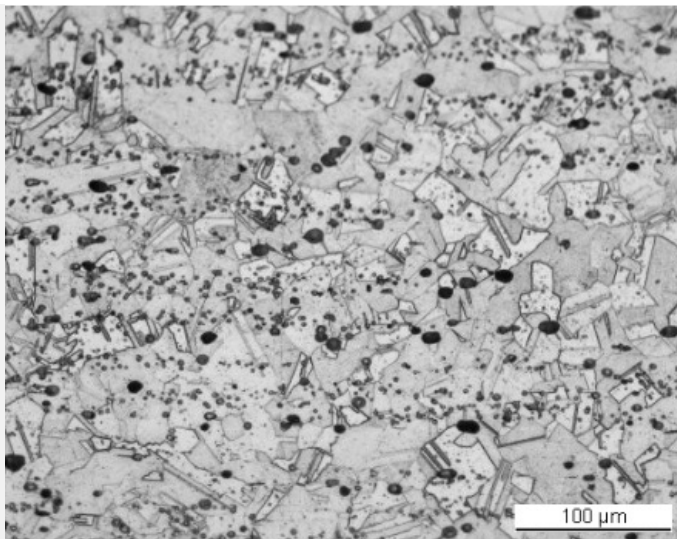
Fig. 5: Micrograph of the metal sample from Fig. 3 (detail), etched, bright field. The metal shows a structure of polygonal and twinned grains. Copper oxide inclusions are visible as dark spots,

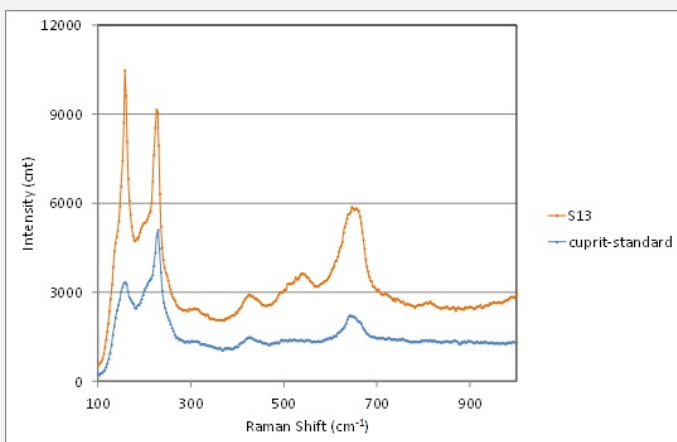
Fig. 6: Raman spectrum of a red inclusion (S13) of Fig. 4 compared to a cuprite standard spectrum. Settings: laser wavelength 532nm, acquisition time 100s, one accumulation, filter D2 (0.75-0.8mW), hole 500, slit 80, grating 600. Method of analysis: Raman spectroscopy. Lab of Swiss National Museum, Affoltern a. Albis ZH,

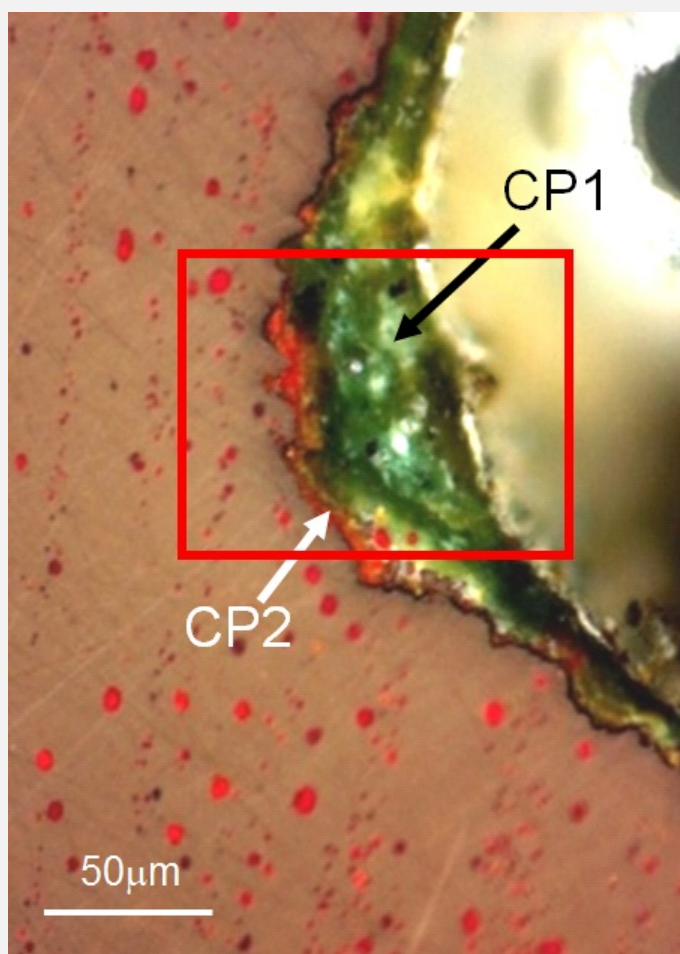
Fig. 7: Micrograph of the metal sample from Fig. 3 (rotated by 90°) and corresponding to the stratigraphy of Fig. 9, polarised light. Metal with red copper oxide inclusions. The black particles in the green corrosion layer are quartz inclusions. The area selected for elemental chemical distribution (Fig. 8) is marked by a red rectangle,

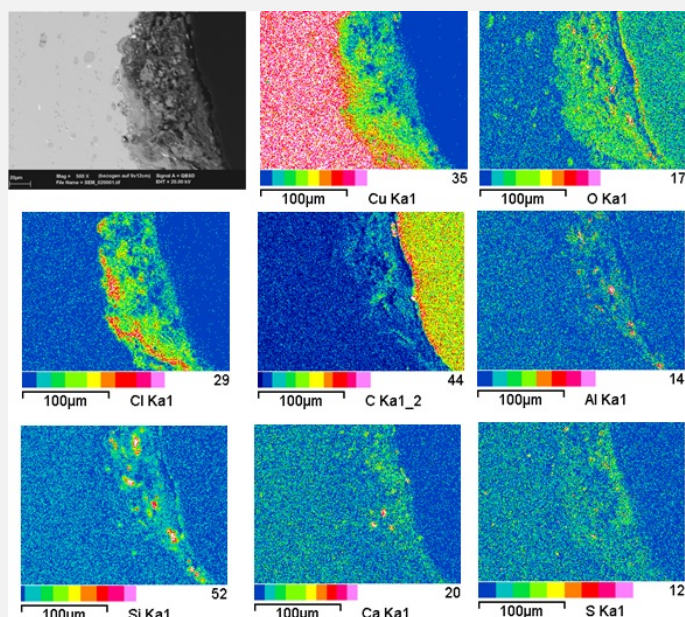
Table 2: Chemical composition (mass %, <: below the detection limit) of the inclusions (light-grey and white in Fig. 8) in the metal. Method of analysis: SEM/EDS, Laboratory of Analytical Chemistry, Empa.

Fig. 8: SEM image, BSE-mode, and elemental chemical distribution of the selected area of Fig. 7. Method of examination: SEM/EDS, Laboratory of Analytical Chemistry, Empa,
