SHOE NAIL 2637 1370.B. – HYPOEUTECTOID STEEL – ROMAN TIMES – SWITZERLAND

| Artefact name | Shoe nail 2637 1370.B. |
| Authors | Christian. Degriigny (HE-Arc CR, Neuchâtel, Neuchâtel, Switzerland) & Valentin. Boissonnas (HE-Arc CR, Neuchâtel, Neuchâtel, Switzerland) & Vincent Chappuis. (HE-Arc CR, Neuchâtel, Neuchâtel, Switzerland) |

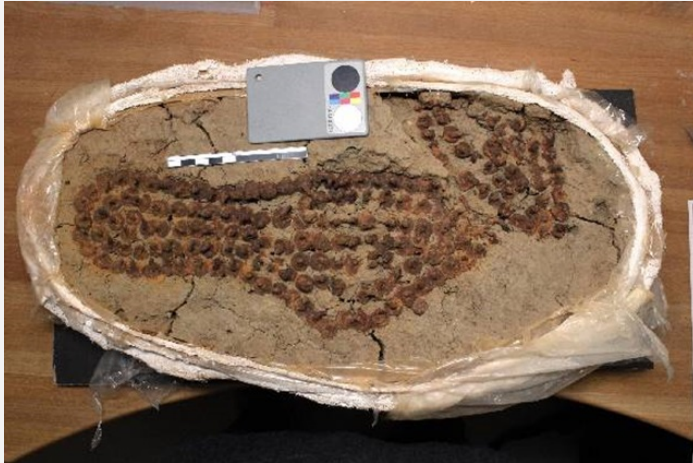
Fig. 1: A Roman shoe nail from a block taken from an excavation site before conservation,

| Description of the artefact | A Roman shoe nail from a block taken from an excavation site (Fig. 1) covered with a thick corrosion crust. The forged nails were hammered into the leather soles on a bucking tool. Average dimensions of the shoe nails: L = about 14mm; diameter = 11mm; W = up to 0.8g. |

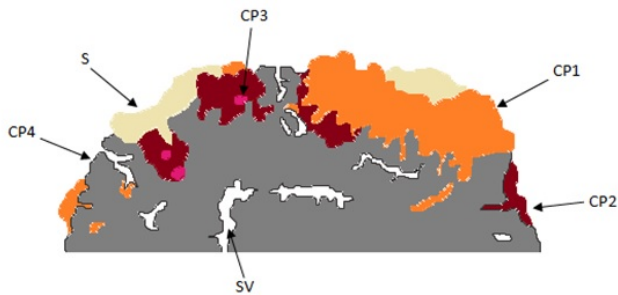
- S = compact sand-clay soil.
- CP1 = powdery soil, orange-coloured by corrosion products.
- CP2 = dark-red corrosion crust, breaks into bits.
- CP3 = vivid pink-red and globular corrosion products.
- CP4 = dark grey to black and very hard corrosion products, results in an dark-orange powder when scratched.
- SV = structural void near the center of the cross section, seems to draw a square shape.

Fig. 3: Preliminary stratigraphy of the corrosion layers based on the observation of a broken nail,

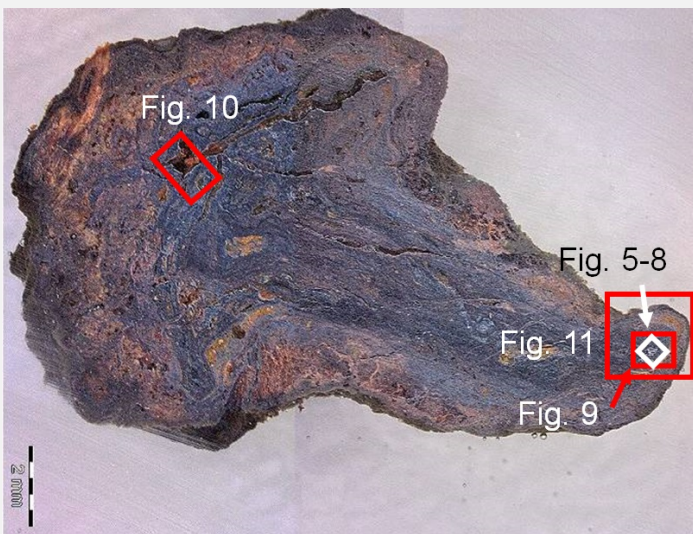
Fig. 4: Micrograph of the cross-section of the nail showing the location of figs. 5 to 11,

A longitudinal cut through the nail (Fig. 4). Dimensions: L = 16.4mm; W = about 12.0mm.

The metal is heavily corroded and the thickness of the corrosion crust is irregular, varying from 0.8 to 3.8mm, with an average of about 2mm. The corrosion has replaced most of the metal (Fig. 4). Between corrosion layers the limit of the original structure is visible. Some leather fibers seem to be preserved as pseudomorphic structures in voids of the metal core (POM1, Figs. 9 and 10). The carbon mapping (Fig.11) shows the presence of carbon in these areas. This can also be due to the penetration of the mounting resin in the cracks.

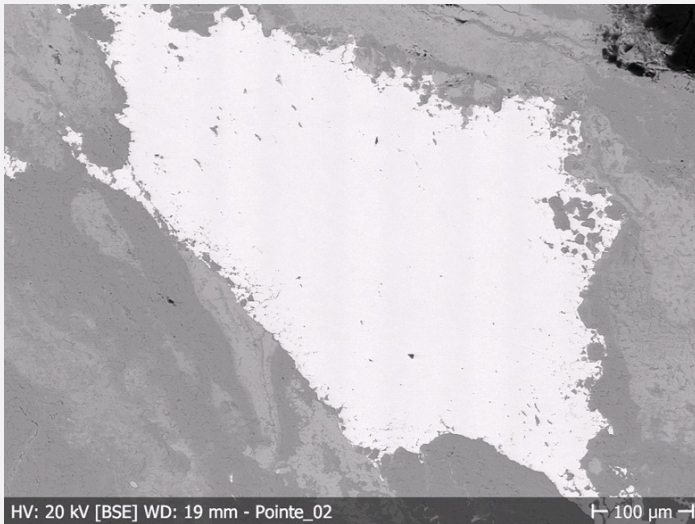
The remaining metal is an hypoeutectoid steel (Fig. 5 and 6), containing Fe, Si and O slags inclusions (possibly fayalite FeO.SiO_2), and consisting of less than 1% of the total volume of the highly mineralized nail. After Nital etching, it shows intergranular corrosion on one of its sides (Figs. 7 and 8).

Fig. 5: SEM, BSE-mode picture of remaining metal from cross-section of Fig. 4,

Fig. 6: SEM, BSE-mode picture of inclusions in remaining metal (detail of Fig. 5),

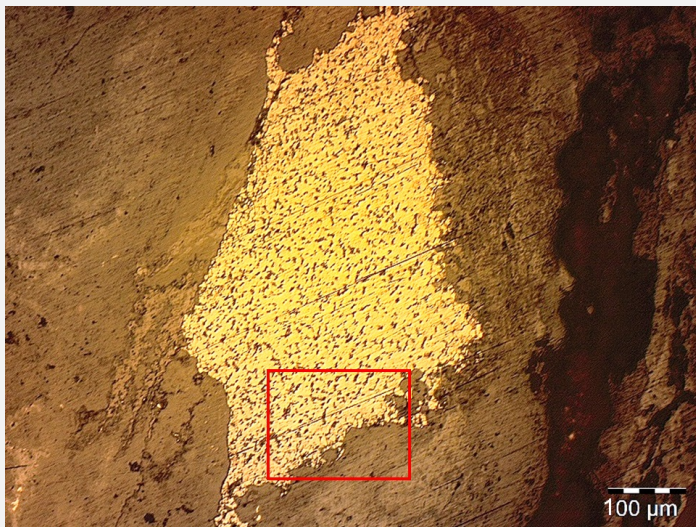
Fig. 8: Micrograph of the selected area of Fig. 7, Nital etched with no clear grain structure, bright field, Intergranular corrosion and grey phase (perlite?) are observed,

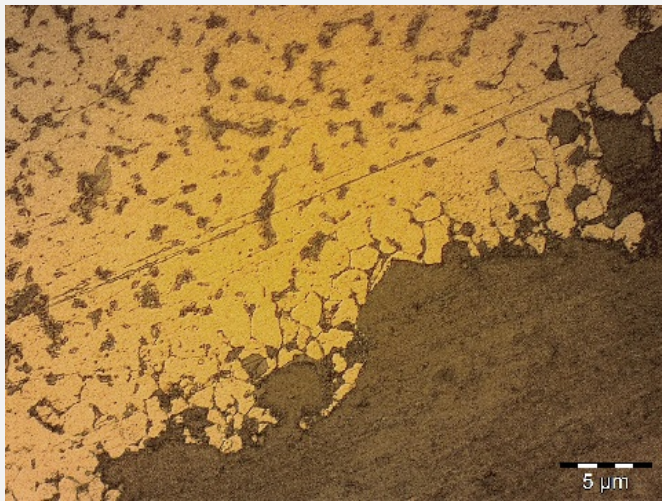
Fig. 9: Micrograph of the metal sample from Fig. 4, bright field. The delimited zone shows what could be leather pseudomorphic fibers filling a void,

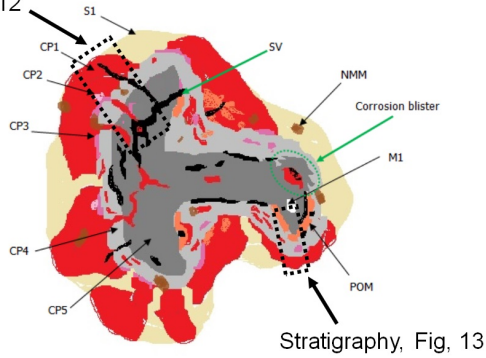
The schematic representation of corrosion layers of Fig. 3 integrating additional information based on the analyses carried out is given in Fig. 14. The following strata were identified:

Fig. 14: Improved stratigraphic representation of the nail from visual observations and analyses and visualization of the two stratigraphies of Figs. 12 and 13,
