SHOE NAIL 2637 1370.B. - HYPOEUTECTOID STEEL - ROMAN TIMES - SWITZERLAND

Artefact name	Shoe nail 2637 1370.B.
Authors	Christian. Degrigny (HE-Arc CR, Neuchâtel, Neuchâtel, Switzerland) & Valentin. Boissonnas (HE-Arc CR, Neuchâtel, Neuchâtel, Switzerland) & Vincent Chappuis. (HE-Arc CR, Neuchâtel, Neuchâtel, Switzerland)
Url	/artefacts/1248/

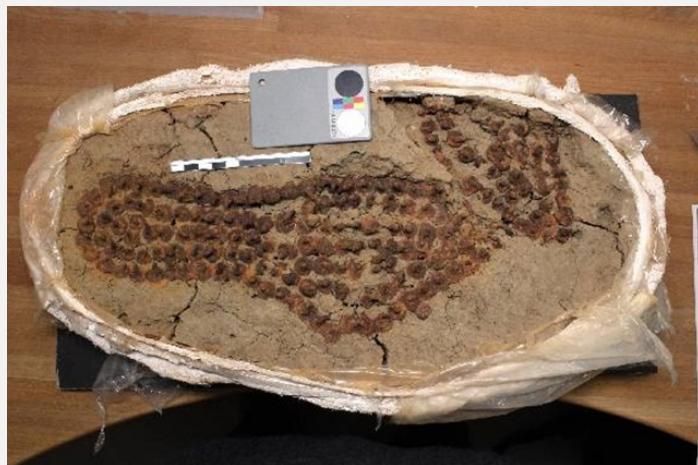
Fig. 1: A Roman shoe nail from a block taken from an excavation site before conservation.

Description of the artefact	A Roman shoe nail from a block taken from an excavation site (Fig. 1) covered with a thick corrosion crust. The forged nails were hammered into the leather soles on a bucking tool. Average dimensions of the shoe nails: L = about 14mm; diameter = 11mm; W = up to 0.8g.
Type of artefact	clothing element
Origin	Hofstetterfeld, near Roman Necropolis, Sursee, Lucerne, Switzerland
Recovering date	Unknown
Chronology category	Roman Times
chronology tpq	<input type="text" value="50"/> A.D. ▾
chronology taq	<input type="text" value="100"/> A.D. ▾
Chronology comment	2nd half 1st century AD.
Burial conditions / environment	Soil
Artefact location	Denkmalpflege und Archäologie des Kantons, Luzern
Owner	Denkmalpflege und Archäologie des Kantons, Luzern
Inv. number	2637 1370.B.
Recorded conservation data	Block-lifted (in plaster), desiccated storage with silica gel.

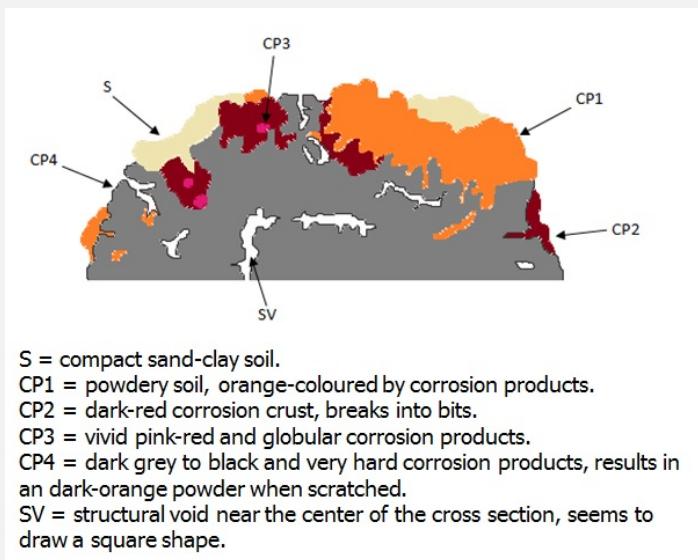
Fig. 3: Preliminary stratigraphy of the corrosion layers based on the observation of a broken nail,

S = compact sand-clay soil.
CP1 = powdery soil, orange-coloured by corrosion products.
CP2 = dark-red corrosion crust, breaks into bits.
CP3 = vivid pink-red and globular corrosion products.
CP4 = dark grey to black and very hard corrosion products, results in a dark-orange powder when scratched.
SV = structural void near the center of the cross section, seems to draw a square shape.

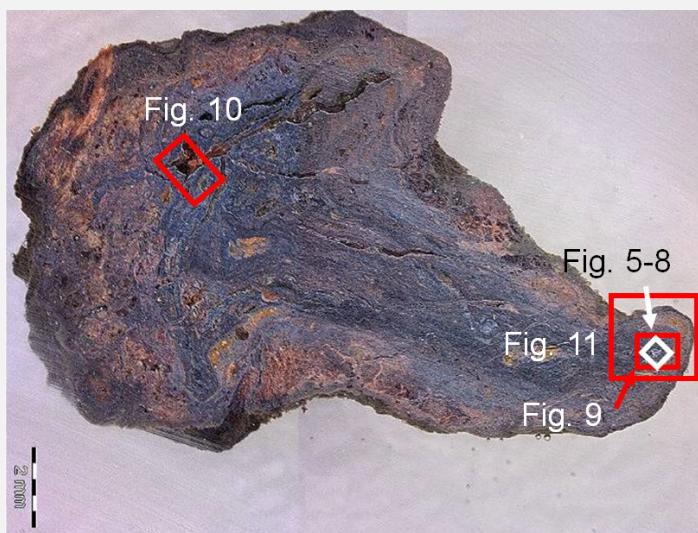
Fig. 4: Micrograph of the cross-section of the nail showing the location of figs. 5 to 11,

Description of sample	A longitudinal cut through the nail (Fig. 4). Dimensions: L = 16.4mm; W = about 12.0mm.
Alloy	Hypoeutectoid steel
Technology	Forged
Lab number of sample	HE-Arc CR 1457-S1.
Sample location	HE-Arc CR, Neuchâtel, Neuchâtel
Responsible institution	HE-Arc CR, Neuchâtel, Neuchâtel
Date and aim of sampling	2013, metallography and elementary composition of the metal

The metal is heavily corroded and the thickness of the corrosion crust is irregular, varying from 0.8 to 3.8mm, with an average of about 2mm. The corrosion has replaced most of the metal (Fig. 4). Between corrosion layers the limit of the original structure is visible. Some leather fibers seem to be preserved as pseudomorphic structures in voids of the metal core (POM1, Figs. 9 and 10). The carbon mapping (Fig.11) shows the presence of carbon in these areas. This can also be due to the penetration of the mounting resin in the cracks.

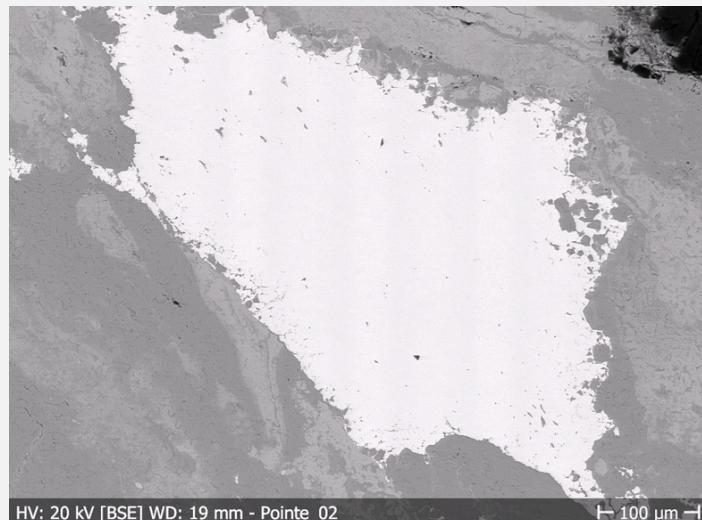
The remaining metal is an hypoeutectoid steel (Fig. 5 and 6), containing Fe, Si and O slags inclusions (possibly fayalite $FeO\cdot SiO_2$), and consisting of less than 1% of the total volume of the highly mineralized nail. After Nital etching, it shows intergranular corrosion on one of its sides (Figs. 7 and 8).

Fig. 5: SEM, BSE-mode picture of remaining metal from cross-section of Fig. 4,

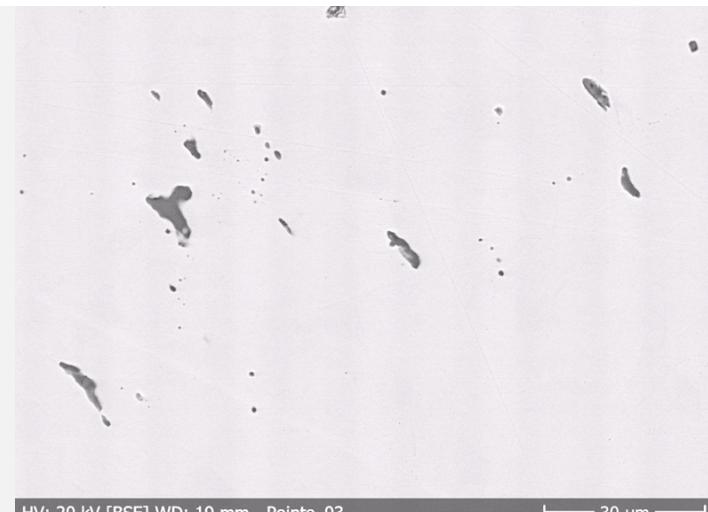
Fig. 6: SEM, BSE-mode picture of inclusions in remaining metal (detail of Fig. 5).

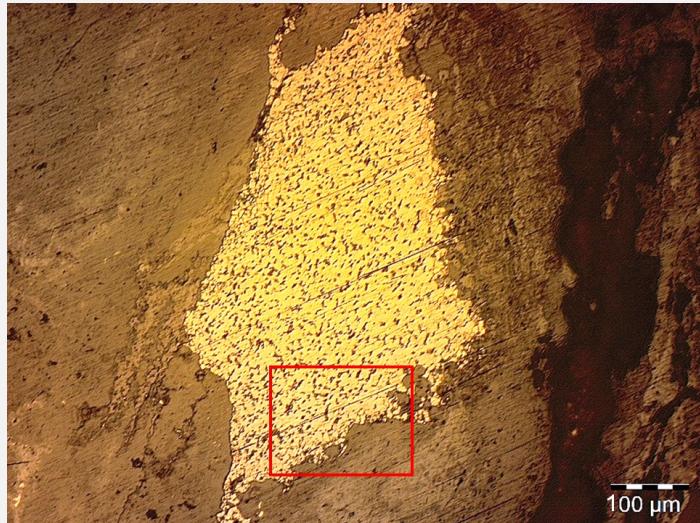
Fig. 7: Micrograph of the metal sample from Fig. 5 (detail, rotated 90°), Nital etched, bright field, with indication of Fig. 8 (red rectangle)

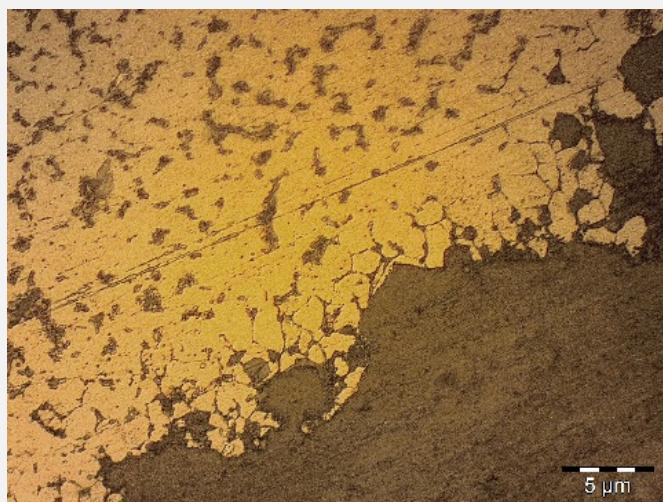
Fig. 8: Micrograph of the selected area of Fig. 7, Nital etched with no clear grain structure, bright field, Intergranular corrosion and grey phase (perlite?) are observed.

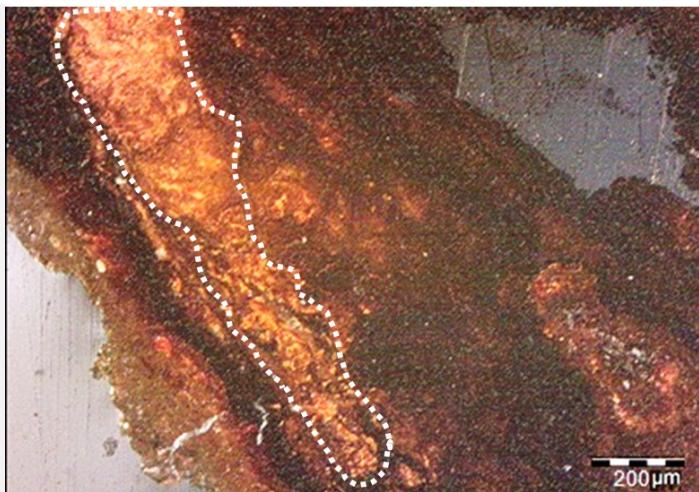
Fig. 9: Micrograph of the metal sample from Fig. 4, bright field. The delimitated zone shows what could be leather pseudomorphic fibers filling a void,

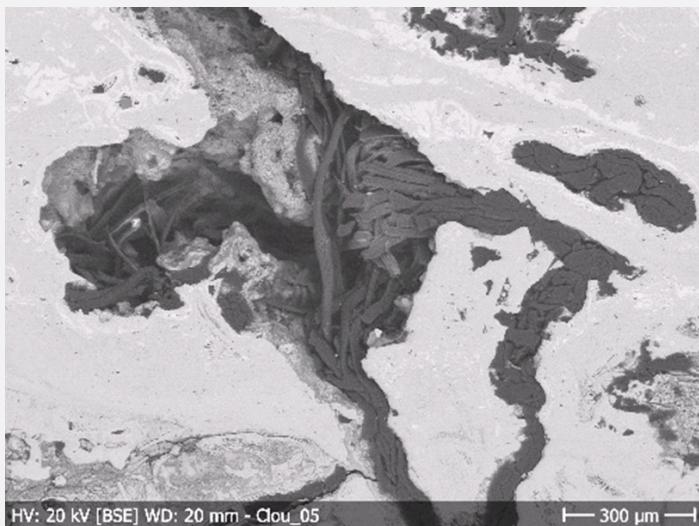
Fig. 10: SEM - BSE-mode picture of another void filled with fibers in the head of the nail (see Fig. 4),

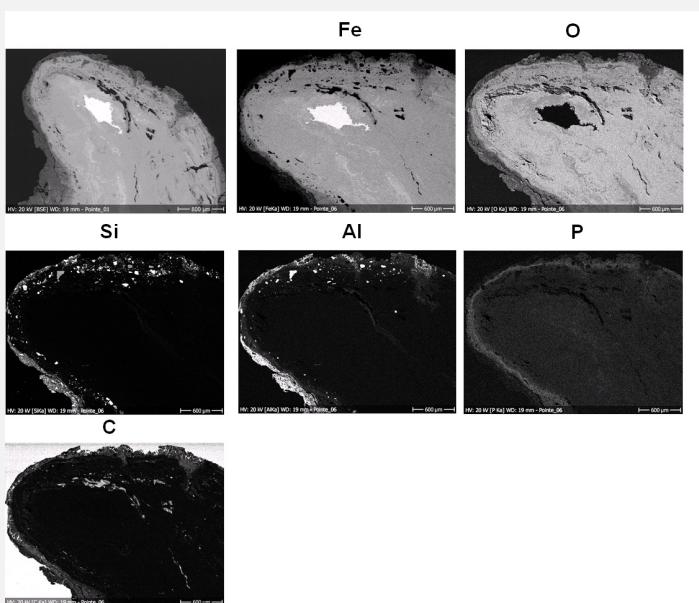
Si, Al, P and K can be considered external markers, helping to determine the limit of the original surface (Fig. 11 and Table 1). The outer layer of corrosion products (CP1-3) ranges from dark grey to orange in bright field and contains less O and Fe on its borders than the inner layer (CP4-5, Figs. 4 and 11, Table 1). The SEM pictures show a marbling appearance of the inner corrosion layer (CP5). Cl and S do not seem to be present in the sampled nail.

Fig. 11: Elemental chemical distribution of the selected area from Fig. 4 (90° counter-clockwise rotated). SEM-EDS.

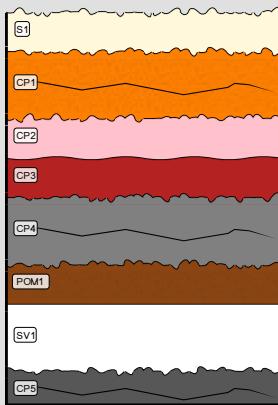
Fig. 12: Stratigraphic representation of the nail in cross-section (dark field) using the MiCorr application. The characteristics of the strata are only accessible by clicking on the drawing that redirects you to the search tool by stratigraphy representation. This representation can be compared to Fig. 14, Credit HE-Arc CR, V.Chappuis.

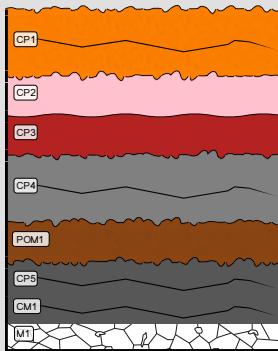
Fig. 13: Stratigraphic representation of the nail in cross-section (dark field) using the MiCorr application. The characteristics of the strata are only accessible by clicking on the drawing that redirects you to the search tool by stratigraphy representation. This representation can be compared to Fig. 14, Credit HE-Arc CR, V.Chappuis.

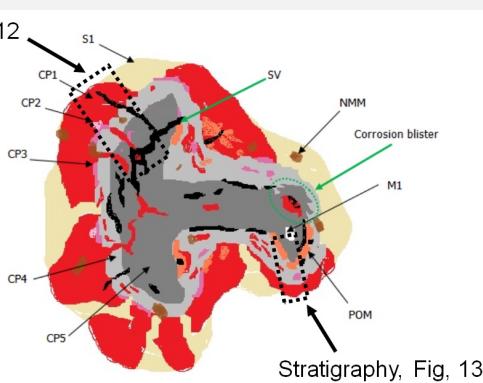
The schematic representation of corrosion layers of Fig. 3 integrating additional information based on the analyses carried out is given in Fig. 14. The following strata were identified:

S1 = sand-clay soil, compact, cemented when dry, powdery when abraded, very thin particle size (usually about and less than 0.1mm). Undefined thickness (soil). CP1 = powdery orange (loosely coherent) and matte corrosion crust, sometimes forming humps. Partially mixed with S1 and POM layers (diffused interfaces). 1 to 5 millimeters thick.

CP2 = vivid red or pink dots, more brittle than powdery (loose cohesion) and mostly matte, only two or three observed, always above CP3 interfaces. Usually 1 mm spheric diameter.

CP3 = dark reddish corrosion product, forming smooth, matte and brittle layers that are parallel to CP4, with a clean and regular interface. The corrosion products are generally hard, but sometimes break up into grains, resulting in a more irregular interface. The layer is approximately 0.5mm thick.

CP4 = dark grey to black corrosion product, smooth with pseudo-metallic reflection (a bit glossy), very hard, when scratched results in orange powder, with somewhat irregular shape and thickness (ranging from 0.3 to 2mm).

CP5 = dark grey to black corrosion product, generally a bit darker than CP4. Smooth with pseudo-metallic reflection, even harder than CP4 and when scratched it turns into an orange coloured powder. Irregular interface regarding CP4. Clear transition and somewhat parallel from CP4 to CP5. As regards its thickness, it fills the remaining volume.

SV = structural void, present as fissures that either pass through the different layers, or are present at corrosion interfaces, especially at the CP4/CP5 interface. The void is 0.1 to 0.3mm thick and partially filled with POM in the outer layers.

Fig. 14: Improved stratigraphic representation of the nail from visual observations and analyses and visualization of the two stratigraphies of Figs. 12 and 13,
