HISPANO-SUIZA WATER PUMP – AL ALLOY – FRANCE

Artefact name	Hispano-Suiza water pump
Authors	Christian. Degriigny (HE-Arc CR, Neuchâtel, Neuchâtel, Switzerland) & Elodie. Granget (HE-Arc CR, Neuchâtel, Neuchâtel, Switzerland) & Brice. Chalançon (MNAM (Musée National de l'Automobile de Mulhouse), Mulhouse, Alsace, France)
Url	/artefacts/1250/

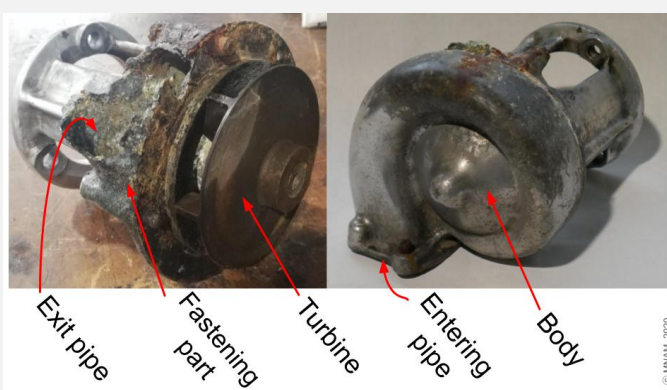
Fig. 2: Body, turbine, fastening part and pipes located on the Hispano water pump,

The exit pipe of the fastening part considered within this study is heavily corroded.

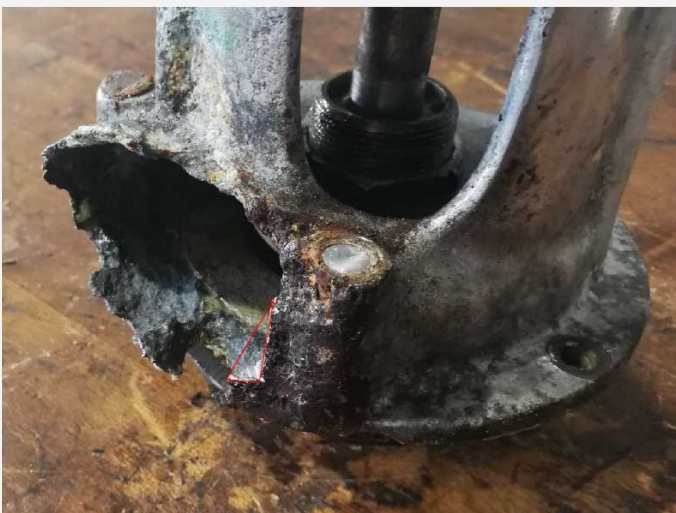
Fig. 5: Close-up view of the corroded exit pipe of the disassembled Hispano water pump, showing the sampled area,

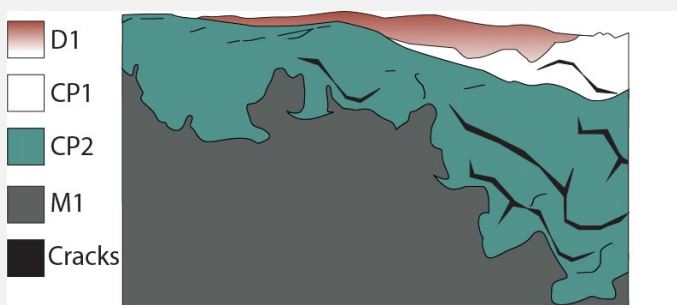
The schematic representation below gives an overview of the corrosion layers encountered on the corroded pipe of the fastening part of the pump (Fig. 6).

The CP strata show big cracks and can be removed with a bit of scratching (severable). CP2 has a green-blueish color. Over most of the corroded part there is a thick red-orange deposit. This is probably coming from the corroded steel screws, used to fasten the parts of the water-pump.

Fig. 6: Stratigraphic representation of the corroded exit pipe of the water pump by macroscopic observation, M = metal, CP = corrosion product, D = deposit,

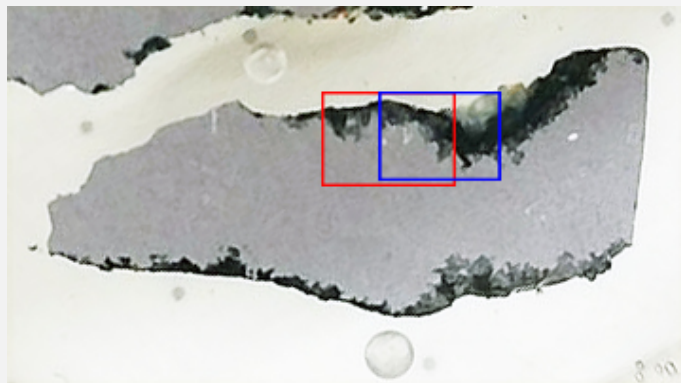
Fig. 7: Micrograph of the sample taken from the corroded exit pipe of the fastening part of the water pump (Figs. 3 to 5), showing the location of Figs. 8-9 in red and Figs. 11-15 in blue. This is a transversal cut of what is left of the exit pipe, severely consumed by corrosion,

Description of sample	A fragment of the exit pipe of the fastening part of the pump has been sampled and embedded as shown on Fig. 7. This is a transversal cut of what is left of the exit pipe, severely consumed by corrosion.
Alloy	Al Alloy
Technology	Cast
Lab number of sample	None
Sample location	HE-Arc CR, Neuchâtel, Neuchâtel
Responsible institution	MNAM (Musée National de l'Automobile de Mulhouse), Mulhouse, Alsace
Date and aim of sampling	31.12.2019 - Sampled for Metallography

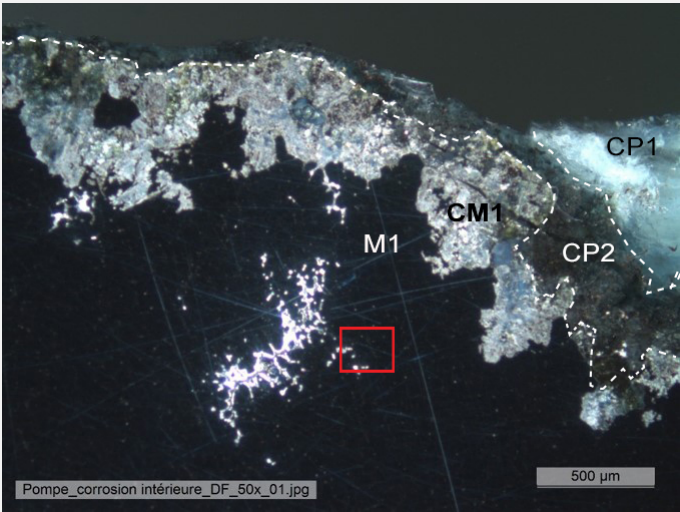
The porosity of this aluminium-copper alloy (Table 1) has been confirmed by optical (Figs. 8 and 9) and SEM observations on the cross-section of the fastening part's fragment (Fig. 10). The metal has a dendritic microstructure (Fig. 10).

Fig. 8: Micrograph of the selected area (in red) of the sample shown on Fig. 7, unetched, dark field with location of Fig. 10,

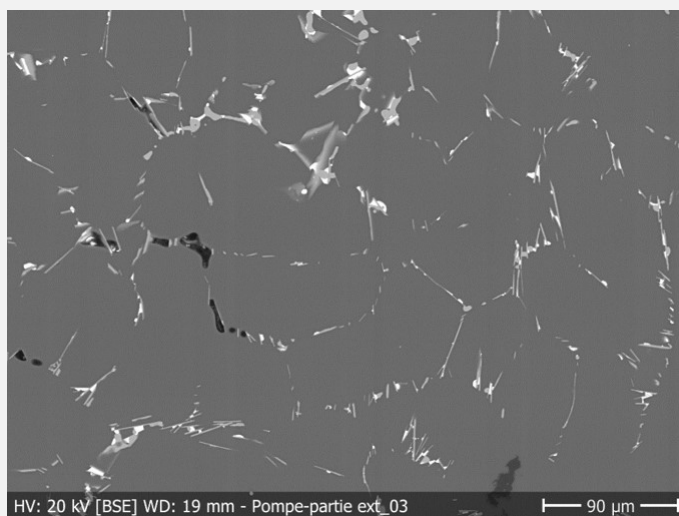
Local analyses on each phase appearing on Fig. 10 showed that the main phase is composed of Al and the interdendritic phases are composed of Al, Cu and Fe as well as Sn precipitates. This distribution is given through EDS elemental chemical distributions (Figs. 12 to 14).

Fig. 10: SEM image (BSE mode) of the metal sample from Fig. 8 showing the microstructure of the fastening part. Black = pore, dark grey = main phase, light grey = interdendritic phase and white = Sn precipitate,

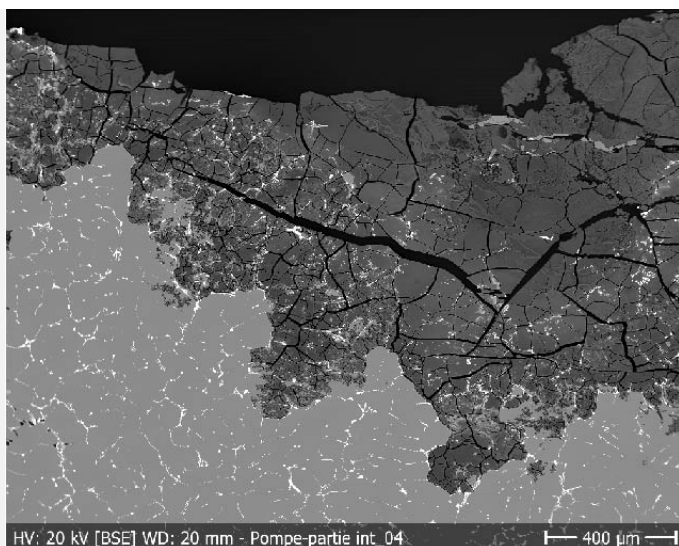
The SEM image of Fig. 11 clearly shows a network of cracks throughout CM1 and CPs. These cracks are not marking any clear separation between strata, but seem to affect all corrosion layers. The main Al phase is preferentially oxidized, while the interdendritic phase seems to be preserved in the corrosion products (Figs. 11 to 13). Na and K but no Fe are detected in the corrosion layers CM1 and CPs (Fig. 14). This surface is in contact with the coolant (glycol + additives, usually mixed 1/1 in water), which sometimes contain Na or K-based corrosion inhibitors. A cluster of CaCO₃ was identified on the very surface of the sample (Fig. 15). CaCO₃ can sometimes precipitate if the water used to mix the coolant is hard.

Fig. 11: SEM image (BSE mode) of the selected area (in blue) of the sample shown on Fig. 7, showing the remaining metal on the bottom and CM1 /CPs on top,

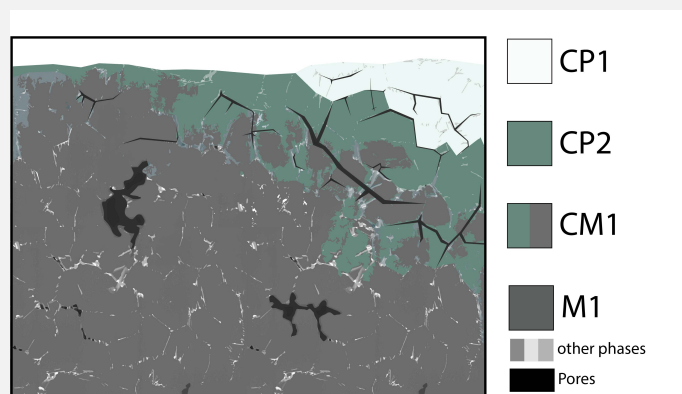
Fig. 17: Improved stratigraphic representation of the corrosion structure of the exit pipe of the disassembled Hispano water pump,

The heavily corroded exit pipe of the fastening part of this Hispano-suiza water pump is made out of an Al-Cu cast alloy with traces of Sn, Fe and Si(?). The corrosion is through the dendritic microstructure: the main phase (Al) is preferentially oxidized, while the interdendritic phase (Fe, Sn, Cu) and Sn precipitates are preserved in the corrosion products. This component of the engine being in contact with the coolant might explain the presence of Na, K and Ca in the corrosion layers.
