HISPANO-SUIZA WATER PUMP – AL ALLOY – FRANCE

Artefact name Hispano-Suiza water pump

Authors Christian. Degriigny (HE-Arc CR, Neuchâtel, Neuchâtel, Switzerland) & Elodie. Granget (HE-Arc CR, Neuchâtel, Neuchâtel, Switzerland) & Brice. Chalançon (MNAM (Musée National de l'Automobile de Mulhouse), Mulhouse, Alsace, France)

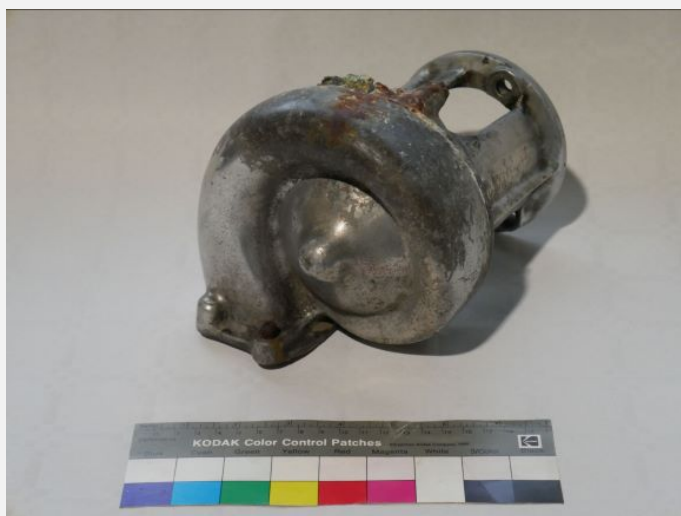
Fig. 1: Hispano-suiza water pump, unknown model,

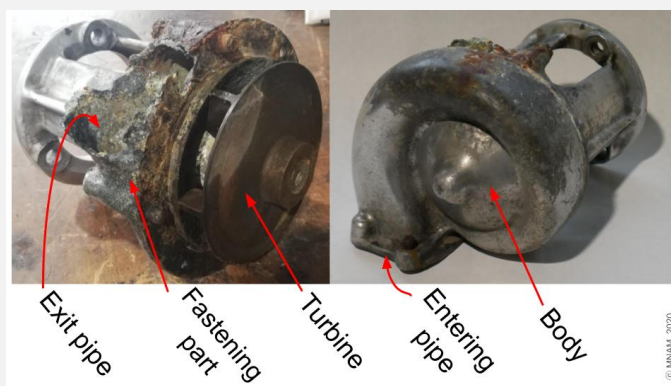
Fig. 2: Body, turbine, fastening part and pipes located on the Hispano water pump,

This Hispano-suiza water pump (Fig. 1), measuring around 15x15x20 cm, is made of 3 parts (Fig. 2):

- > A body (or cover), shaped like a snail, containing the entering pipe,
- > A turbine, inside the pump, connected through the fastening part to a rotating shaft of the engine,
- > A fastening part, screwed on the body with steel screws and brass gasket-rings containing the exit pipe.

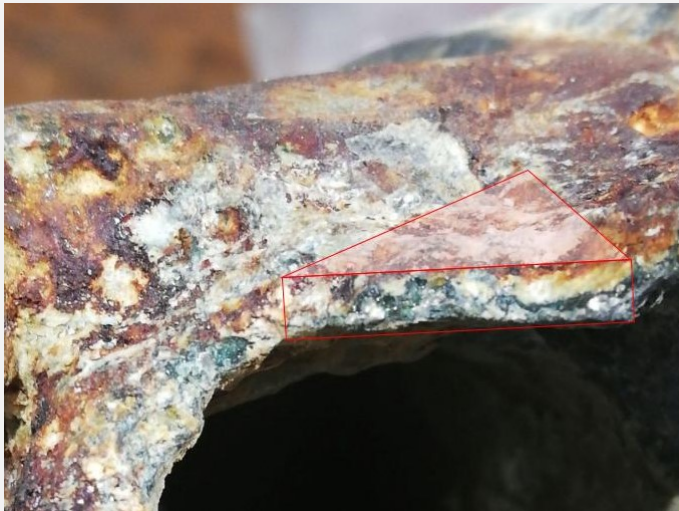
Fig. 4: Close-up view of the Hispano water pump, with the exit pipe sampling area,

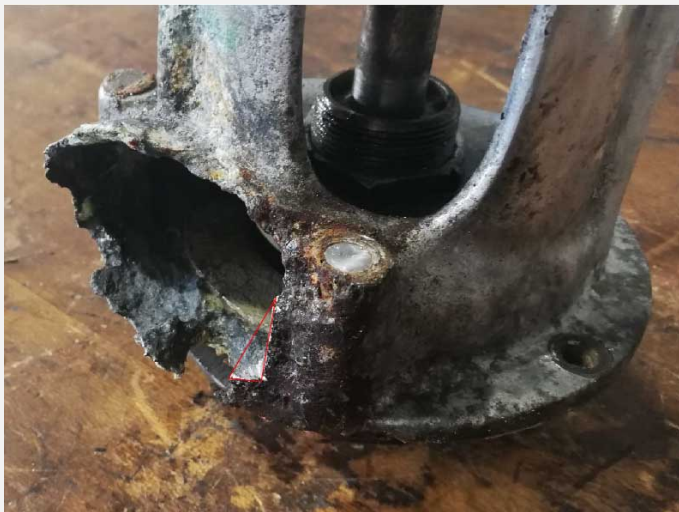
The exit pipe of the fastening part considered within this study is heavily corroded.

Fig. 5: Close-up view of the corroded exit pipe of the disassembled Hispano water pump, showing the sampled area,

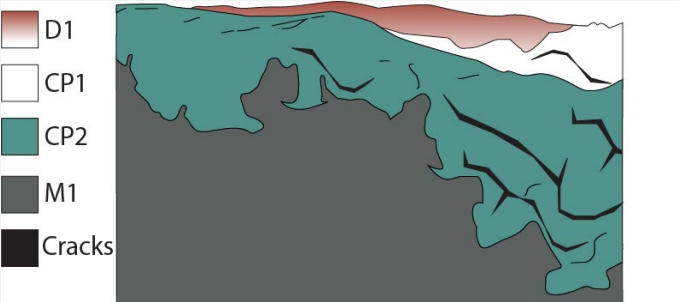
The schematic representation below gives an overview of the corrosion layers encountered on the corroded pipe of the fastening part of the pump (Fig. 6).

The CP strata show big cracks and can be removed with a bit of scratching (severable). CP2 has a green-blueish color. Over most of the corroded part there is a thick red-orange deposit. This is probably coming from the corroded

steel screws, used to fasten the parts of the water-pump.

Fig. 6: Stratigraphic representation of the corroded exit pipe of the water pump by macroscopic observation, M = metal, CP = corrosion product, D = deposit,

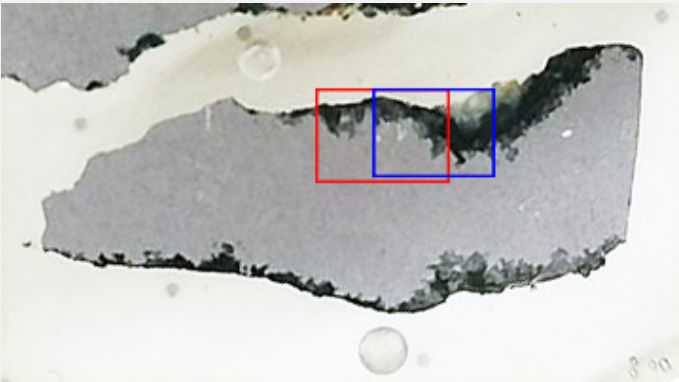
Fig. 7: Micrograph of the sample taken from the corroded exit pipe of the fastening part of the water pump (Figs. 3 to 5), showing the location of Figs. 8-9 in red and Figs. 11-15 in blue. This is a transversal cut of what is left of the exit pipe, severely consumed by corrosion,

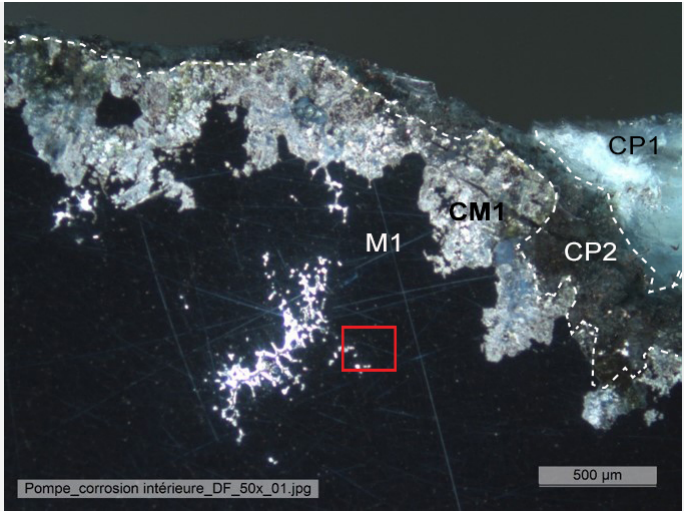
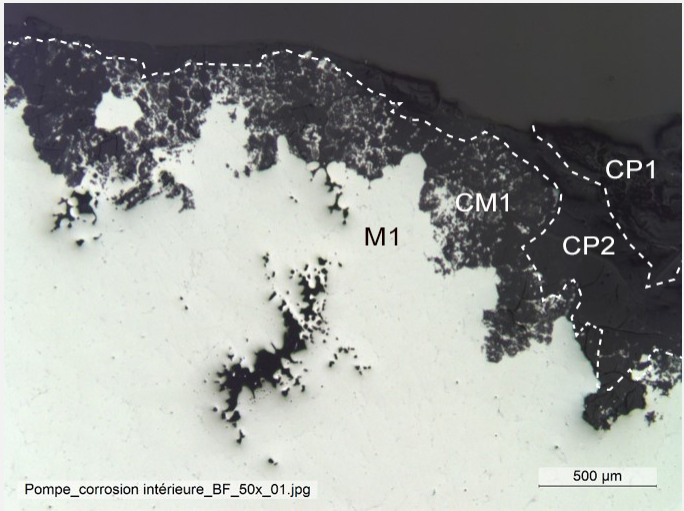
The porosity of this aluminium-copper alloy (Table 1) has been confirmed by optical (Figs. 8 and 9) and SEM observations on the cross-section of the fastening part's fragment (Fig. 10). The metal has a dendritic microstructure (Fig. 10).

Fig. 8: Micrograph of the selected area (in red) of the sample shown on Fig. 7, unetched, dark field with location of Fig. 10,

Fig. 9: Micrograph similar to Fig. 8, unetched, bright field,

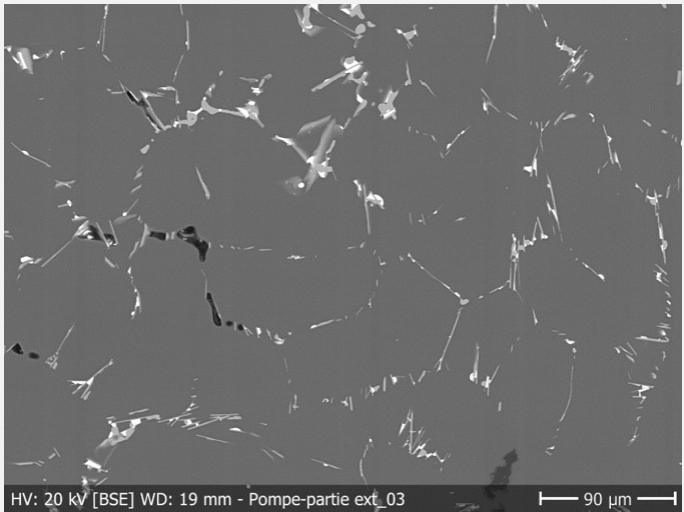
Local analyses on each phase appearing on Fig. 10 showed that the main phase is composed of Al and the interdendritic phases are composed of Al, Cu and Fe as well as Sn precipitates. This distribution is given through EDS elemental chemical distributions (Figs. 12 to 14).

Fig. 10: SEM image (BSE mode) of the metal sample from Fig. 8 showing the microstructure of the fastening part. Black = pore, dark grey = main phase, light grey = interdendritic phase and white = Sn precipitate,

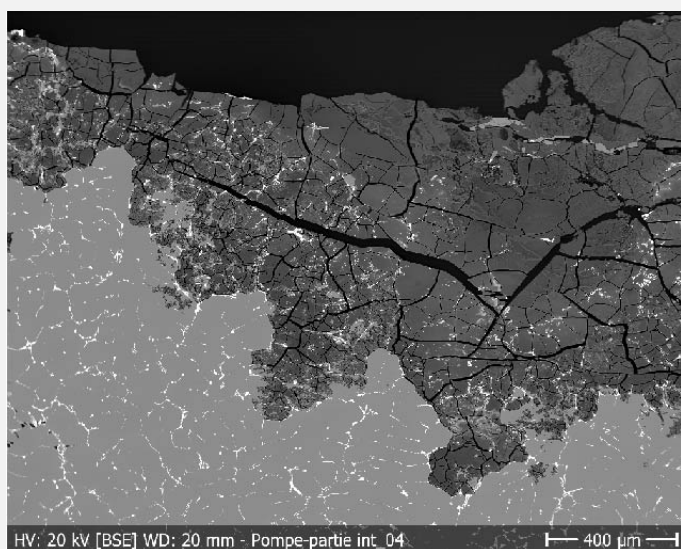
The SEM image of Fig. 11 clearly shows a network of cracks throughout CM1 and CPs. These cracks are not marking any clear separation between strata, but seem to affect all corrosion layers. The main Al phase is preferentially oxidized, while the interdendritic phase seems to be preserved in the corrosion products (Figs. 11 to 13). Na and K but no Fe are detected in the corrosion layers CM1 and CPs (Fig. 14). This surface is in contact with the coolant (glycol + additives, usually mixed 1/1 in water), which sometimes contain Na or K-based corrosion inhibitors. A cluster of CaCO_3 was identified on the very surface of the sample (Fig. 15). CaCO_3 can sometimes precipitate if the water used to mix the coolant is hard.

Fig. 11: SEM image (BSE mode) of the selected area (in blue) of the sample shown on Fig. 7, showing the remaining metal on the bottom and CM1 /CPs on top,

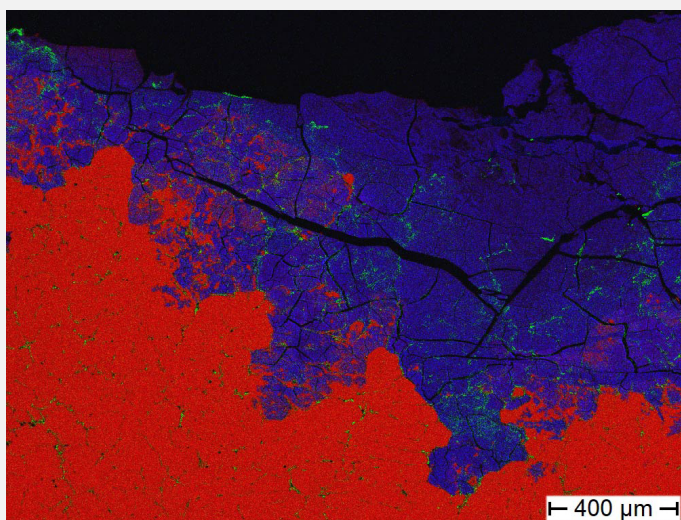
Fig. 12: Al (red), O (blue) and Cu (green) distribution of the area of Fig. 11. Method of analysis: SEM-EDS. Lab. of Electronic Microscopy and Microanalysis, Néode, HEI Arc,

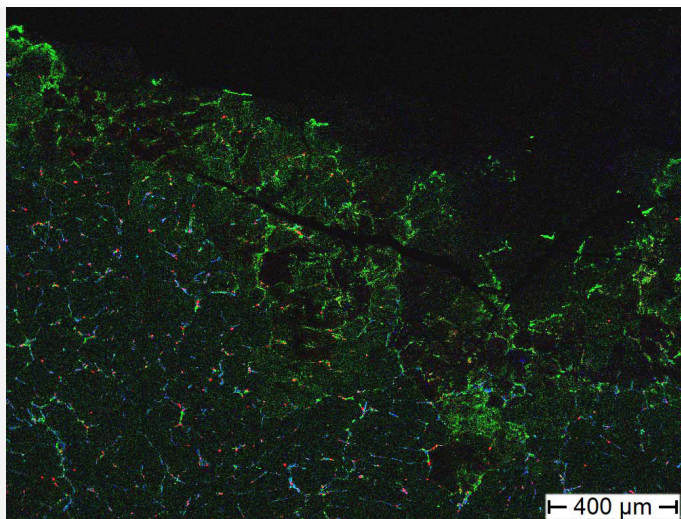
Fig. 13: Sn (red), Fe (blue) and Cu (green) distribution of the area of Fig. 11. Method of analysis: SEM-EDS. Lab. of Electronic Microscopy and Microanalysis, Néode, HEI Arc,

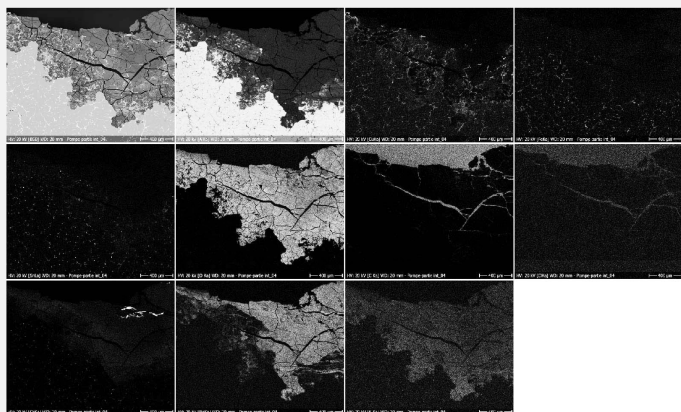
Fig. 14: SEM image and elemental chemical distribution of the area of Fig. 11. Method of analysis: SEM-EDS. Lab. of Electronic Microscopy and Microanalysis, Néode, HEI Arc,

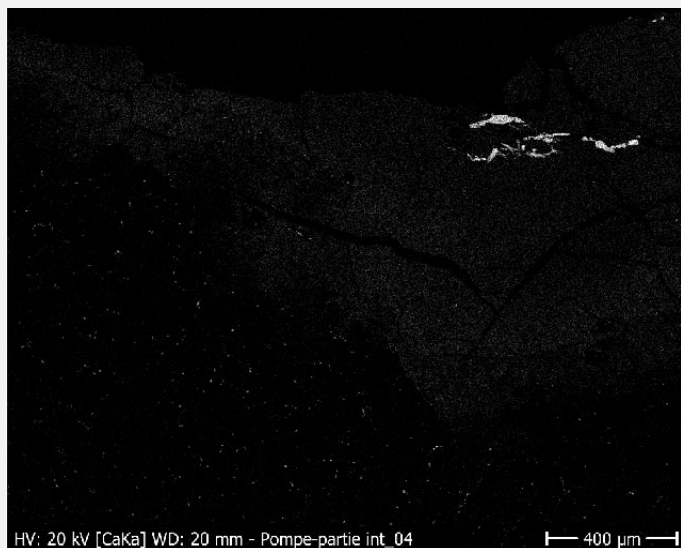
Fig. 15: Ca distribution of the area of Fig. 11. Method of analysis: SEM-EDS. Lab. of Electronic Microscopy and Microanalysis, Néode, HEI Arc,

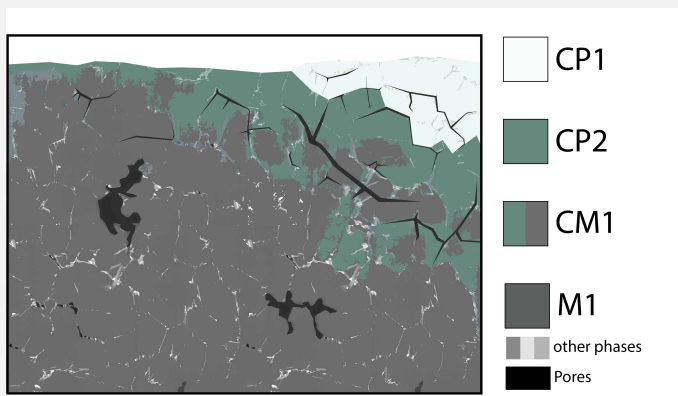
The schematic representation of corrosion layers of Fig. 6 integrating additional information based on the analyses carried out is given in Fig. 17.

Fig. 17: Improved stratigraphic representation of the corrosion structure of the exit pipe of the disassembled Hispano water pump,

The heavily corroded exit pipe of the fastening part of this Hispano-suiza water pump is made out of an Al-Cu cast alloy with traces of Sn, Fe and Si(?). The corrosion is through the dendritic microstructure: the main phase (Al) is preferentially oxidized, while the interdendritic phase (Fe, Sn, Cu) and Sn precipitates are preserved in the corrosion products. This component of the engine being in contact with the coolant might explain the presence of Na, K and Ca in the corrosion layers.
