# HISPANO-SUIZA WATER PUMP - AL ALLOY - FRANCE

<b>Artefact name</b>	Hispano-Suiza water pump
<b>Authors</b>	Christian. Degriigny (HE-Arc CR, Neuchâtel, Neuchâtel, Switzerland) & Elodie. Granget (HE-Arc CR, Neuchâtel, Neuchâtel, Switzerland) & Brice. Chalauçon (MNAM (Musée National de l'Automobile de Mulhouse), Mulhouse, Alsace, France)
<b>Url</b>	/artefacts/1250/

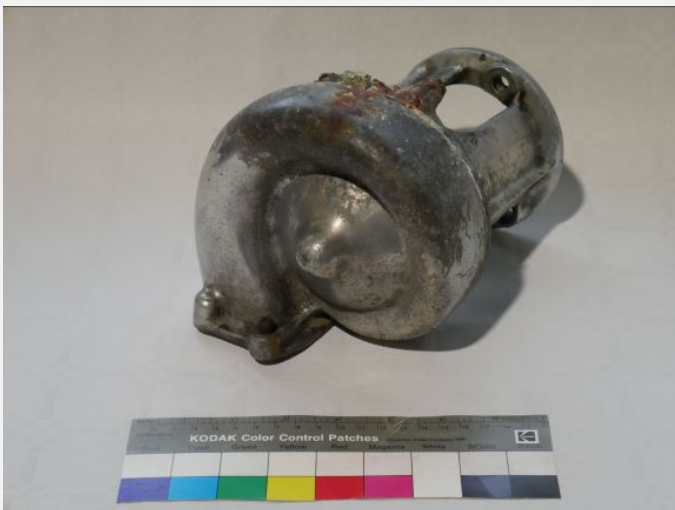
Fig. 1: Hispano-suiza water pump, unknown model,

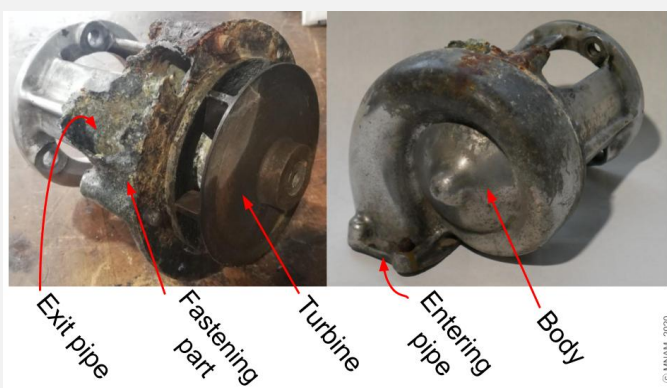
Fig. 2: Body, turbine, fastening part and pipes located on the Hispano water pump,

The exit pipe of the fastening part considered within this study is heavily corroded.

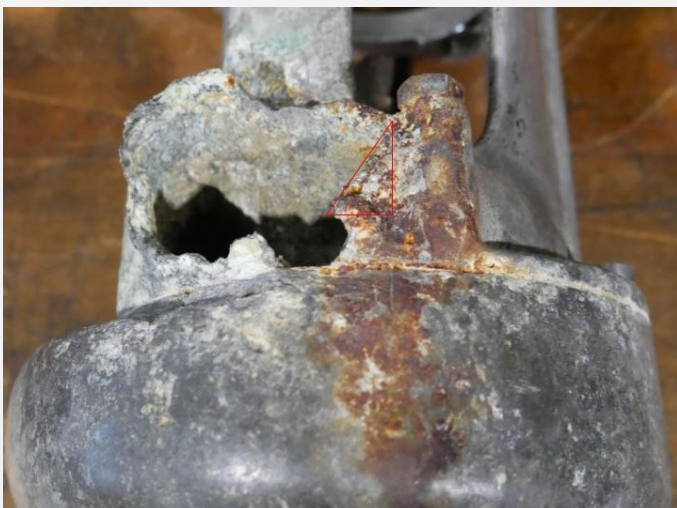
Fig. 3: Location of sampling area on the Hispano water pump,

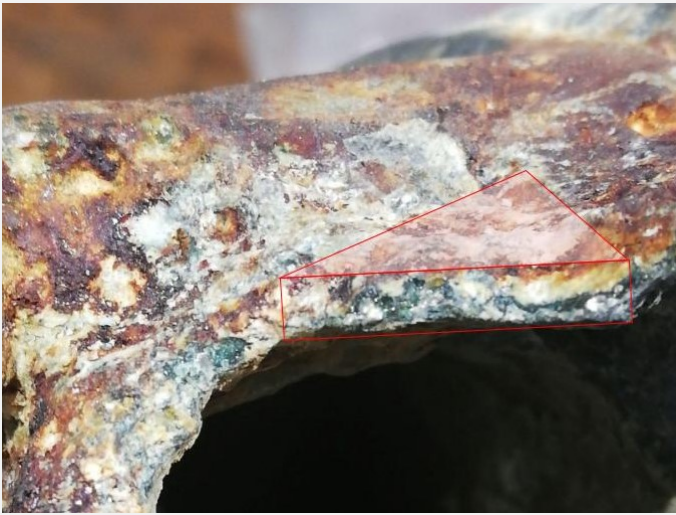
Fig. 4: Close-up view of the Hispano water pump, with the exit pipe sampling area,

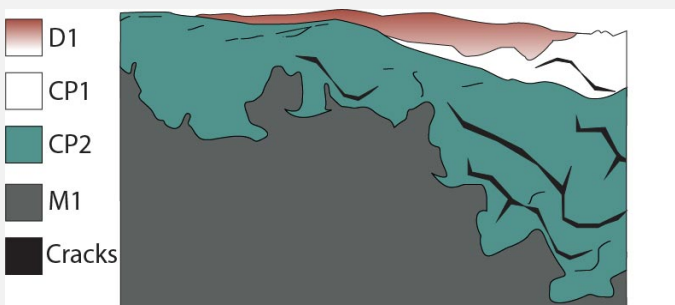
The schematic representation below gives an overview of the corrosion layers encountered on the corroded pipe of the fastening part of the pump (Fig. 6).

The CP strata show big cracks and can be removed with a bit of scratching (severable). CP2 has a green-blueish color. Over most of the corroded part there is a thick red-orange deposit. This is probably coming from the corroded steel screws, used to fasten the parts of the water-pump.

Fig. 6: Stratigraphic representation of the corroded exit pipe of the water pump by macroscopic observation, M = metal, CP = corrosion product, D = deposit,

During the sampling, the orange colored deposit layer (D1 on Fig. 6) was lost.

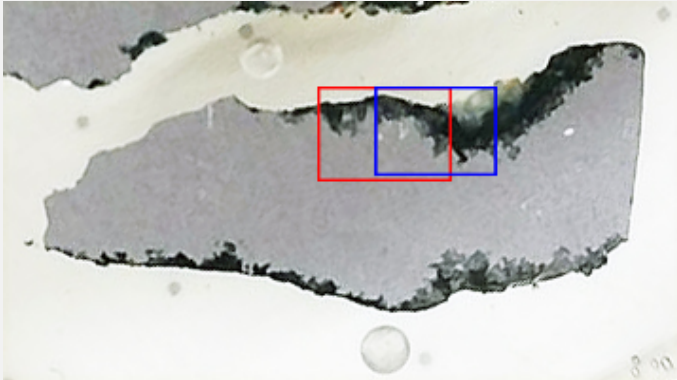
Fig. 7: Micrograph of the sample taken from the corroded exit pipe of the fastening part of the water pump (Figs. 3 to 5), showing the location of Figs. 8-9 in red and Figs. 11-15 in blue. This is a transversal cut of what is left of the exit pipe, severely consumed by corrosion,

<b>Description of sample</b>	A fragment of the exit pipe of the fastening part of the pump has been sampled and embedded as shown on Fig. 7. This is a transversal cut of what is left of the exit pipe, severely consumed by corrosion.
<b>Alloy</b>	Al Alloy
<b>Technology</b>	Cast
<b>Lab number of sample</b>	None
<b>Sample location</b>	HE-Arc CR, Neuchâtel, Neuchâtel
<b>Responsible institution</b>	MNAM (Musée National de l'Automobile de Mulhouse), Mulhouse, Alsace
<b>Date and aim of sampling</b>	31.12.2019 - Sampled for Metallography

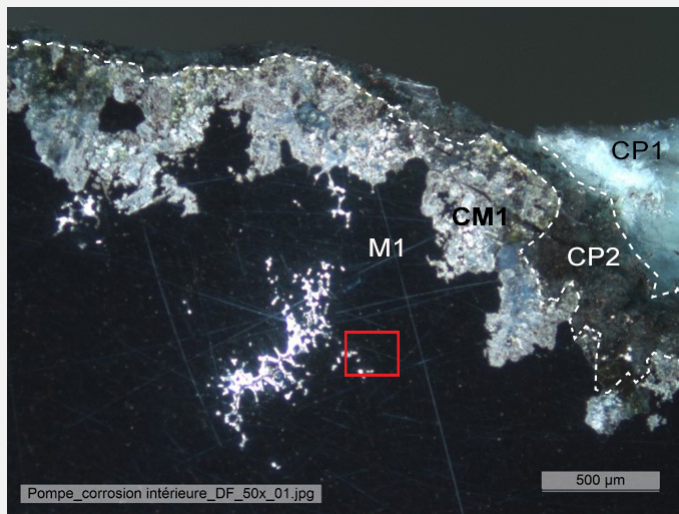
The porosity of this aluminium-copper alloy (Table 1) has been confirmed by optical (Figs. 8 and 9) and SEM observations on the cross-section of the fastening part's fragment (Fig. 10). The metal has a dendritic microstructure (Fig. 10).

Fig. 8: Micrograph of the selected area (in red) of the sample shown on Fig. 7, unetched, dark field with location of Fig. 10,

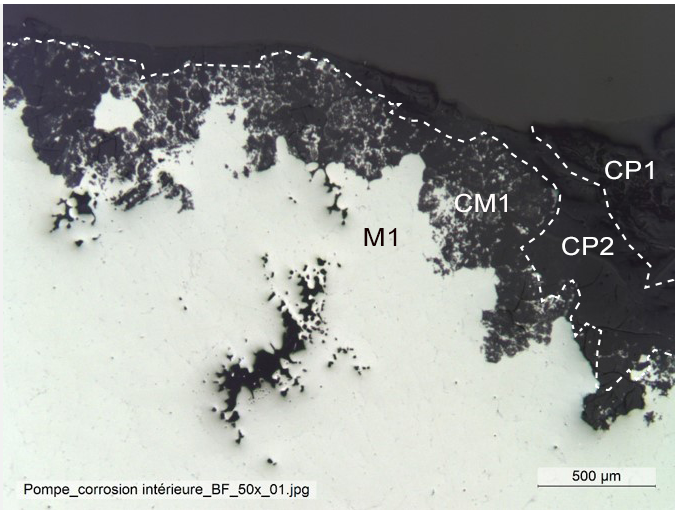
Fig. 9: Micrograph similar to Fig. 8, unetched, bright field,

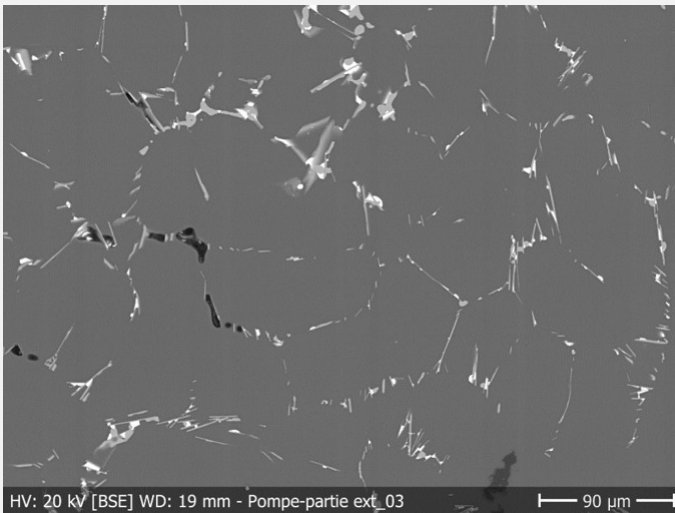
Local analyses on each phase appearing on Fig. 10 showed that the main phase is composed of Al and the interdendritic phases are composed of Al, Cu and Fe as well as Sn precipitates. This distribution is given through EDS elemental chemical distributions (Figs. 12 to 14).

Fig. 10: SEM image (BSE mode) of the metal sample from Fig. 8 showing the microstructure of the fastening part. Black = pore, dark grey = main phase, light grey = interdendritic phase and white = Sn precipitate,

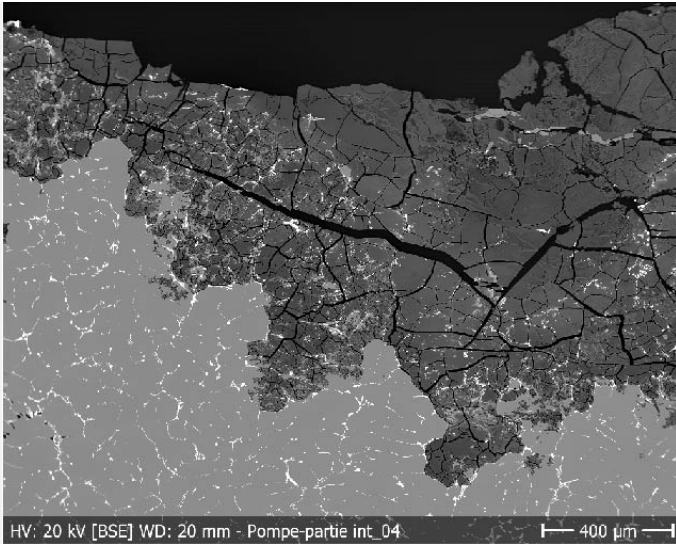
The SEM image of Fig. 11 clearly shows a network of cracks throughout CM1 and CPs. These cracks are not marking any clear separation between strata, but seem to affect all corrosion layers. The main Al phase is preferentially oxidized, while the interdendritic phase seems to be preserved in the corrosion products (Figs. 11 to 13). Na and K but no Fe are detected in the corrosion layers CM1 and CPs (Fig. 14). This surface is in contact with the coolant (glycol + additives, usually mixed 1/1 in water), which sometimes contain Na or K-based corrosion inhibitors. A cluster of CaCO<sub>3</sub> was identified on the very surface of the sample (Fig. 15). CaCO<sub>3</sub> can sometimes precipitate if the water used to mix the coolant is hard.

Fig. 11: SEM image (BSE mode) of the selected area (in blue) of the sample shown on Fig. 7, showing the remaining metal on the bottom and CM1 /CPs on top,

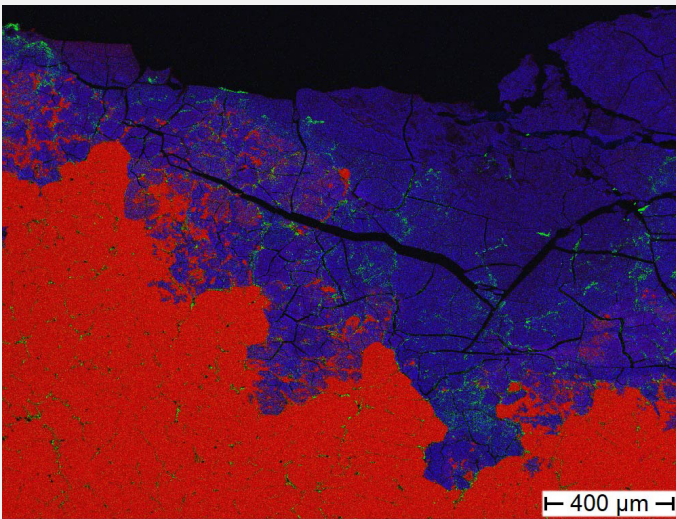
Fig. 12: Al (red), O (blue) and Cu (green) distribution of the area of Fig. 11. Method of analysis: SEM-EDS. Lab. of Electronic Microscopy and Microanalysis, Néode, HEI Arc,

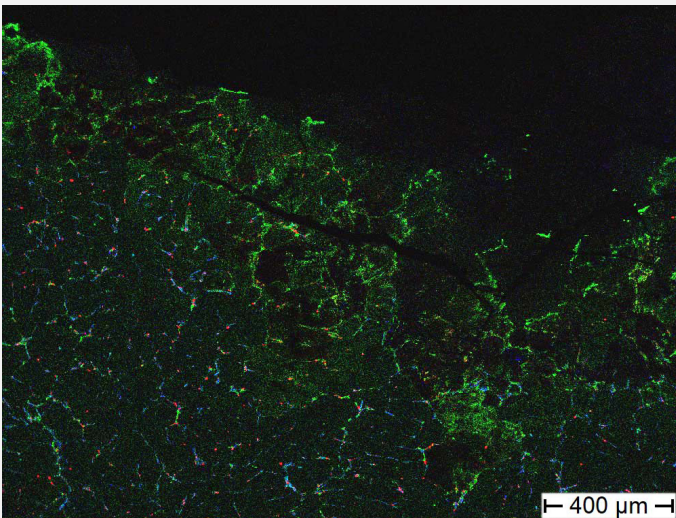
Fig. 13: Sn (red), Fe (blue) and Cu (green) distribution of the area of Fig. 11. Method of analysis: SEM-EDS. Lab. of Electronic Microscopy and Microanalysis, Néode, HEI Arc,

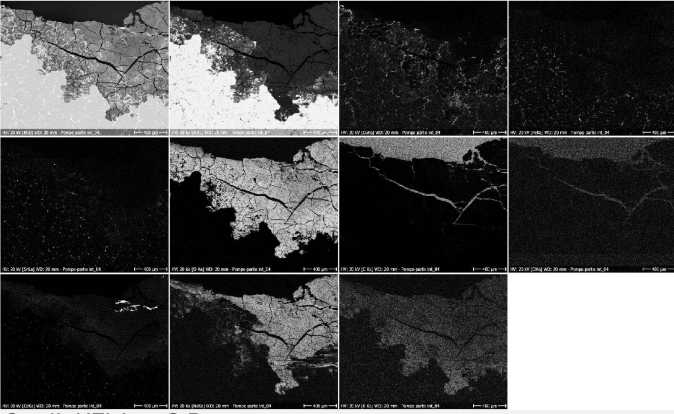
Fig. 14: SEM image and elemental chemical distribution of the area of Fig. 11. Method of analysis: SEM-EDS. Lab. of Electronic Microscopy and Microanalysis, Néode, HEI Arc,

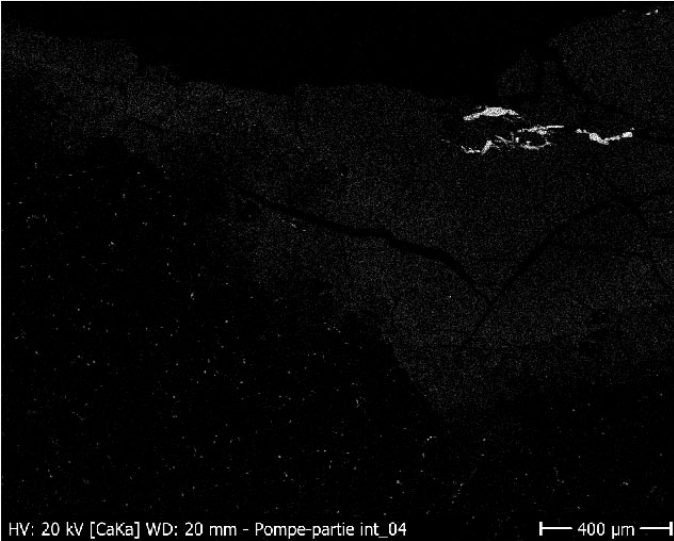
Fig. 15: Ca distribution of the area of Fig. 11. Method of analysis: SEM-EDS. Lab. of Electronic Microscopy and Microanalysis, Néode, HEI Arc,

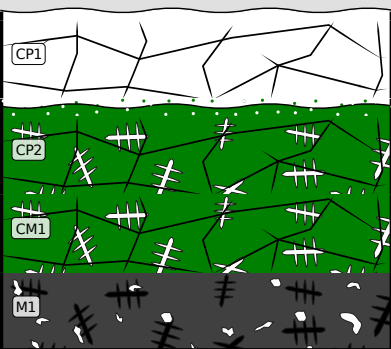
Fig. 16: Stratigraphic representation of the sample taken from the fastening part of the Hispano water pump in cross-section (dark field) using the MiCorr application. The characteristics of the strata are only accessible by clicking on the drawing that redirects you to the search tool by stratigraphy representation. This representation can be compared to Fig. 9, Credit HE-Arc CR, E.Granget.

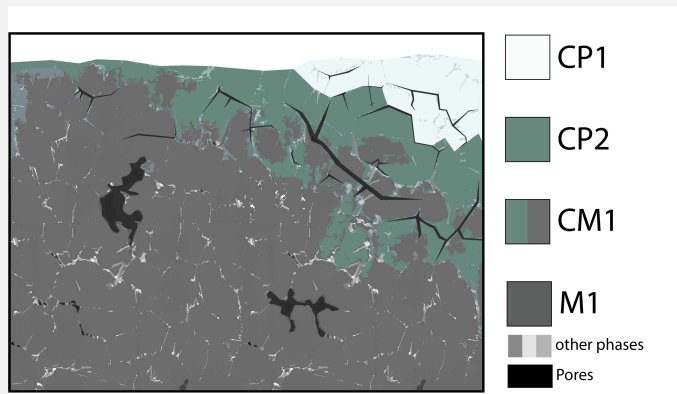
The schematic representation of corrosion layers of Fig. 6 integrating additional information based on the analyses carried out is given in Fig. 17.

Fig. 17: Improved stratigraphic representation of the corrosion structure of the exit pipe of the disassembled Hispano water pump,

The heavily corroded exit pipe of the fastening part of this Hispano-suiza water pump is made out of an Al-Cu cast alloy with traces of Sn, Fe and Si(?). The corrosion is through the dendritic microstructure: the main phase (Al) is preferentially oxidized, while the interdendritic phase (Fe, Sn, Cu) and Sn precipitates are preserved in the corrosion products. This component of the engine being in contact with the coolant might explain the presence of Na, K and Ca in the corrosion layers.
