HISPANO-SUIZA WATER PUMP – AL ALLOY – FRANCE

Artefact name	Hispano-Suiza water pump
Authors	Christian. Degriigny (HE-Arc CR, Neuchâtel, Neuchâtel, Switzerland) & Elodie. Granget (HE-Arc CR, Neuchâtel, Neuchâtel, Switzerland) & Brice. Chalançon (MNAM (Musée National de l'Automobile de Mulhouse), Mulhouse, Alsace, France)
Url	/artefacts/1250/

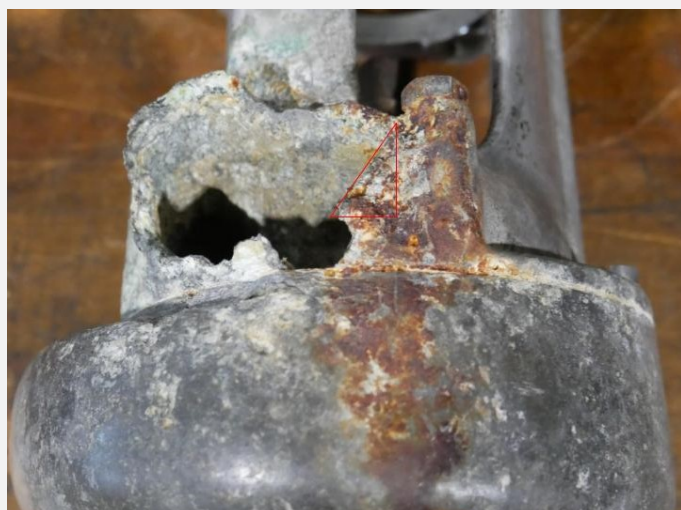
Fig. 3: Location of sampling area on the Hispano water pump,

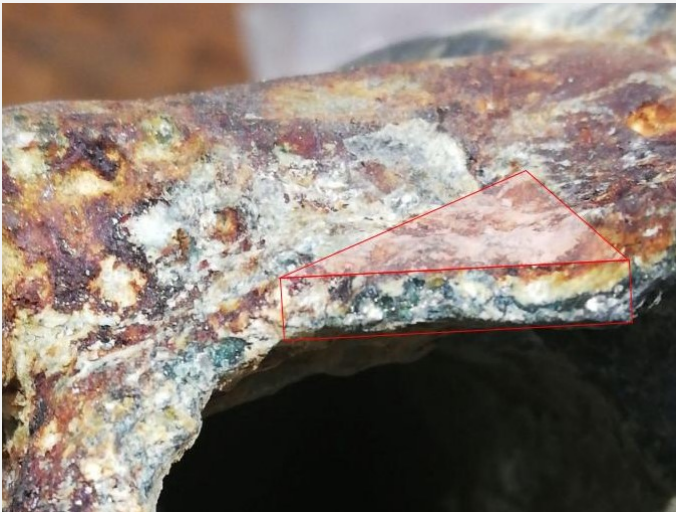
Fig. 4: Close-up view of the Hispano water pump, with the exit pipe sampling area,

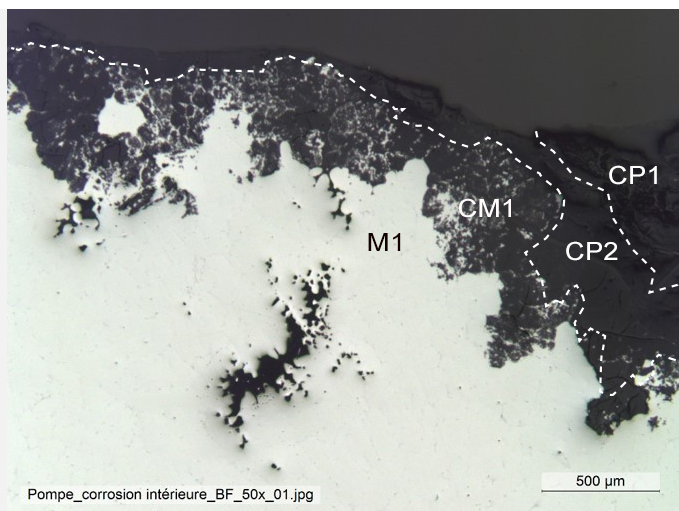
The porosity of this aluminium-copper alloy (Table 1) has been confirmed by optical (Figs. 8 and 9) and SEM observations on the cross-section of the fastening part's fragment (Fig. 10). The metal has a dendritic microstructure (Fig. 10).

Fig. 9: Micrograph similar to Fig. 8, unetched, bright field,

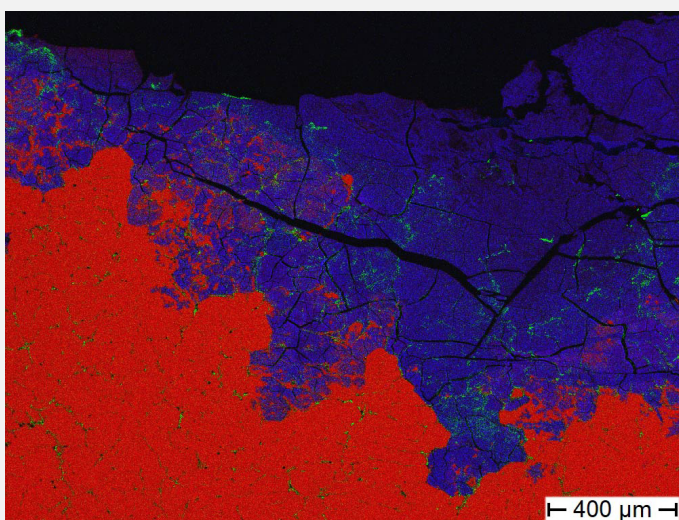
Fig. 12: Al (red), O (blue) and Cu (green) distribution of the area of Fig. 11. Method of analysis: SEM-EDS. Lab. of Electronic Microscopy and Microanalysis, Néode, HEI Arc,

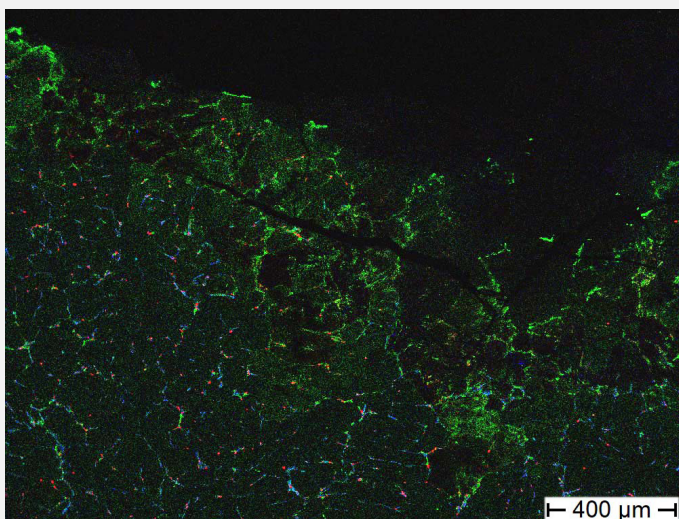
Fig. 13: Sn (red), Fe (blue) and Cu (green) distribution of the area of Fig. 11. Method of analysis: SEM-EDS. Lab. of Electronic Microscopy and Microanalysis, Néode, HEI Arc,

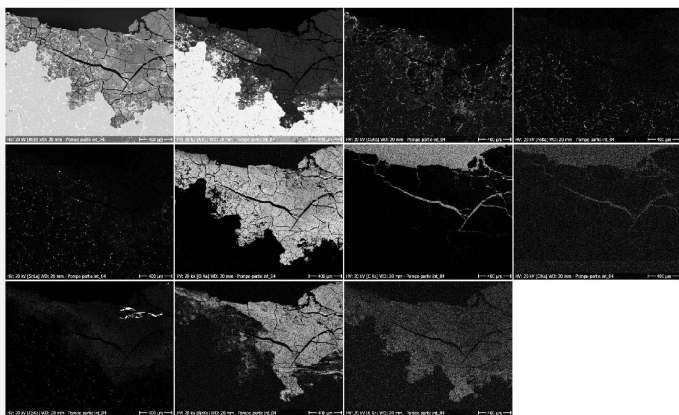
Fig. 14: SEM image and elemental chemical distribution of the area of Fig. 11. Method of analysis: SEM-EDS. Lab. of Electronic Microscopy and Microanalysis, Néode, HEI Arc,

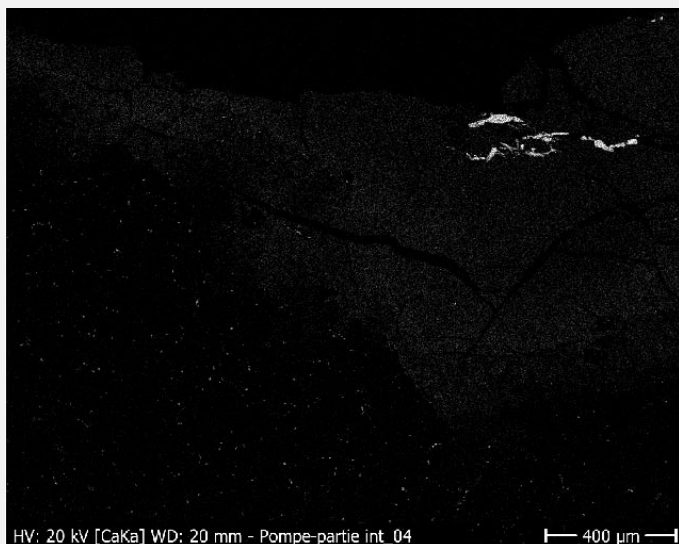
Fig. 15: Ca distribution of the area of Fig. 11. Method of analysis: SEM-EDS. Lab. of Electronic Microscopy and Microanalysis, Néode, HEI Arc,

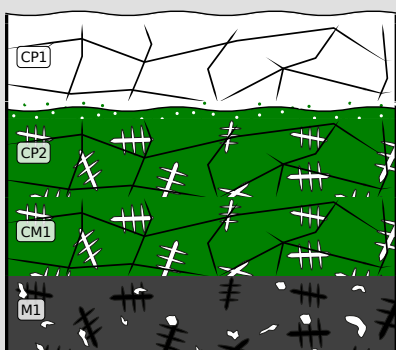
Fig. 16: Stratigraphic representation of the sample taken from the fastening part of the Hispano water pump in cross-section (dark field) using the MiCorr application. The characteristics of the strata are only accessible by clicking on the drawing that redirects you to the search tool by stratigraphy representation. This representation can be compared to Fig. 9, Credit HE-Arc CR, E.Granget.
