HISPANO-SUIZA WATER PUMP - AL ALLOY - FRANCE

Artefact name Hispano-Suiza water pump

Authors Christian. Degriigny (HE-Arc CR, Neuchâtel, Neuchâtel, Switzerland) & Elodie. Granget (HE-Arc CR, Neuchâtel, Neuchâtel, Switzerland) & Brice. Chalanson (MNAM (Musée National de l'Automobile de Mulhouse), Mulhouse, Alsace, France)

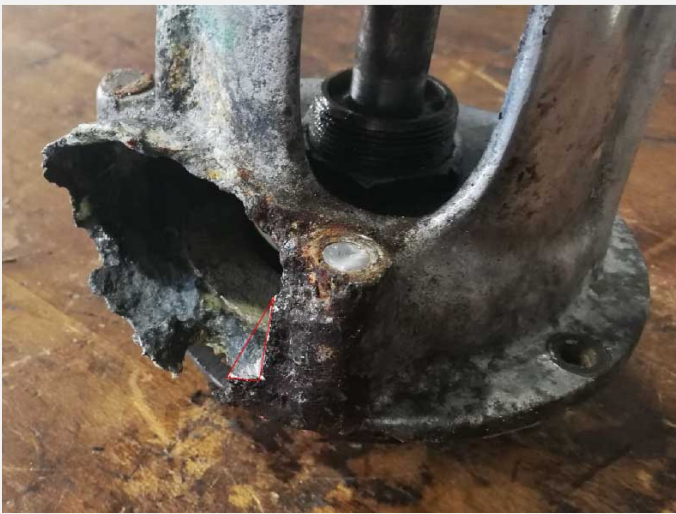
Fig. 5: Close-up view of the corroded exit pipe of the disassembled Hispano water pump, showing the sampled area,

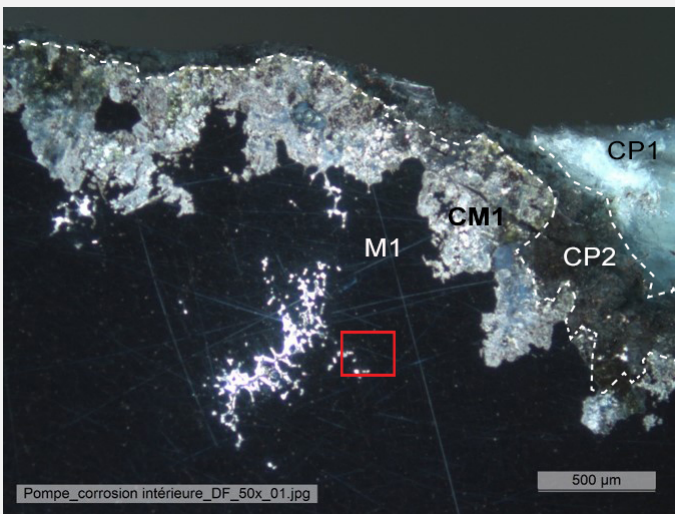
The porosity of this aluminium-copper alloy (Table 1) has been confirmed by optical (Figs. 8 and 9) and SEM observations on the cross-section of the fastening part's fragment (Fig. 10). The metal has a dendritic microstructure (Fig. 10).

Fig. 8: Micrograph of the selected area (in red) of the sample shown on Fig. 7, unetched, dark field with location of Fig. 10,

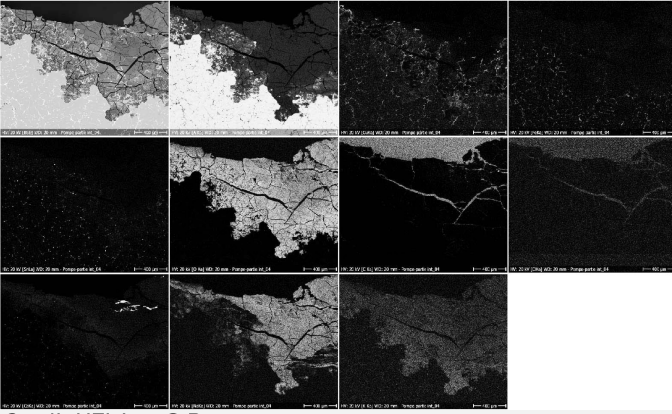
Fig. 14: SEM image and elemental chemical distribution of the area of Fig. 11. Method of analysis: SEM-EDS. Lab. of Electronic Microscopy and Microanalysis, Néode, HEI Arc,

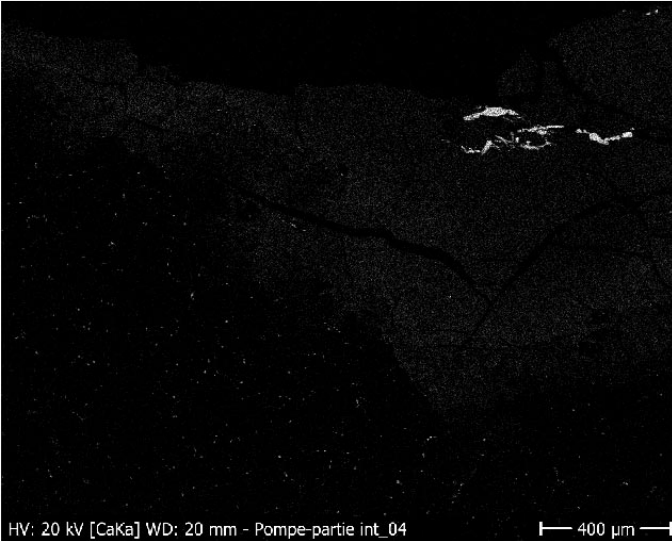
Fig. 15: Ca distribution of the area of Fig. 11. Method of analysis: SEM-EDS. Lab. of Electronic Microscopy and Microanalysis, Néode, HEI Arc,

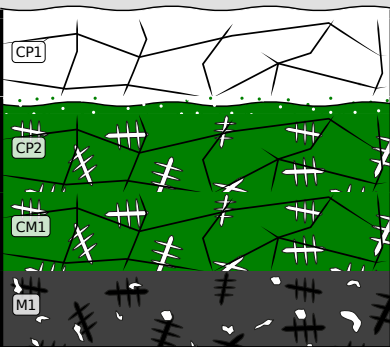
Fig. 16: Stratigraphic representation of the sample taken from the fastening part of the Hispano water pump in cross-section (dark field) using the MiCorr application. The characteristics of the strata are only accessible by clicking on the drawing that redirects you to the search tool by stratigraphy representation. This representation can be compared to Fig. 9, Credit HE-Arc CR, E.Granget.

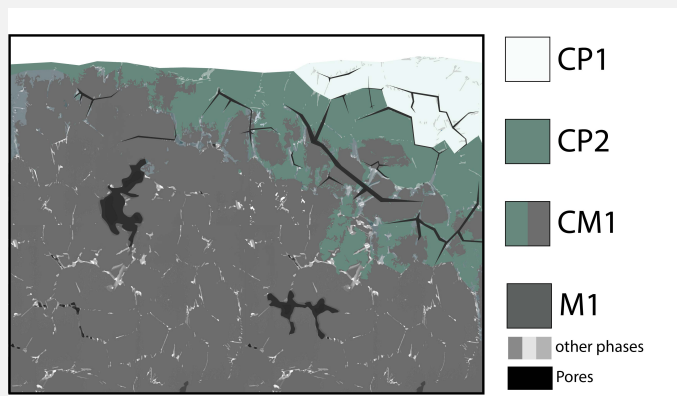
Fig. 17: Improved stratigraphic representation of the corrosion structure of the exit pipe of the disassembled Hispano water pump,

The heavily corroded exit pipe of the fastening part of this Hispano-suiza water pump is made out of an Al-Cu cast alloy with traces of Sn, Fe and Si(?). The corrosion is through the dendritic microstructure: the main phase (Al) is preferentially oxidized, while the interdendritic phase (Fe, Sn, Cu) and Sn precipitates are preserved in the corrosion products. This component of the engine being in contact with the coolant might explain the presence of Na, K and Ca in the corrosion layers.
