# BUGATTI 37 CYLINDER HEAD GASKET 0416 – AL ALLOY – MODERN TIMES – FRANCE

**Artefact name** Bugatti 37 cylinder head gasket 0416

**Authors** Christian. Degrigny (HE-Arc CR, Neuchâtel, Neuchâtel, Switzerland) & Elodie. Granget (HE-Arc CR, Neuchâtel, Neuchâtel, Switzerland) & Brice. Chalançon (MNAM (Musée National de l'Automobile de Mulhouse), Mulhouse, Alsace, France)

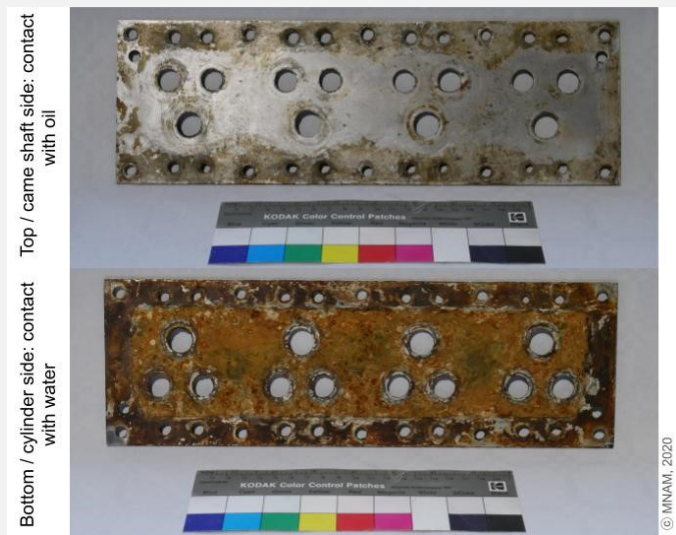
Fig. 1: General picture of the corroded cylinder head gasket of the Bugatti Type 37. Top side facing the camshaft and bottom part in contact with the coolant of the block,

The Bugatti Type 37 will be restored. When the car was dismantled, this gasket was deemed too corroded to be kept. A new part will be put in its place during the restoration. Consequently, this part has been classified as study material, allowing for sampling for metallography.

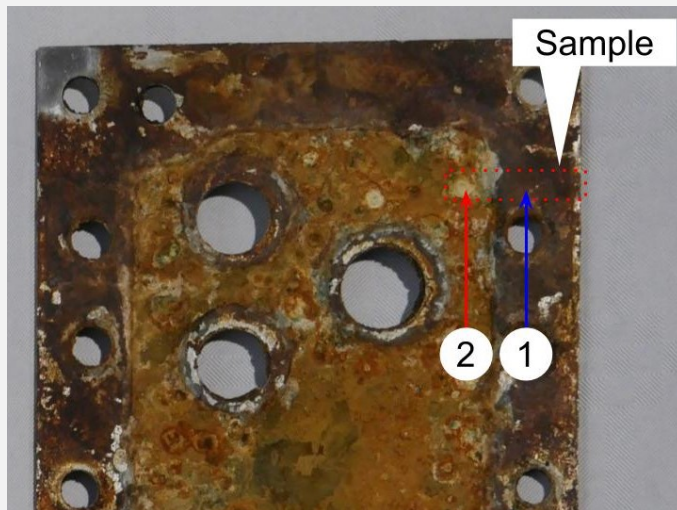
Fig. 3: Bugatti Type 37 cylinder head gasket. Location of the sampling area (red rectangle). Stratigraphic observation sites, in contact with the block [1] and in contact with the coolant [2],

Fig.3 clearly shows the limit where the gasket is in contact with the cylinder block ([1] edges and circular openings in the center) and where it is in contact with the coolant ([2] center).

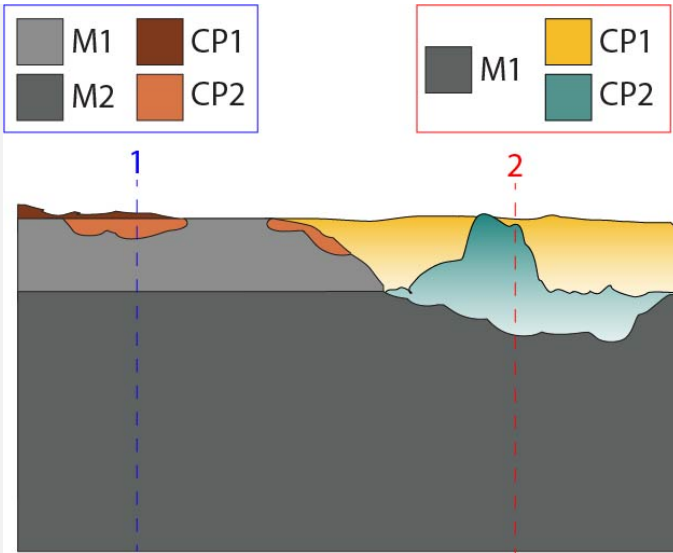
The schematic representation below gives an overview of the corrosion layers encountered on these areas (Fig. 4). The metal core (M1) is colaminated on both sides with metal M2.

Stratigraphy [1]	Stratigraphy [2]
The metal contains the strata M1 and M2.	The first metal stratum is missing and only the core metal (M2 in strat.[1], now M1) remains.
The CP1 is a thin brown layer loosely attached to the surface of M1. It can be removed with a firm brush.	The CP1 is a thick bright orange layer, really powdery and easily detached. It can be partly removed with a firm brush. The coloration is less important closer to the metal interface, where the products are white. This layer is also really fragile and friable.
In some places, CP2 develops within M1. It is colored in bright orange and can be broken in pieces with a toothpick.	The CP2 is peaking through CP1 in some places, colored in green.

Fig. 4: Stratigraphic representation of corrosion zones in contact with the block [1] and in contact with the coolant [2],

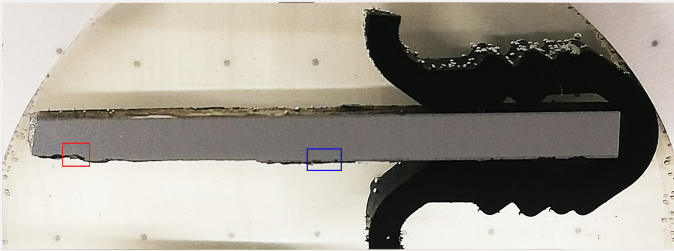
Fig. 5: Micrograph of the cross-section sampled from the Bugatti T37 gasket showing the location of zone 1 in blue (Fig. 6) and zone 2 in red (Fig. 8),

The sample shown on Fig.5 is a transversal cut of the gasket presenting 3 different corrosion sites.

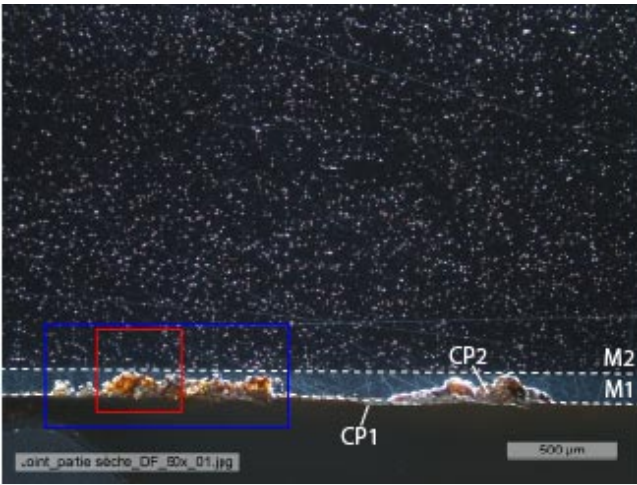
Fig. 6: Micrograph of the cross-section of the gasket, zone 1, shown on Fig. 5 unetched, dark field, showing the location of

the EDS elemental chemical distribution of Fig. 10 to 13 (in blue) and of the SEM image of Fig. 7 (in red),

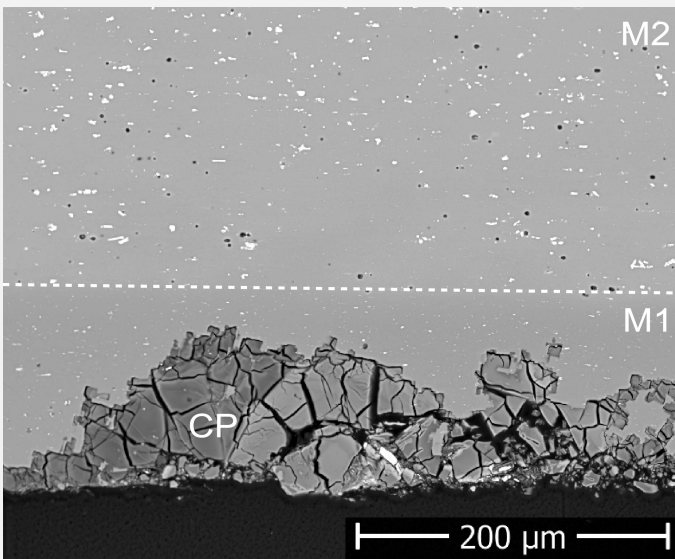
Fig. 7 shows oriented inclusions on both M1 and M2, as well as a lot of small pores in M2.

Local analyses on each phase appearing on Fig. 7 showed that the roll-bounded metal M1 is a compact (non-porous) sheet of pure Al (Table 1) with oriented inclusions of Fe and Si. The core M2 is a very porous alloy composed of Al with bigger oriented inclusions of Si, Mn, Fe, Mg.

Fig 7: SEM detail (BSE mode) of zone 1 of the colaminated sheet in cross-section. The core metal (M2) is porous (in black) and shows oriented inclusions (in white) and the colaminated metal (M1) is compact and has smaller oriented inclusions (in white). Corrosion products (in dark grey) are limited to M1,

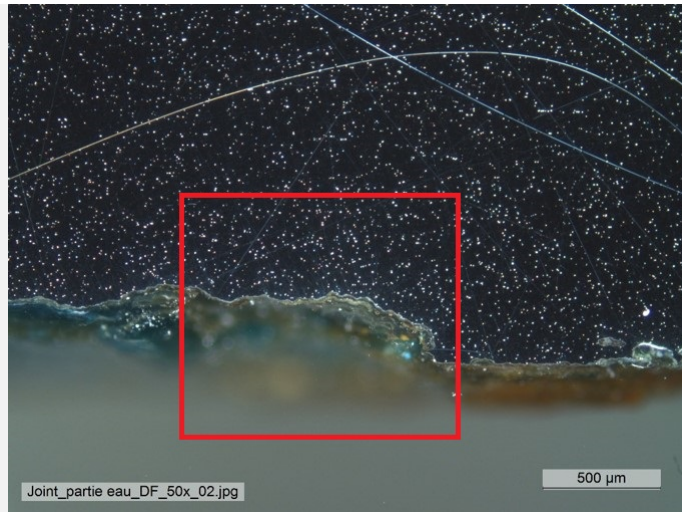
Fig. 7 shows that the corrosion products progress through M1 and develop a network of cracks. Fig. 8 shows that the corrosion can expand even further through M2 (zone 2), the corrosion products being more stratified (Fig. 9).

Fig. 8: Micrograph of the cross-section of the gasket, zone 2, shown on Fig. 5 unetched, dark field, showing the location of

the SEM image of Fig. 9 (in red),

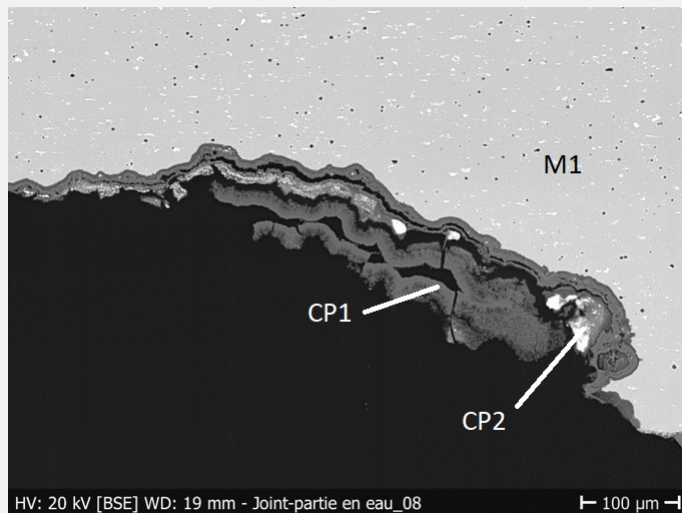
Fig 9: SEM detail (BSE mode) of zone 2 of the gasket in cross-section. The colaminated Al is missing. The core metal (now M1) is porous (black spots) and shows oriented inclusions (in white). The corrosion products (CP1) are very friable and retain clusters of inclusions that are also corroded (CP2),

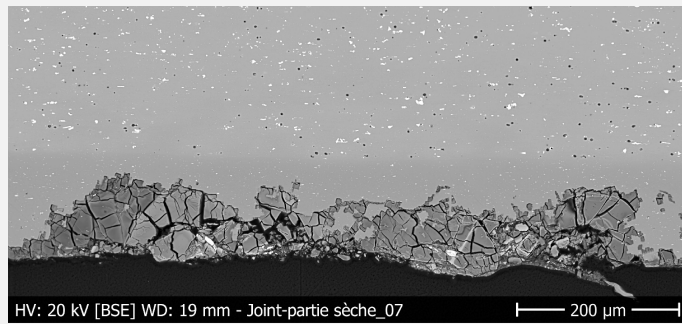
Fig. 10: SEM image (BSE mode) of the cross-section of zone 2 of the gasket (detail of Fig. 6) showing the core metal on top (M2) and the heavily corroded colaminated metal (M1),

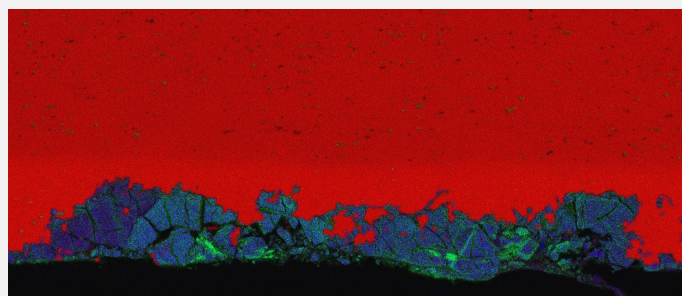
The EDS elemental chemical distribution of zone 1 is given in Fig. 11 to 13. The corrosion layers contain S (probably aluminium sulfate (Fig. 12), polluted with Fe (Fig. 11)). The presence of sulfur can be explained by the proximity of the gasket to the combustion chamber. As for the iron, it is probably coming from the steel block.

Fig. 11: Al (red), O (blue) and Fe (green) chemical distribution of the area of Fig. 10. Method of analysis: SEM-EDS. Lab. of Electronic Microscopy and Microanalysis, Néode, HEI Arc.

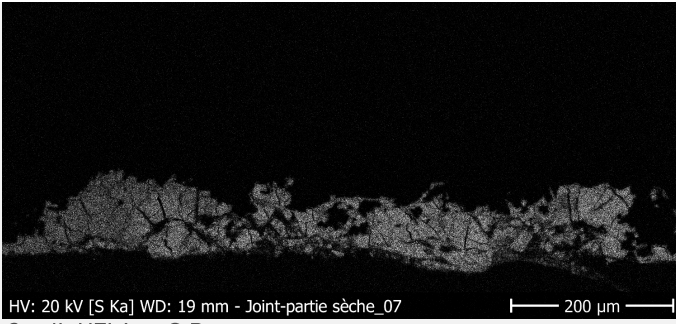
Fig. 12: S chemical distribution of the area of Fig. 10. Method of analysis: SEM-EDS. Lab. of Electronic Microscopy and Microanalysis, Néode, HEI Arc.

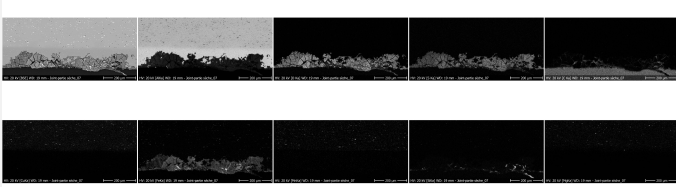
Fig. 13: SEM image and elemental chemical distribution of the area of Fig. 10. Method of analysis: SEM-EDS. Lab. of Electronic Microscopy and Microanalysis, Néode, HEI Arc.

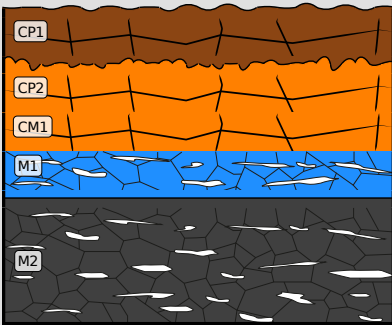
Fig. 14: Stratigraphic representation of the gasket (zone 1) in cross-section (dark field), using the MiCorr application. The characteristics of the strata are only accessible by clicking on the drawing that redirects you to the search tool by stratigraphy representation. This representation can be compared to Fig. 7, Credit HE-Arc CR, E.Granget.

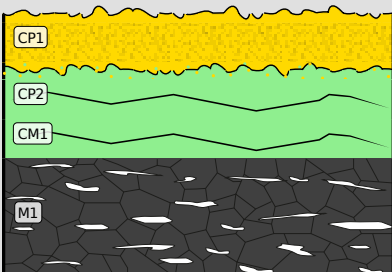
Fig. 15: Stratigraphic representation of the gasket (zone 2) in cross-section (dark field), using the MiCorr application. The characteristics of the strata are only accessible by clicking on the drawing that redirects you to the search tool by stratigraphy representation. This representation can be compared to Fig. 9, Credit HE-Arc CR, E.Granget.

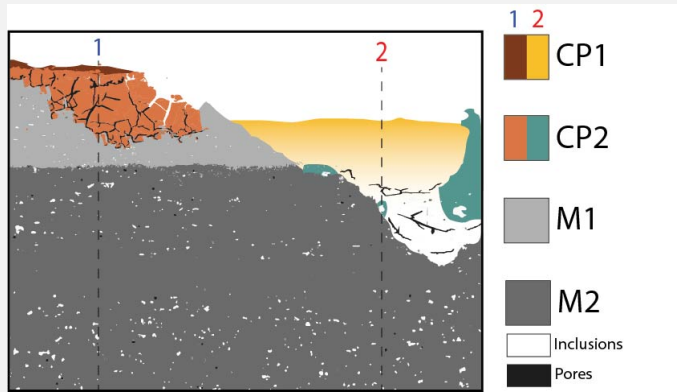
The schematic representations of corrosion layers of Figs. 6 and 7 integrating additional information based on the analyses carried out is given in Fig. 16.

No analyses could be carried out on the top thicker part of CP1.

Fig. 16: Improved stratigraphic representation of the 2 corrosion structures of the Bugatti cylinder head gasket. CP1 could not be analysed,
