# BUGATTI 37 CYLINDER HEAD GASKET 0416 - AL ALLOY - MODERN TIMES - FRANCE

<b>Artefact name</b>	Bugatti 37 cylinder head gasket 0416
<b>Authors</b>	Christian. Degrigny (HE-Arc CR, Neuchâtel, Neuchâtel, Switzerland) & Elodie. Granget (HE-Arc CR, Neuchâtel, Neuchâtel, Switzerland) & Brice. Chalançon (MNAM (Musée National de l'Automobile de Mulhouse), Mulhouse, Alsace, France)
<b>Url</b>	/artefacts/1251/

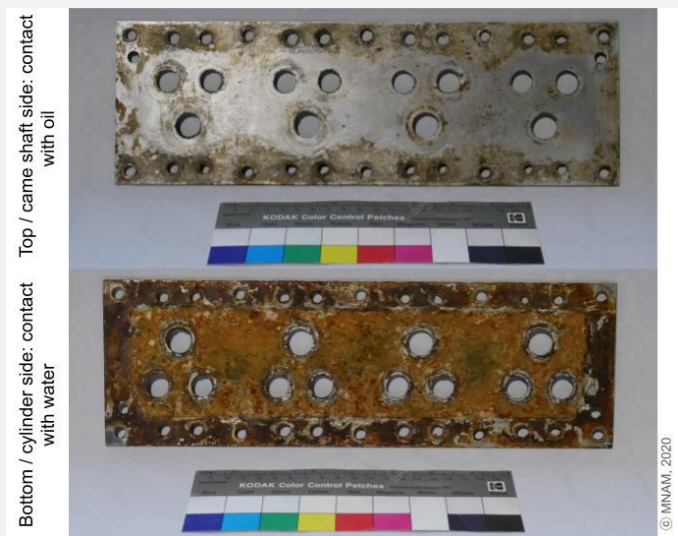
Fig. 1: General picture of the corroded cylinder head gasket of the Bugatti Type 37. Top side facing the camshaft and bottom part in contact with the coolant of the block,

The Bugatti Type 37 will be restored. When the car was dismantled, this gasket was deemed too corroded to be kept. A new part will be put in its place during the restoration. Consequently, this part has been classified as study material, allowing for sampling for metallography.

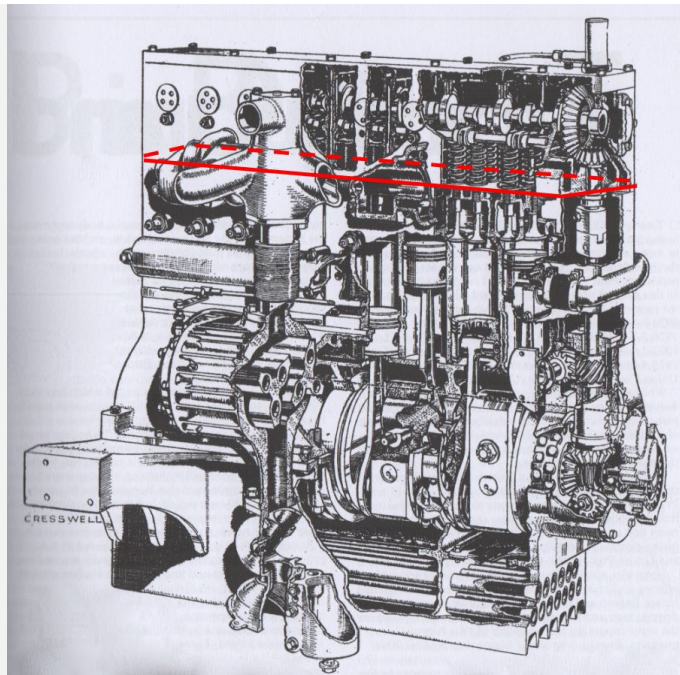
Fig. 2: Gasket located in red on technical drawing of the engine from Cresswell,

<b>Description of the artefact</b>	A coolant flows through the cylinder block inside galleries. This aluminium gasket is making a tight junction between the camshaft and the top of the block (Fig. 2). It keeps the water or coolant (water + glycol-based antifreeze) from mixing with the lubricant used on the shaft, the pistons and the cylinders. The wet side is facing the cylinder block. The other side is dry.
<b>Type of artefact</b>	Technical object
<b>Origin</b>	MNAM (Musée National de l'Automobile de Mulhouse), Mulhouse, Alsace, France
<b>Recovering date</b>	Unknown
<b>Chronology category</b>	Modern Times
<b>chronology tpq</b>	<input type="text" value="1926"/> A.D. ▼
<b>chronology taq</b>	<input type="text" value=""/> ---- ▼
<b>Chronology comment</b>	The production of this model started in 1926
<b>Burial conditions / environment</b>	Outdoor to indoor atmosphere
<b>Artefact location</b>	MNAM (Musée National de l'Automobile de Mulhouse), Mulhouse, Alsace

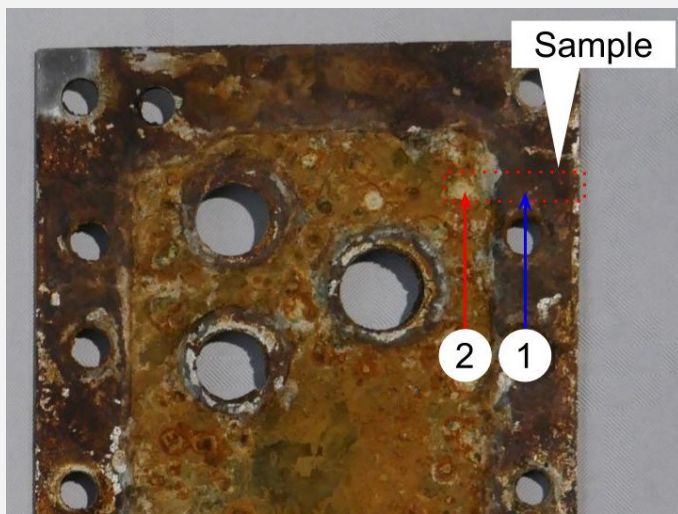
Fig. 3: Bugatti Type 37 cylinder head gasket. Location of the sampling area (red rectangle). Stratigraphic observation sites, in contact with the block [1] and in contact with the coolant [2],

Fig.3 clearly shows the limit where the gasket is in contact with the cylinder block ([1] edges and circular openings in the center) and where it is in contact with the coolant ([2] center).

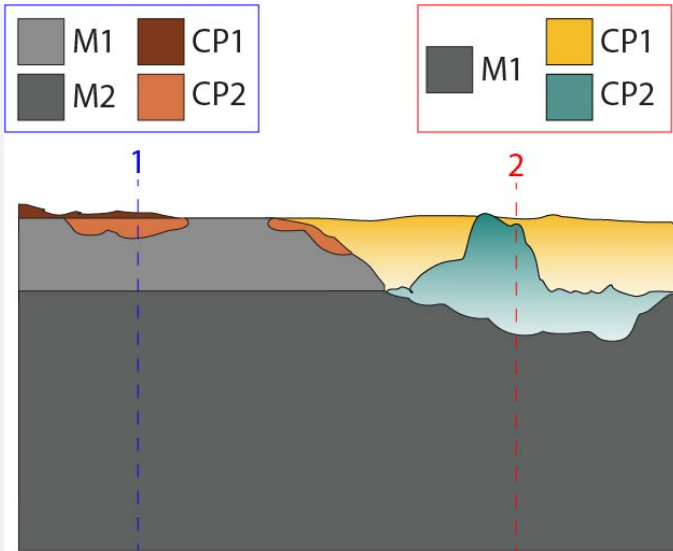
The schematic representation below gives an overview of the corrosion layers encountered on these areas (Fig. 4). The metal core (M1) is colaminated on both sides with metal M2.

Stratigraphy [1]	Stratigraphy [2]
The metal contains the strata M1 and M2.	The first metal stratum is missing and only the core metal (M2 in strat.[1], now M1) remains.
The CP1 is a thin brown layer loosely attached to the surface of M1. It can be removed with a firm brush.	The CP1 is a thick bright orange layer, really powdery and easily detached. It can be partly removed with a firm brush. The coloration is less important closer to the metal interface, where the products are white. This layer is also really fragile and friable.
In some places, CP2 develops within M1. It is colored in bright orange and can be broken in pieces with a toothpick.	The CP2 is peaking through CP1 in some places, colored in green.

Fig. 4: Stratigraphic representation of corrosion zones in contact with the block [1] and in contact with the coolant [2],

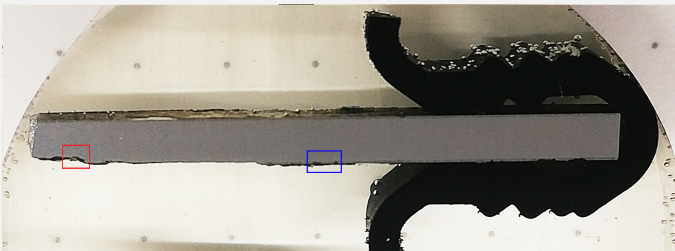
Fig. 5: Micrograph of the cross-section sampled from the Bugatti T37 gasket showing the location of zone 1 in blue (Fig. 6) and zone 2 in red (Fig. 8),

The sample shown on Fig.5 is a transversal cut of the gasket presenting 3 different corrosion sites.

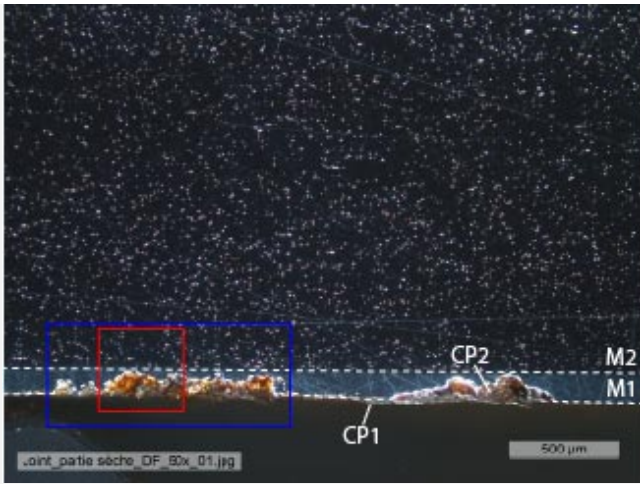
Fig. 6: Micrograph of the cross-section of the gasket, zone 1, shown on Fig. 5 unetched, dark field, showing the location of the EDS elemental chemical distribution of Fig. 10 to 13 (in blue) and of the SEM image of Fig. 7 (in red),

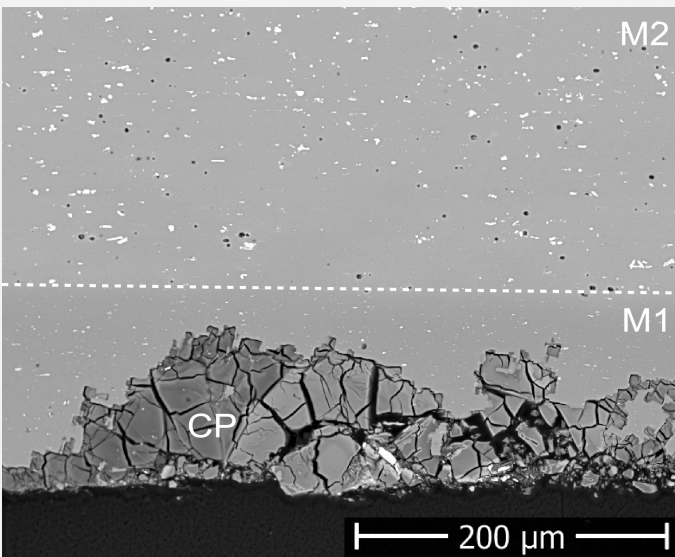
Fig. 7 shows oriented inclusions on both M1 and M2, as well as a lot of small pores in M2. Local analyses on each phase appearing on Fig. 7 showed that the roll-bounded metal M1 is a compact (non-porous) sheet of pure Al (Table 1) with oriented inclusions of Fe and Si. The core M2 is a very porous alloy composed of Al with bigger oriented inclusions of Si, Mn, Fe, Mg.

Fig 7: SEM detail (BSE mode) of zone 1 of the colaminated sheet in cross-section. The core metal (M2) is porous (in black) and shows oriented inclusions (in white) and the colaminated metal (M1) is compact and has smaller oriented inclusions (in white). Corrosion products (in dark grey) are limited to M1,

Fig. 7 shows that the corrosion products progress through M1 and develop a network of cracks. Fig. 8 shows that the corrosion can expand even further through M2 (zone 2), the corrosion products being more stratified (Fig. 9).

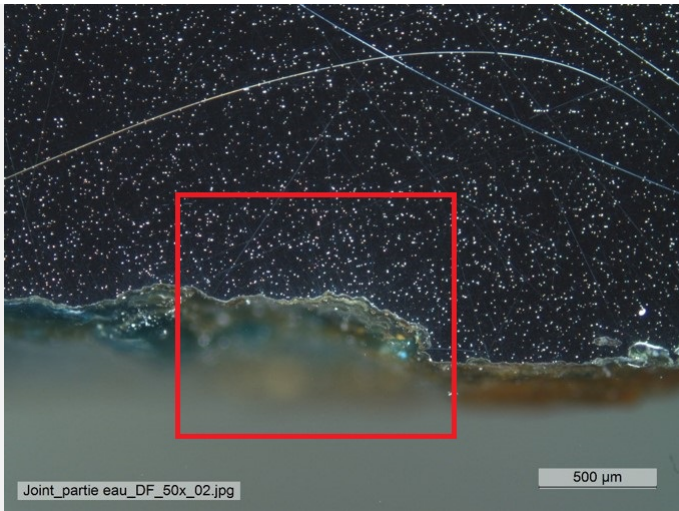
Fig. 8: Micrograph of the cross-section of the gasket, zone 2, shown on Fig. 5 unetched, dark field, showing the location of the SEM image of Fig. 9 (in red),

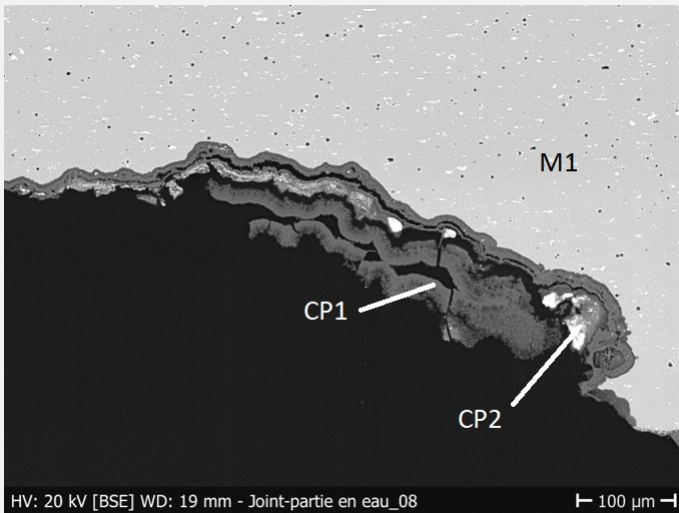
Fig 9: SEM detail (BSE mode) of zone 2 of the gasket in cross-section. The colaminated Al is missing. The core metal (now M1) is porous (black spots) and shows oriented inclusions (in white). The corrosion products (CP1) are very friable and retain clusters of inclusions that are also corroded (CP2),

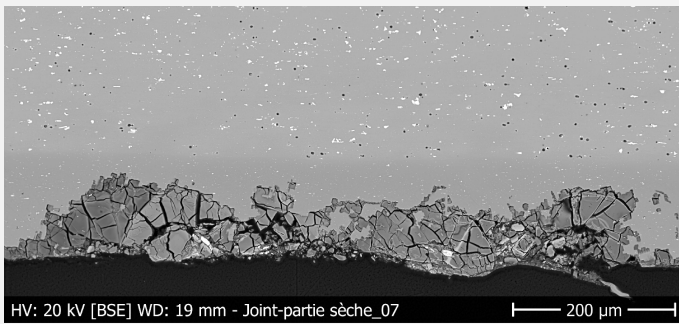
Fig. 10: SEM image (BSE mode) of the cross-section of zone 2 of the gasket (detail of Fig. 6) showing the core metal on top (M2) and the heavily corroded colaminated metal (M1),

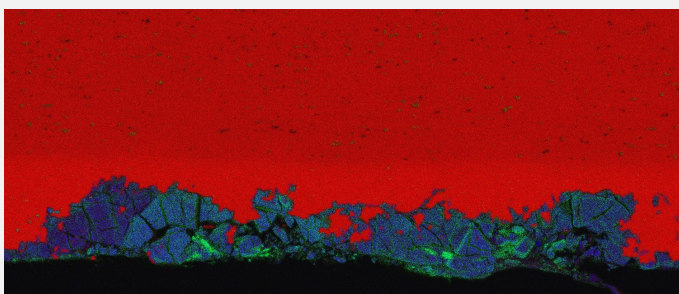
The EDS elemental chemical distribution of zone 1 is given in Fig. 11 to 13. The corrosion layers contain S (probably aluminium sulfate (Fig. 12), polluted with Fe (Fig. 11)). The presence of sulfur can be explained by the proximity of the gasket to the combustion chamber. As for the iron, it is probably coming from the steel block.

Fig. 11: Al (red), O (blue) and Fe (green) chemical distribution of the area of Fig. 10. Method of analysis: SEM-EDS. Lab. of Electronic Microscopy and Microanalysis, Néode, HEI Arc.

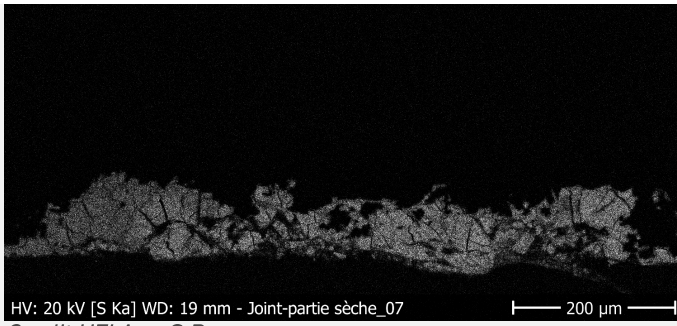
Fig. 12: S chemical distribution of the area of Fig. 10. Method of analysis: SEM-EDS. Lab. of Electronic Microscopy and Microanalysis, Néode, HEI Arc.

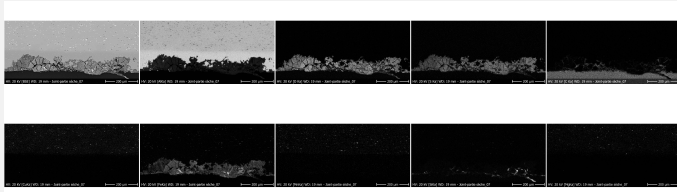
Fig. 13: SEM image and elemental chemical distribution of the area of Fig. 10. Method of analysis: SEM-EDS. Lab. of Electronic Microscopy and Microanalysis, Néode, HEI Arc.

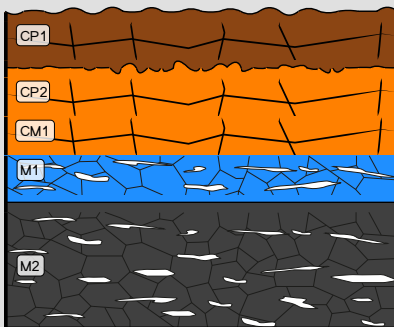
Fig. 14: Stratigraphic representation of the gasket (zone 1) in cross-section (dark field), using the MiCorr application. The characteristics of the strata are only accessible by clicking on the drawing that redirects you to the search tool by stratigraphy representation. This representation can be compared to Fig. 7, Credit HE-Arc CR, E.Granget.

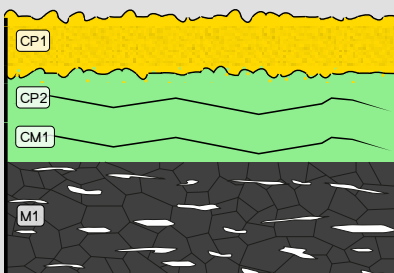
Fig. 15: Stratigraphic representation of the gasket (zone 2) in cross-section (dark field), using the MiCorr application. The characteristics of the strata are only accessible by clicking on the drawing that redirects you to the search tool by stratigraphy representation. This representation can be compared to Fig. 9, Credit HE-Arc CR, E.Granget.

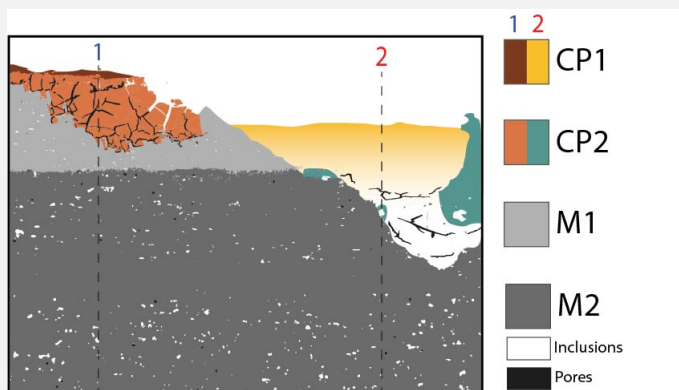
The schematic representations of corrosion layers of Figs. 6 and 7 integrating additional information based on the analyses carried out is given in Fig. 16.

No analyses could be carried out on the top thicker part of CP1.

Fig. 16: Improved stratigraphic representation of the 2 corrosion structures of the Bugatti cylinder head gasket. CP1 could not be analysed,
