# BUGATTI 37 CYLINDER HEAD GASKET 0416 - AL ALLOY - MODERN TIMES - FRANCE

<b>Artefact name</b>	Bugatti 37 cylinder head gasket 0416
<b>Authors</b>	Christian. Degriigny (HE-Arc CR, Neuchâtel, Neuchâtel, Switzerland) & Elodie. Granget (HE-Arc CR, Neuchâtel, Neuchâtel, Switzerland) & Brice. Chalançon (MNAM (Musée National de l'Automobile de Mulhouse), Mulhouse, Alsace, France)
<b>Url</b>	/artefacts/1251/

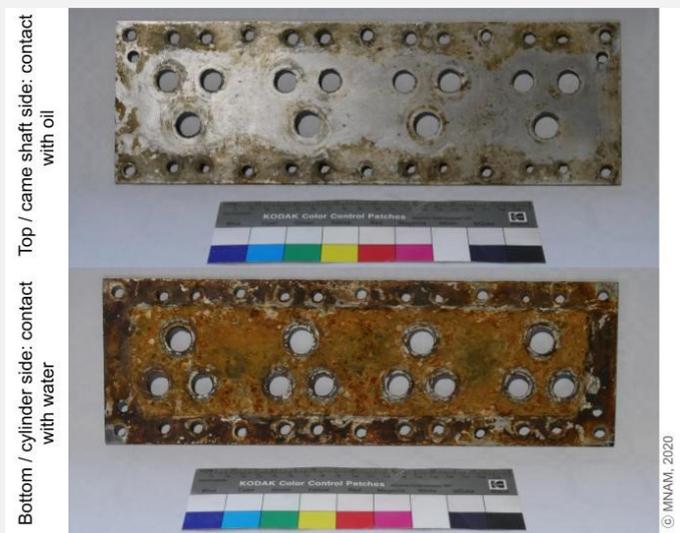
Fig. 1: General picture of the corroded cylinder head gasket of the Bugatti Type 37. Top side facing the camshaft and bottom part in contact with the coolant of the block,

The Bugatti Type 37 will be restored. When the car was dismantled, this gasket was deemed too corroded to be kept. A new part will be put in its place during the restoration. Consequently, this part has been classified as study material, allowing for sampling for metallography.

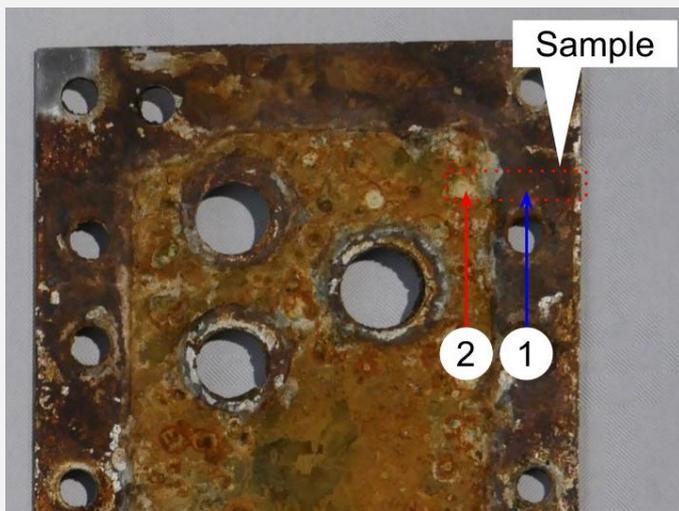
Fig. 3: Bugatti Type 37 cylinder head gasket. Location of the sampling area (red rectangle). Stratigraphic observation sites, in contact with the block [1] and in contact with the coolant [2],

Fig.3 clearly shows the limit where the gasket is in contact with the cylinder block ([1] edges and circular openings in the center) and where it is in contact with the coolant ([2] center).

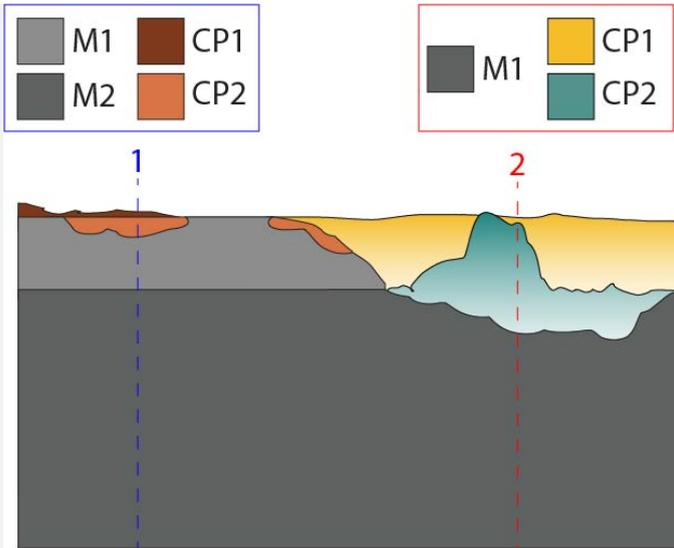
The schematic representation below gives an overview of the corrosion layers encountered on these areas (Fig. 4). The metal core (M1) is colaminated on both sides with metal M2.

Stratigraphy [1]	Stratigraphy [2]
The metal contains the strata M1 and M2.	The first metal stratum is missing and only the core metal (M2 in strat.[1], now M1) remains.
The CP1 is a thin brown layer loosely attached to the surface of M1. It can be removed with a firm brush.	The CP1 is a thick bright orange layer, really powdery and easily detached. It can be partly removed with a firm brush. The coloration is less important closer to the metal interface, where the products are white. This layer is also really fragile and friable.
In some places, CP2 develops within M1. It is colored in bright orange and can be broken in pieces with a toothpick.	The CP2 is peaking through CP1 in some places, colored in green.

Fig. 4: Stratigraphic representation of corrosion zones in contact with the block [1] and in contact with the coolant [2],

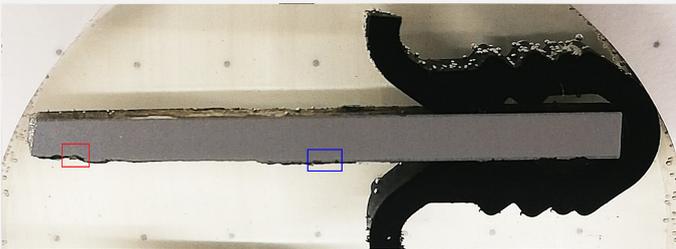
Fig. 5: Micrograph of the cross-section sampled from the Bugatti T37 gasket showing the location of zone 1 in blue (Fig. 6) and zone 2 in red (Fig. 8),

The sample shown on Fig.5 is a transversal cut of the gasket presenting 3 different corrosion sites.

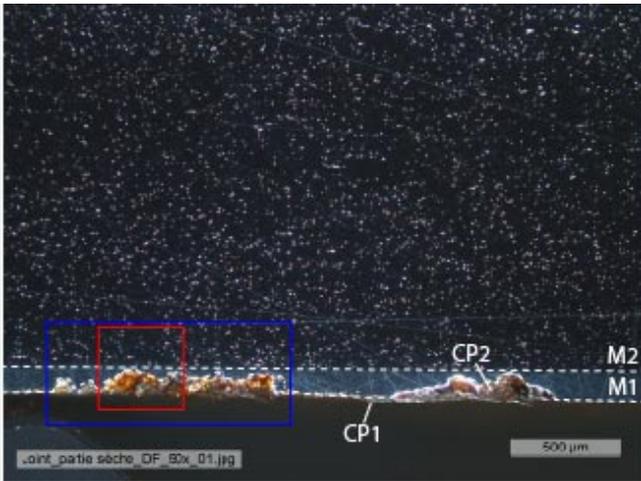
Fig. 6: Micrograph of the cross-section of the gasket, zone 1, shown on Fig. 5 unetched, dark field, showing the location of the EDS elemental chemical distribution of Fig. 10 to 13 (in blue) and of the SEM image of Fig. 7 (in red),

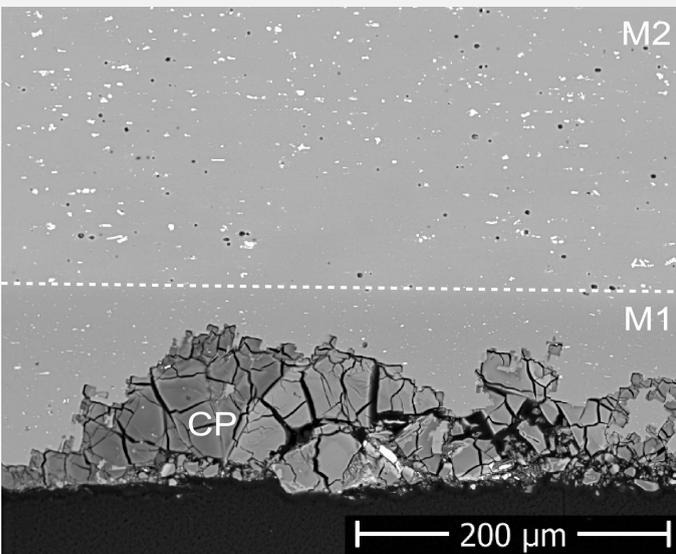
Fig. 7 shows oriented inclusions on both M1 and M2, as well as a lot of small pores in M2. Local analyses on each phase appearing on Fig. 7 showed that the roll-bounded metal M1 is a compact (non-porous) sheet of pure Al (Table 1) with oriented inclusions of Fe and Si. The core M2 is a very porous alloy composed of Al with bigger oriented inclusions of Si, Mn, Fe, Mg.

Fig 7: SEM detail (BSE mode) of zone 1 of the colaminated sheet in cross-section. The core metal (M2) is porous (in black) and shows oriented inclusions (in white) and the colaminated metal (M1) is compact and has smaller oriented inclusions (in white). Corrosion products (in dark grey) are limited to M1,

Fig. 7 shows that the corrosion products progress through M1 and develop a network of cracks. Fig. 8 shows that the corrosion can expand even further through M2 (zone 2), the corrosion products being more stratified (Fig. 9).

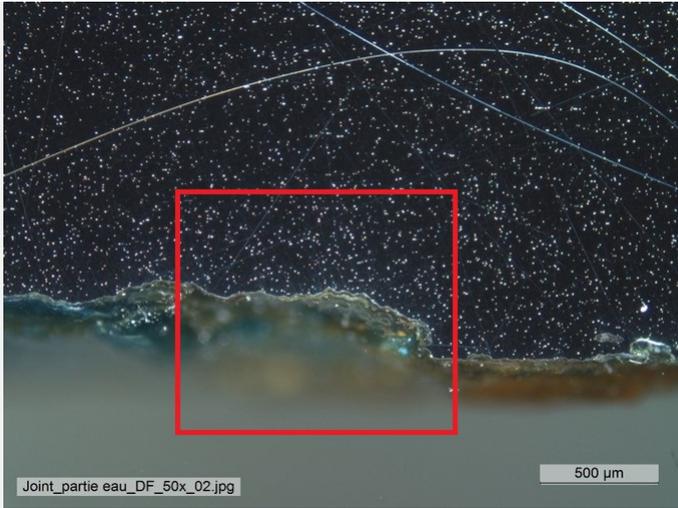
Fig. 8: Micrograph of the cross-section of the gasket, zone 2, shown on Fig. 5 unetched, dark field, showing the location of the SEM image of Fig. 9 (in red),

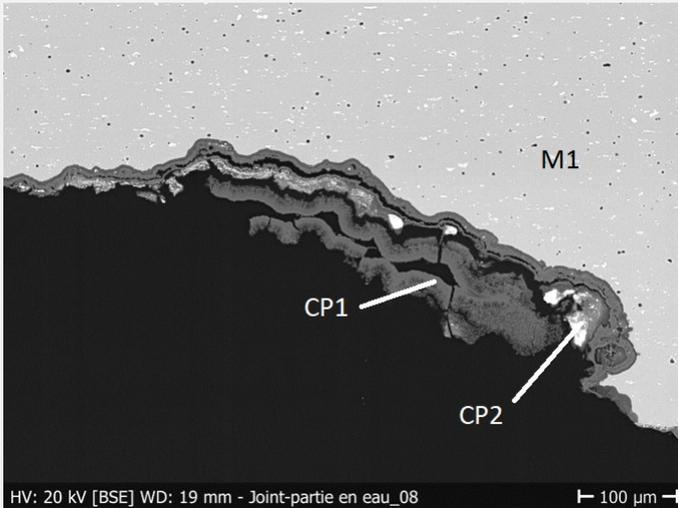
Fig 9: SEM detail (BSE mode) of zone 2 of the gasket in cross-section. The colaminated Al is missing. The core metal (now M1) is porous (black spots) and shows oriented inclusions (in white). The corrosion products (CP1) are very friable and retain clusters of inclusions that are also corroded (CP2),

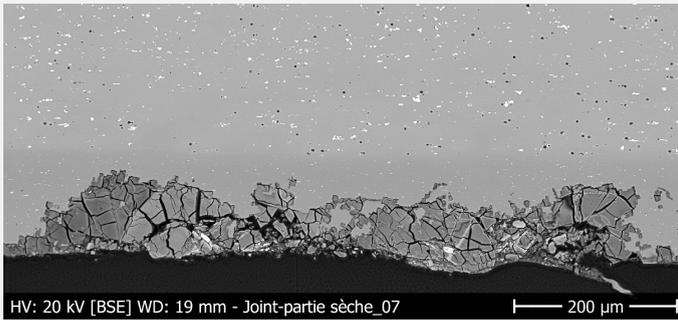
Fig. 10: SEM image (BSE mode) of the cross-section of zone 2 of the gasket (detail of Fig. 6) showing the core metal on top (M2) and the heavily corroded colaminated metal (M1),

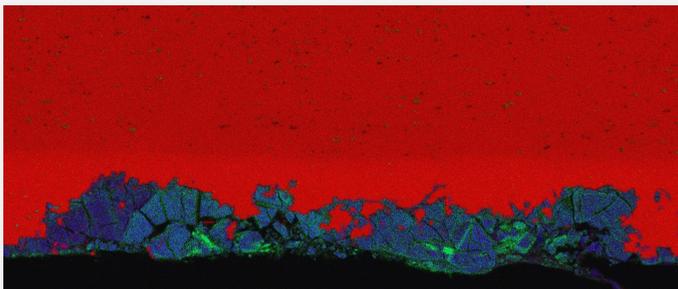
The EDS elemental chemical distribution of zone 1 is given in Fig. 11 to 13. The corrosion layers contain S (probably aluminium sulfate (Fig. 12), polluted with Fe (Fig. 11)). The presence of sulfur can be explained by the proximity of the gasket to the combustion chamber. As for the iron, it is probably coming from the steel block.

Fig. 11: Al (red), O (blue) and Fe (green) chemical distribution of the area of Fig. 10. Method of analysis: SEM-EDS. Lab. of Electronic Microscopy and Microanalysis, Néode, HEI Arc.

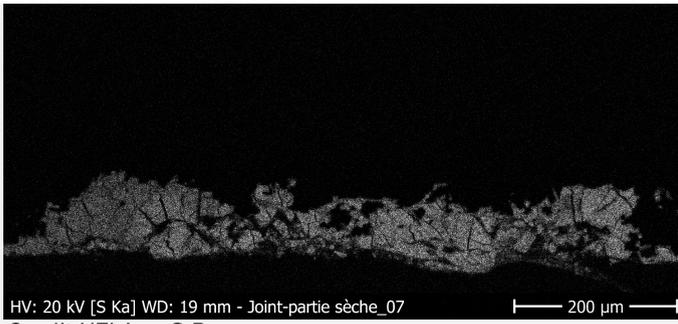
Fig. 12: S chemical distribution of the area of Fig. 10. Method of analysis: SEM-EDS. Lab. of Electronic Microscopy and Microanalysis, Néode, HEI Arc.

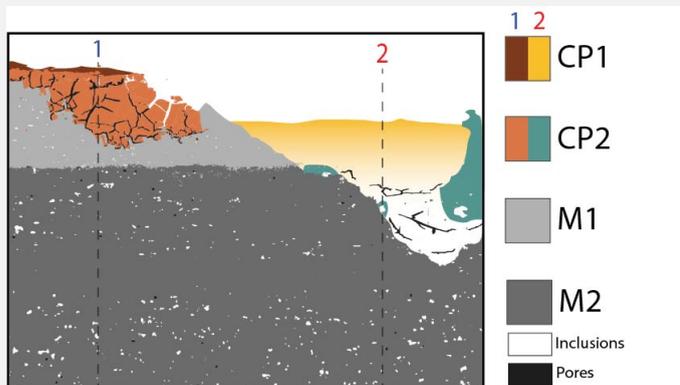
No analyses could be carried out on the top thicker part of CP1.

Fig. 16: Improved stratigraphic representation of the 2 corrosion structures of the Bugatti cylinder head gasket. CP1 could not be analysed,

The side of the gasket facing the cylinder block has a different corrosion pattern depending on whether the area is immersed or not. The surface in contact with the cylinder block shows a priori corrosion consisting of highly cracked aluminium sulphate (network). The surface immersed in the coolant is heavily corroded. The colaminated Al sheet has been completely consumed, and the corrosion progresses through the support metal, retaining inclusions of the alloy in its products. This layer is very brittle and tends to delaminate.

All the corrosion products are contaminated with iron oxides, probably from the block. The immersed part is covered with a thick crust of what is believed to be a mixture of ferrous and aluminium-based products.
