## BUGATTI COOLING SYSTEM PIPE – AL ALLOY – UNKNOWN – FRANCE

**Artefact name** Bugatti cooling system pipe

**Authors** Christian. Degriigny (HE-Arc CR, Neuchâtel, Neuchâtel, Switzerland) & Elodie. Granget (HE-Arc CR, Neuchâtel, Neuchâtel, Switzerland) & Brice. Chalauçon (MNAM (Musée National de l'Automobile de Mulhouse), Mulhouse, Alsace, France)

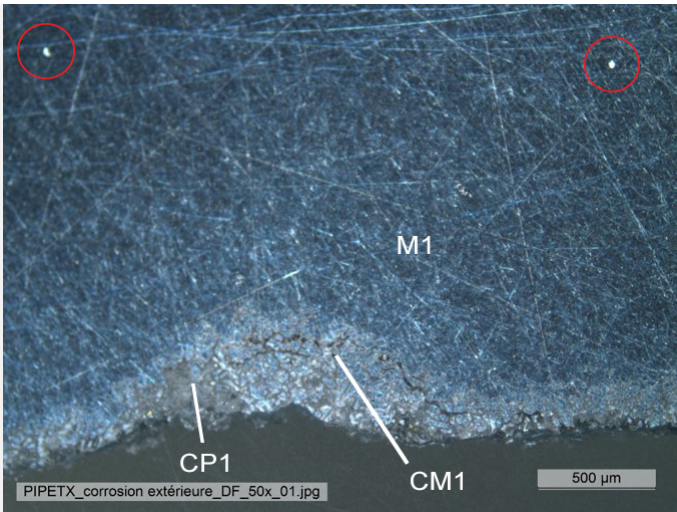
The metal is an aluminium alloy containing both Cu and Zn. It is slightly porous (Fig. 7, red circles). Its dendritic microstructure is revealed by observation in bright field (Fig. 8) and with SEM (Fig. 9).

Fig. 7: Micrograph of the selected area shown on Fig.6 (rotated by 90°), unetched, dark field with indication of pores (red circles),

The BF and DF images (Figs. 7 and 8) show a few big cracks at the interface between CM1 and M1. The SEM image shows that they expand in a network of additional microcracks (Fig. 13). The pipe suffers from a uniform interdendritic corrosion. The Al, Cu and Zn phase is oxidising preferentially, developing then aluminium oxides, versus the interdendritic phases. In some places, pits of corrosion formed. SEM cartography showed a concentration of Cl at the base of the pit (Fig. 14: Green).

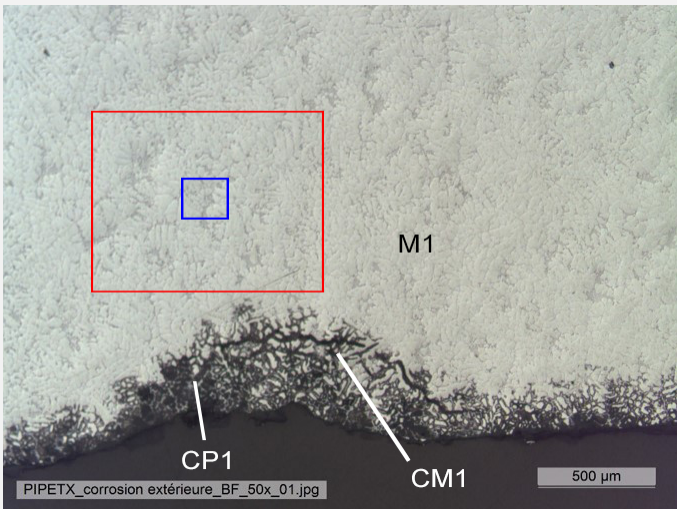
Fig. 8: Micrograph similar to Fig. 7, unetched, bright field showing the locations of Fig. 9 (in red) and Fig. 10 (in blue),

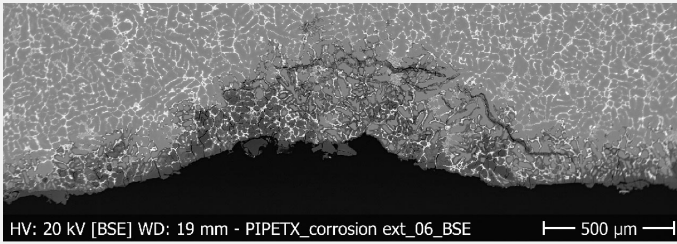
Fig. 13: SEM image of the pitting corrosion of the pipe. BSE, 20kV. Black = Cracks, Dark grey = oxydation, Medium grey = main phase, Light grey = interdendritic phase,

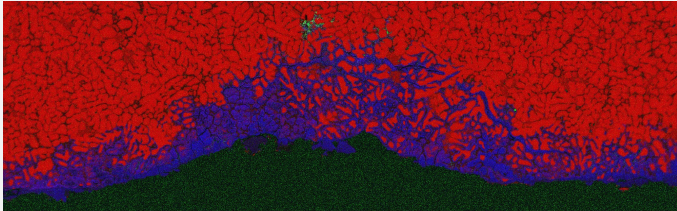
Fig. 14: SEM cartography of a pit of corrosion developing on the pipe. 20kV. Red = Al, Green = Cl, Blue = O,

The external surface shows a uniform interdendritic corrosion preferentially consuming the dendritic phase (Al, Cu, Zn). Pitting corrosion has been identified, with Cl pockets at the base of the pit.

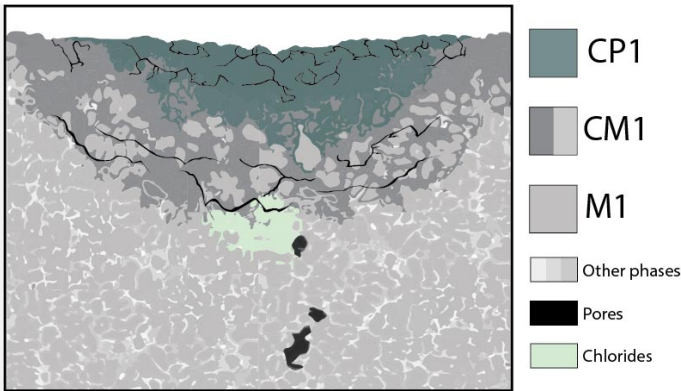
The schematic representation of corrosion layers of Fig. 4 integrating additional information based on the analyses carried out is given in Fig. 15.

Fig. 15: Improved stratigraphic representation of the exit pipe,
