## BUGATTI COOLING SYSTEM PIPE – AL ALLOY – UNKNOWN – FRANCE

**Artefact name** Bugatti cooling system pipe

**Authors** Christian. Degriigny (HE-Arc CR, Neuchâtel, Neuchâtel, Switzerland) & Elodie. Granget (HE-Arc CR, Neuchâtel, Neuchâtel, Switzerland) & Brice. Chalançon (MNAM (Musée National de l'Automobile de Mulhouse), Mulhouse, Alsace, France)

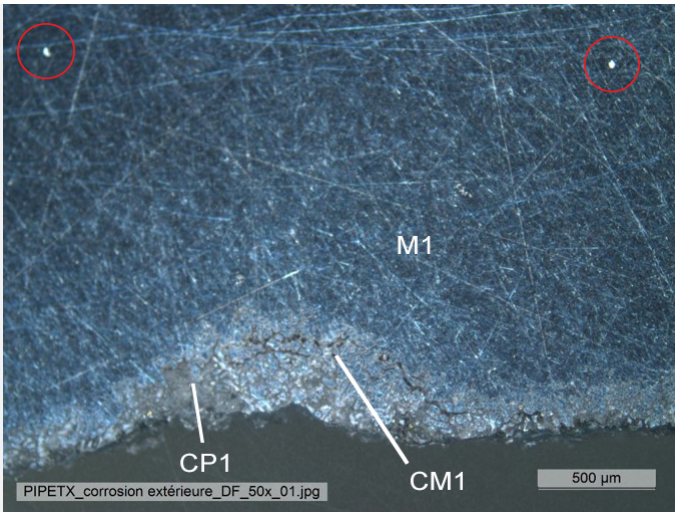
The metal is an aluminium alloy containing both Cu and Zn. It is slightly porous (Fig. 7, red circles). Its dendritic microstructure is revealed by observation in bright field (Fig. 8) and with SEM (Fig. 9).

Fig. 7: Micrograph of the selected area shown on Fig.6 (rotated by 90°), unetched, dark field with indication of pores (red circles),

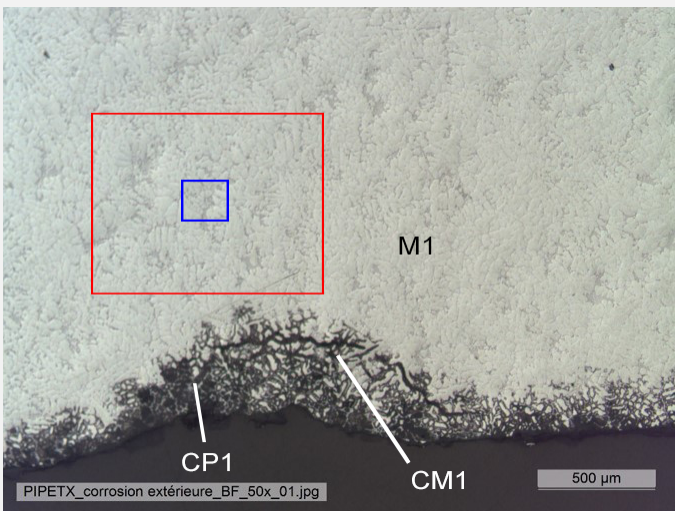
Fig. 8: Micrograph similar to Fig. 7, unetched, bright field showing the locations of Fig. 9 (in red) and Fig. 10 (in blue),

The BF and DF images (Figs. 7 and 8) show a few big cracks at the interface between CM1 and M1. The SEM image shows that they expand in a network of additional microcracks (Fig. 13). The pipe suffers from a uniform interdendritic corrosion. The Al, Cu and Zn phase is oxidising preferentially, developing then aluminium oxides, versus the interdendritic phases. In some places, pits of corrosion formed. SEM cartography showed a concentration of Cl at the base of the pit (Fig. 14: Green).

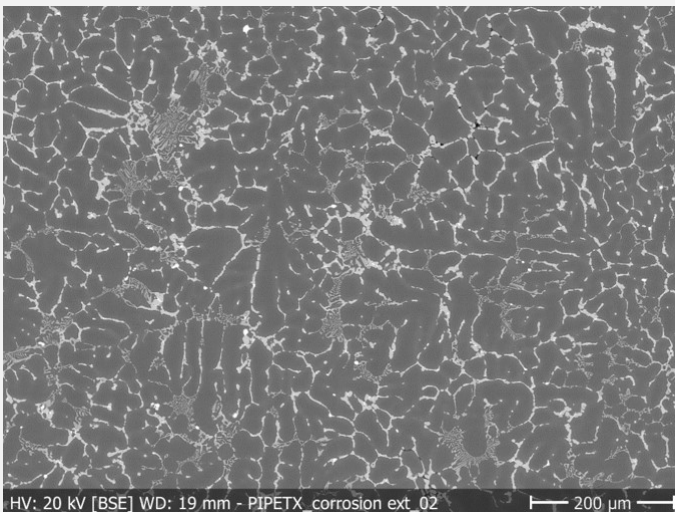
Fig. 9: SEM image (BSE mode) of the metal sample from Fig. 8 showing the microstructure of the pipe. Dark grey = main phase (Al), medium grey = interdendritic phase 1 (eutectic Al, Fe, Cu), light grey = interdendritic phase 2 (Al, Cu) and white = precipitates (Si, Sn),

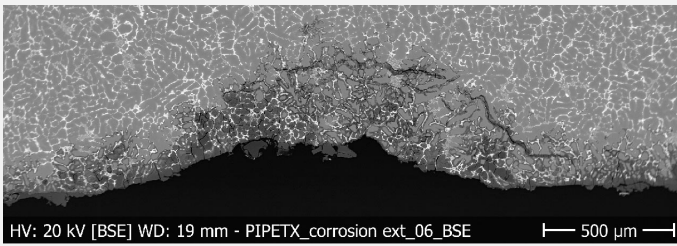
Fig. 13: SEM image of the pitting corrosion of the pipe. BSE, 20kV. Black = Cracks, Dark grey = oxydation, Medium grey = main phase, Light grey = interdendritic phase,

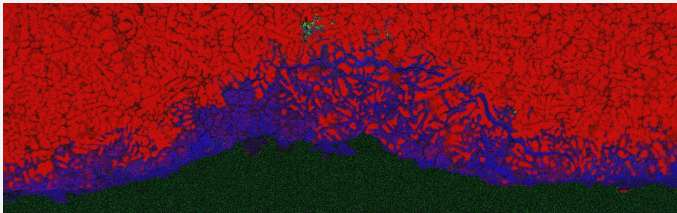
Fig. 14: SEM cartography of a pit of corrosion developing on the pipe. 20kV. Red = Al, Green = Cl, Blue = O,

The external surface shows a uniform interdendritic corrosion preferentially consuming the dendritic phase (Al, Cu, Zn). Pitting corrosion has been identified, with Cl pockets at the base of the pit.
