DOMED CAP NUT – ZN AL SN CU ALLOY – MODERN TIMES – FRANCE

Artefact name Domed cap nut

Authors Christian. Degriigny (HE-Arc CR, Neuchâtel, Neuchâtel, Switzerland) & Mathea. Hovind (University of Oslo, Department of archaeology, conservation and history (IAKH-UiO), Oslo, Oslo, Norway)

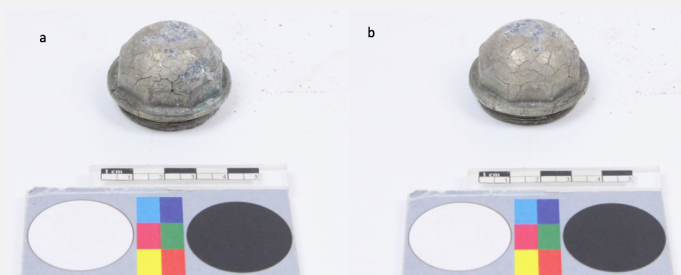
Fig. 1: Octogonal domed cap nut. Profile "a" and "b", to the left and right, respectively,

Description of the artefact	A domed cap nut made of a cast alloy with a metallic plating (Fig. 1). Its shape is octagonal and the inside is hollow. The plating is heavily cracked, leading to surface flaking. The metal underneath appears to be consumed by some kind of internal corrosion. Dimensions: L (∅) = 40mm; H = 28mm; T = 5mm; WT = 49g.
Type of artefact	Cap
Origin	Château de Germolles, Mellecey, Bourgogne, France
Recovering date	Unknown
Chronology category	Modern Times
chronology tpq	<input type="text" value="1900"/> A.D. ▼
chronology taq	<input type="text" value="2000"/> A.D. ▼
Chronology comment	19th - 20th century
Burial conditions / environment	Outdoor atmosphere

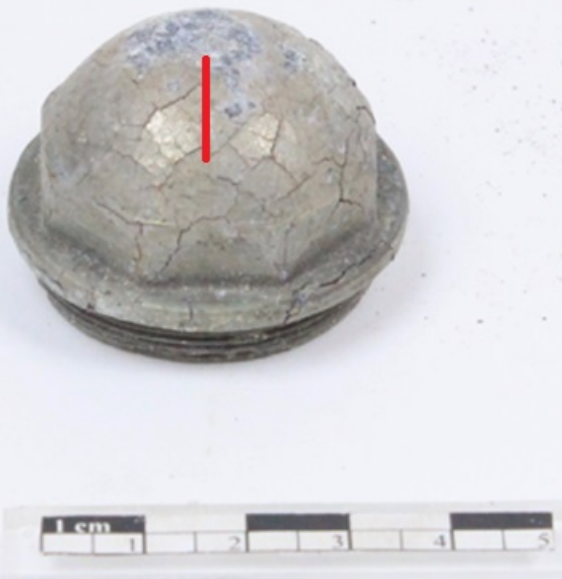
Fig. 2: Zone of the artefact submitted to visual observation and location of sampling area (a cross-section of the metal marked by the red line),

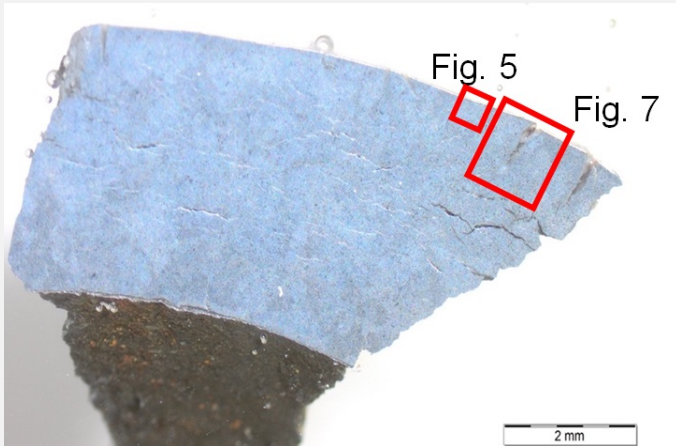
Fig. 4: Micrograph of the cross-section of the sample taken from the domed cap nut showing the locations of Figs. 5 and 7,

Description of sample	The sample is a cross section of the metal, representative of the domed cap nut. It shows external cracks extending from the metal surface and into its structure in addition to internal cracks, visible as thin lines along its longitudinal axis (Fig. 4).
Alloy	Zn Al Sn Cu Alloy
Technology	Cast and plated
Lab number of sample	NZC2018 (Ni/Zn Cap, sampled in 2018)
Sample location	HE-Arc CR, Neuchâtel, Neuchâtel
Responsible institution	HE-Arc CR, Neuchâtel, Neuchâtel
Date and aim of sampling	March 2018, study of corrosion stratigraphy and chemical analyses

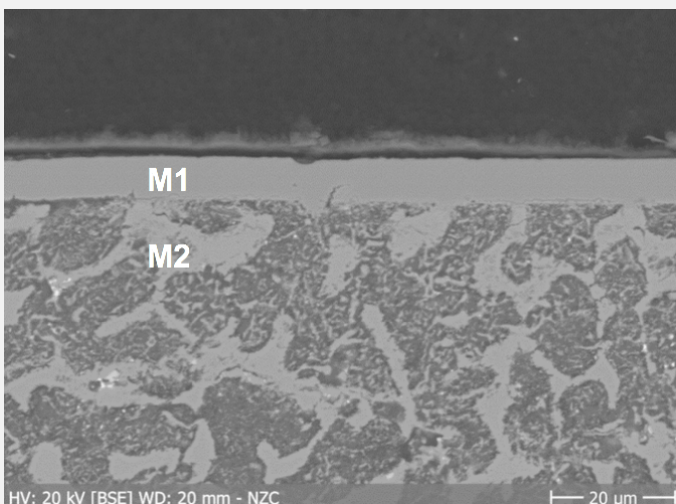
The metal of the domed cap nut (M2) consists of a Zn/Al/Pb/Cu/Sn alloy (Table 1) externally covered by a nickel-based plating (M1) (Figs. 5 and 6) containing some cobalt (Co). The bulk metal (M2) has a dendritic microstructure appearing light grey in bright field, while the interdendritic phase appears white (Fig. 7). The latter is Zn-rich, while the dendritic phase consists of approximately equal amounts of Zn and Al (Table 2, Fig. 9). Observation in SEM (BSE-mode) reveals the presence of Pb-nodules, visible as white irregular spots with a scattered distribution, in addition to opaque grey patches which are rich in Al and Fe (Fig. 8).

Fig. 5: SEM-image (BSE-mode) of a selected area from Fig. 4 (detail), showing the metal plating (M1) and the bulk metal (M2),

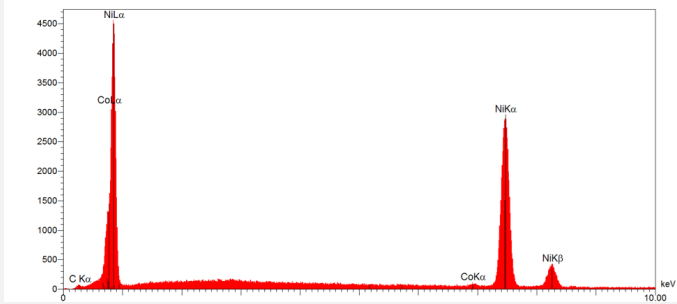
Fig. 6: EDS-spectrum showing the chemical composition of the metal plating (M1). Method of analysis: SEM-EDS. Lab. of Electronic Microscopy and and Microanalysis, Néode, HEI Arc,

The domed cap nut is nickel plated (6-7 micrometers).

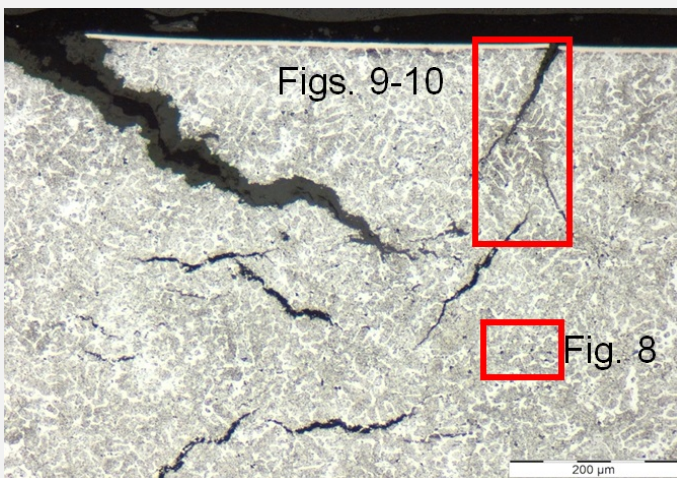
Fig. 7: Micrograph of the metal sample from Fig. 4 (detail), unetched, bright field. The dendrites appear light to dark grey while the interdendritic phase appears white. The metal is characterized by surface cracks as well as internal cracks. The lower red rectangle corresponds to Fig. 8 while the areas selected for elemental chemical distributions (Figs. 9 and 10) are marked by the upper red rectangle,

The dendritic phase is heavily oxidized compared to the interdendritic phase (Table 2 and Fig. 10). The corrosion has developed throughout the entire metal body, generating cracks (Fig. 7). The cracks are Zn and O-rich (Fig. 10) and could be composed of zinc oxide or carbonate. It could be a case of zinc pest, a corrosion phenomenon known to cause disintegration in poor quality alloys (Selwyn 2004, Zhang 2011).

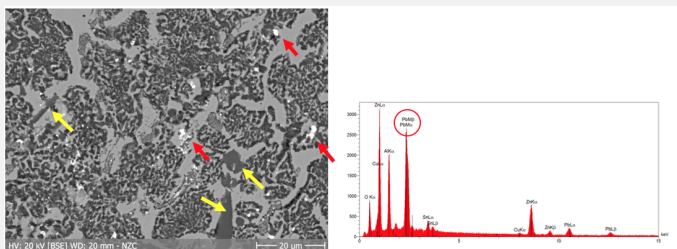
Fig. 8: SEM-image in BSE-mode (left) and EDS-spectrum (right), showing the appearance and the chemical composition of the Pb inclusions (red arrows). The inclusions appear white, the dendrites appear dark grey/black and the interdendritic phase appears grey. Grey opaque patches (yellow arrows) are Fe- and Al-rich phases,

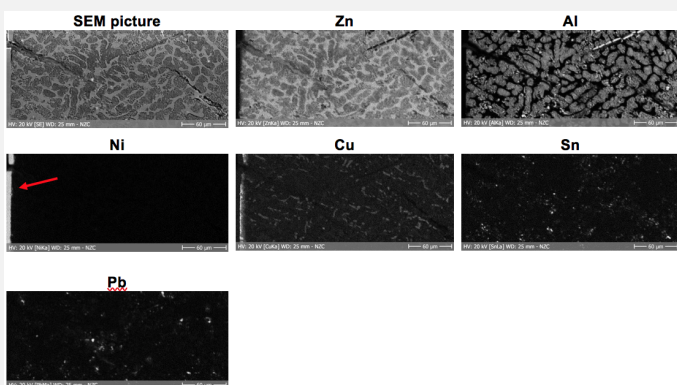
Fig. 9: SEM image and elemental chemical distribution of the selected area from Fig. 7 (rotated 270° and inversed). Method of analysis: SEM-EDS. Lab. of Electronic Microscopy and Microanalysis, Néode, HEI Arc,

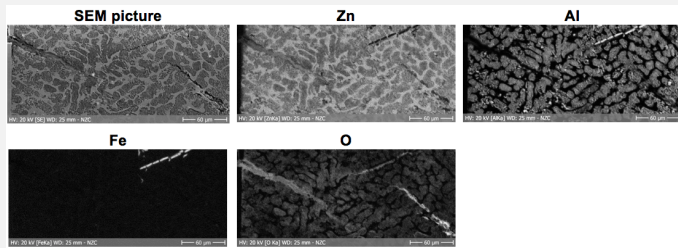
Fig. 10: SEM image and elemental chemical distribution of the selected area from Fig. 7 (rotated 270° and inverted). Method of analysis: SEM-EDS. Lab. of Electronic Microscopy and Microanalysis, Néode, HEI Arc,

Corrosion form	Internal cracking
Corrosion type	zinc pest

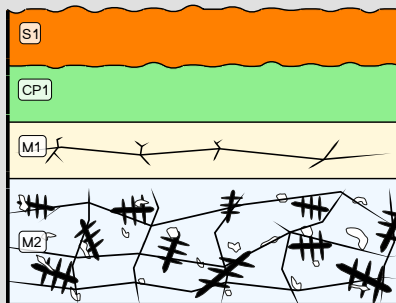
Fig. 11: Stratigraphic representation of the sample taken from the domed cap nut in cross-section (dark field) using the MiCorr application. The characteristics of the strata are only accessible by clicking on the drawing that redirects you to the search tool by stratigraphy representation. Stratigraphy representative of an area with intact metal plating (M1). S1 represents Fe-polluted soil while CP1 is a green translucent corrosion product, Credit UiO-IAKH, M.Hovind.
