# DOMED CAP NUT – ZN AL SN CU ALLOY – MODERN TIMES – FRANCE

**Artefact name** Domed cap nut

**Authors** Christian. Degriigny (HE-Arc CR, Neuchâtel, Neuchâtel, Switzerland) & Mathea. Hovind (University of Oslo, Department of archaeology, conservation and history (IAKH-UiO), Oslo, Oslo, Norway)

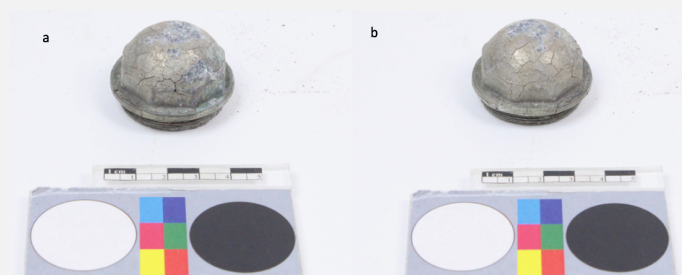
Fig. 1: Octogonal domed cap nut. Profile "a" and "b", to the left and right, respectively,

Description of the artefact	A domed cap nut made of a cast alloy with a metallic plating (Fig. 1). Its shape is octagonal and the inside is hollow. The plating is heavily cracked, leading to surface flaking. The metal underneath appears to be consumed by some kind of internal corrosion. Dimensions: L (ø) = 40mm; H = 28mm; T = 5mm; WT = 49g.		
Type of artefact	Cap		
Origin	Château de Germolles, Mellecey, Bourgogne, France		
Recovering date	Unknown		
Chronology category	Modern Times		
chronology tpq	1900	A.D. ▼	
chronology taq	2000	A.D. ▼	
Chronology comment	19th - 20th century		
Burial conditions / environment	Outdoor atmosphere

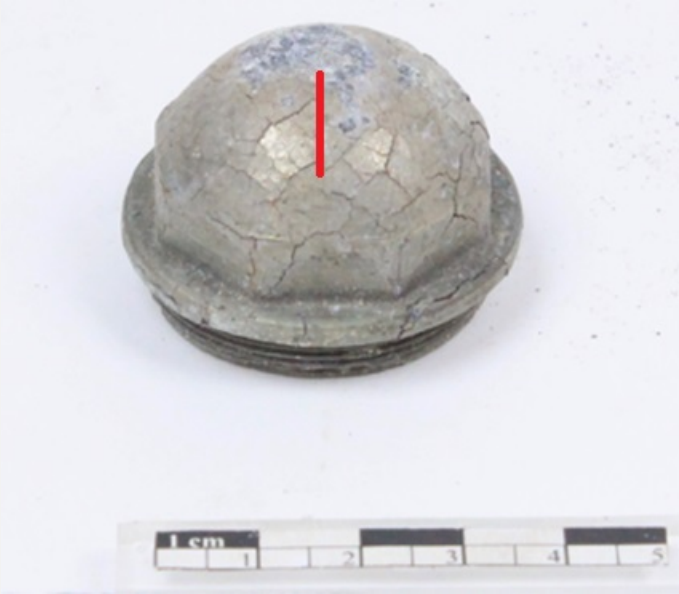
Fig. 2: Zone of the artefact submitted to visual observation and location of sampling area (a cross-section of the metal marked by the red line),

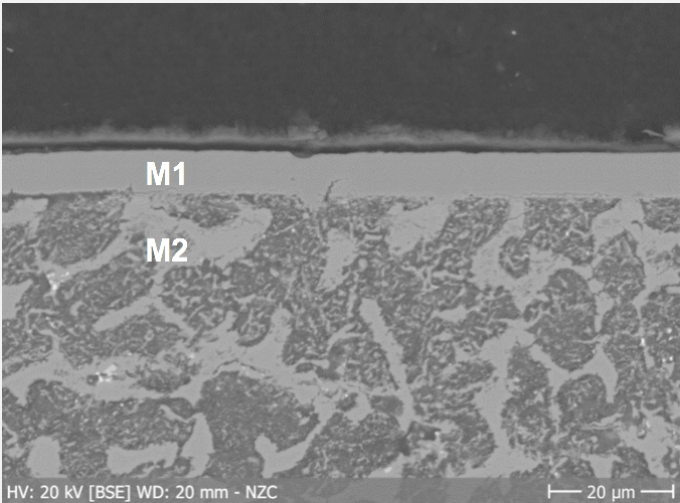
The metal of the domed cap nut (M2) consists of a Zn/Al/Pb/Cu/Sn alloy (Table 1) externally covered by a nickel-based plating (M1) (Figs. 5 and 6) containing some cobalt (Co). The bulk metal (M2) has a dendritic microstructure appearing light grey in bright field, while the interdendritic phase appears white (Fig. 7). The latter is Zn-rich, while the dendritic phase consists of approximately equal amounts of Zn and Al (Table 2, Fig. 9). Observation in SEM (BSE-mode) reveals the presence of Pb-nodules, visible as white irregular spots with a scattered distribution, in addition to opaque grey patches which are rich in Al and Fe (Fig. 8).

Fig. 5: SEM-image (BSE-mode) of a selected area from Fig. 4 (detail), showing the metal plating (M1) and the bulk metal (M2),

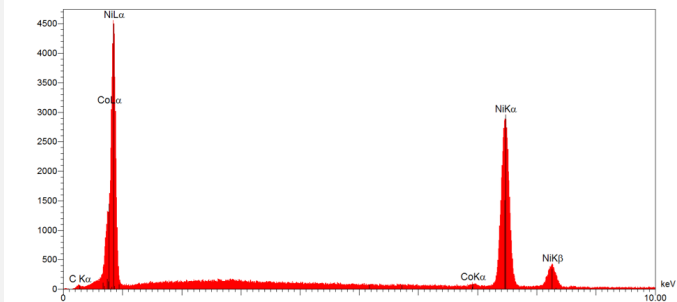
Fig. 6: EDS-spectrum showing the chemical composition of the metal plating (M1). Method of analysis: SEM-EDS. Lab. of Electronic Microscopy and and Microanalysis, Néode, HEI Arc,

The domed cap nut is nickel plated (6-7 micrometers).

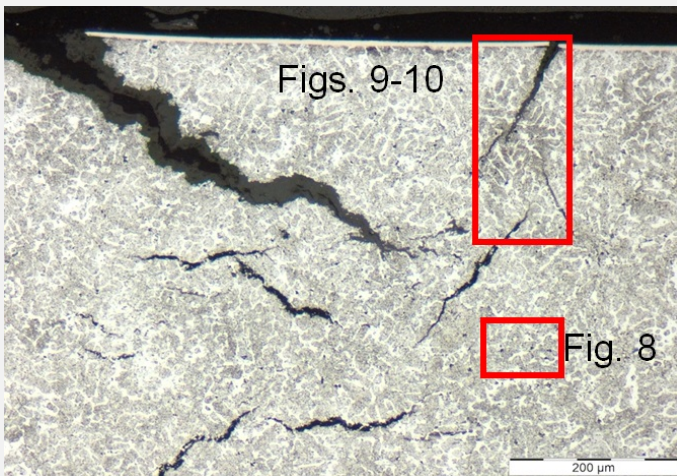
Fig. 7: Micrograph of the metal sample from Fig. 4 (detail), unetched, bright field. The dendrites appear light to dark grey while the interdendritic phase appears white. The metal is characterized by surface cracks as well as internal cracks. The lower red rectangle corresponds to Fig. 8 while the areas selected for elemental chemical distributions (Figs. 9 and 10) are marked by the upper red rectangle,

The dendritic phase is heavily oxidized compared to the interdendritic phase (Table 2 and Fig. 10). The corrosion has developed throughout the entire metal body, generating cracks (Fig. 7). The cracks are Zn and O-rich (Fig. 10) and could be composed of zinc oxide or carbonate. It could be a case of zinc pest, a corrosion phenomenon known to cause disintegration in poor quality alloys (Selwyn 2004, Zhang 2011).

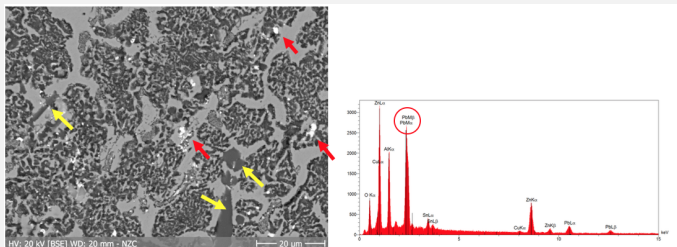
Fig. 8: SEM-image in BSE-mode (left) and EDS-spectrum (right), showing the appearance and the chemical composition of the Pb inclusions (red arrows). The inclusions appear white, the dendrites appear dark grey/black and the interdendritic phase appears grey. Grey opaque patches (yellow arrows) are Fe- and Al-rich phases,

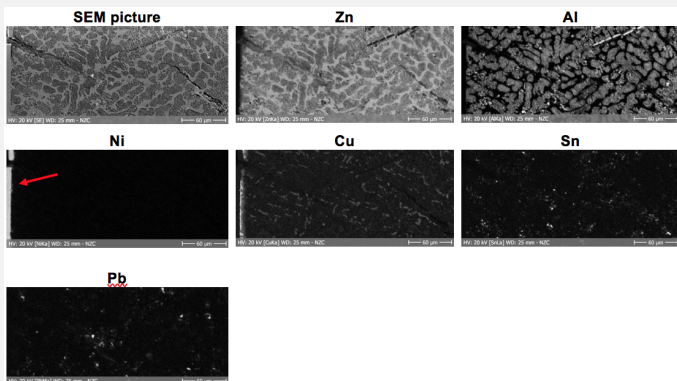
Fig. 9: SEM image and elemental chemical distribution of the selected area from Fig. 7 (rotated 270° and inversed). Method of analysis: SEM-EDS. Lab. of Electronic Microscopy and Microanalysis, Néode, HEI Arc,

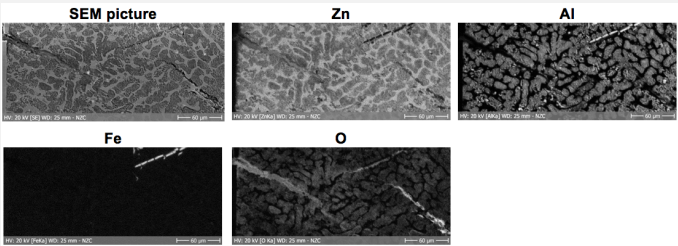
Fig. 10: SEM image and elemental chemical distribution of the selected area from Fig. 7 (rotated 270° and inversed). Method of analysis: SEM-EDS. Lab. of Electronic Microscopy and Microanalysis, Néode, HEI Arc,

Corrosion form	Internal cracking
Corrosion type	zinc pest

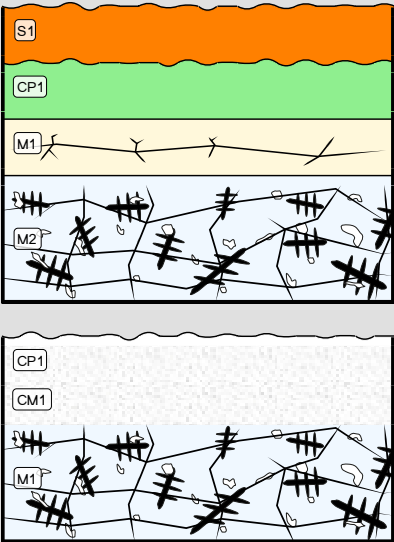
Fig. 11: Stratigraphic representation of the sample taken from the domed cap nut in cross-section (dark field) using the MiCorr application. The characteristics of the strata are only accessible by clicking on the drawing that redirects you to the search tool by stratigraphy representation. Stratigraphy representative of an area with intact metal plating (M1). S1 represents Fe-polluted soil while CP1 is a green translucent corrosion product, Credit UiO-IAKH, M.Hovind.
