# DOMED CAP NUT - ZN AL SN CU ALLOY - MODERN TIMES - FRANCE

Artefact name Domed cap nut

Authors Christian. Degrigny (HE-Arc CR, Neuchâtel, Neuchâtel, Switzerland) & Mathea. Hovind (University of Oslo,

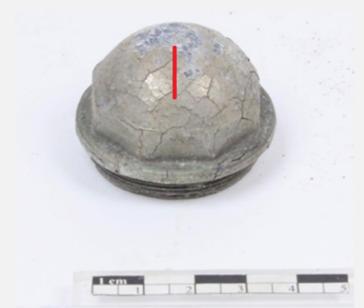
Fig. 2: Zone of the artefact submitted to visual observation and location of sampling area (a cross-section of the metal marked by the red line),

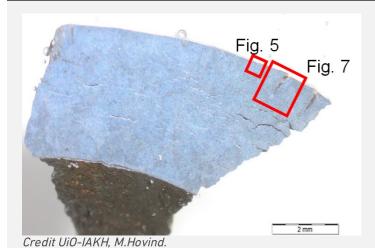
Fig. 4: Micrograph of the cross-section of the sample taken from the domed cap nut showing the locations of Figs. 5 and

The sample is a cross section of the metal, representative of the domed cap nut. It shows external cracks extending from the metal surface and into its structure in addition to internal

cracks, visible as thin lines along its longitudinal axis (Fig. 4).

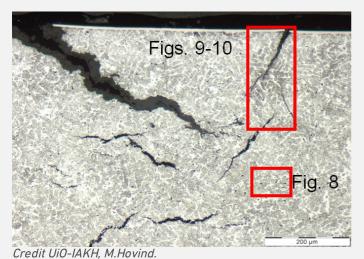
Fig. 7: Micrograph of the metal sample from Fig. 4 (detail), unetched, bright field. The dendrites appear light to dark grey while the interdendritic phase appears white. The metal is characterized by surface cracks as well as internal cracks. The lower red rectangle corresponds to Fig. 8 while the areas selected for elemental chemical distributions (Figs. 9 and 10) are marked by the upper red rectangle,

The dendritic phase is heavily oxidized compared to the interdendritic phase (Table 2 and Fig. 10). The corrosion has developed throughout the entire metal body, generating cracks (Fig. 7). The cracks are Zn and O-rich (Fig. 10) and could be composed of zinc oxide or carbonate. It could be a case of zinc pest, a corrosion phenomenon known to cause disintegration in poor quality alloys (Selwyn 2004, Zhang 2011).
