ROOF GUTTER ELEMENT – ZN ALLOY – MODERN TIMES – FRANCE

Artefact name	Roof gutter element
Authors	Christian. Degriigny (HE-Arc CR, Neuchâtel, Neuchâtel, Switzerland) & Mathea. Hovind (University of Oslo, Department of archaeology, conservation and history (IAKH-UiO), Oslo, Oslo, Norway)
Url	/artefacts/1258/

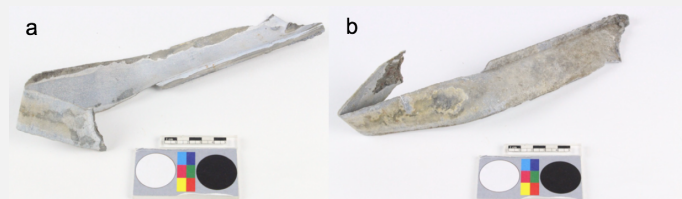
Fig. 1: Roof gutter element having different appearances on each of its surfaces: "a" on the left and "b" on the right,

Description of the artefact	A roof gutter element with remains of lead solder (Fig. 1). Its surfaces are covered by a white, strongly adherent oxide layer. Surface "b" is slightly darker in colour than surface "a" due to the presence of soil particles. Dimensions: L = 265mm; W = 47mm; T = 1mm; WT = 93g.
Type of artefact	Architectural element
Origin	Château de Germolles, Mellecey, Bourgogne, France
Recovering date	Unknown
Chronology category	Modern Times
chronology tpq	1900 A.D. ▼
chronology taq	2000 A.D. ▼
Chronology comment	19th-20th century
Burial conditions / environment	Outdoor atmosphere
Artefact location	HE-Arc CR, Neuchâtel, Neuchâtel
Owner	Château de Germolles, Mellecey, Bourgogne

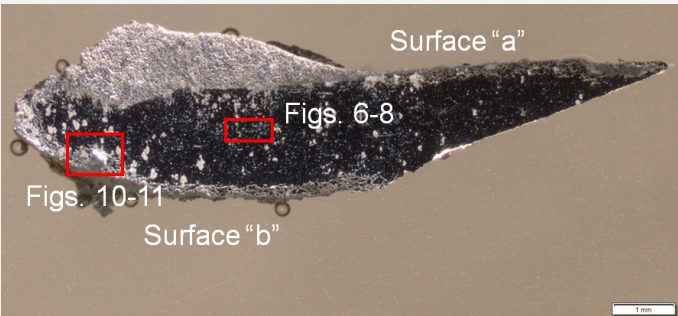
Fig. 4: Micrograph of the sample taken from the roof gutter showing the locations of Figs. 6-8 and 10-11. The uppermost area (in white) is remains of solder, while the zinc metal appears dark grey to black (the white patches are due to secondary oxidation of the sample),

Description of sample	A cross-section (Fig. 4) was cut out where the metal is at an angle of approximately 90° to the flat surface. Its upper edge corresponds to surface “a” and contains remains of solder, while the lower edge corresponds to surface “b”.
Alloy	Zn Alloy
Technology	Annealed after (hot) rolling
Lab number of sample	ZG2018 (zinc gutter sampled in 2018)
Sample location	HE-Arc CR, Neuchâtel, Neuchâtel
Responsible institution	HE-Arc CR, Neuchâtel, Neuchâtel
Date and aim of sampling	March 2018, metallography and chemical analyses

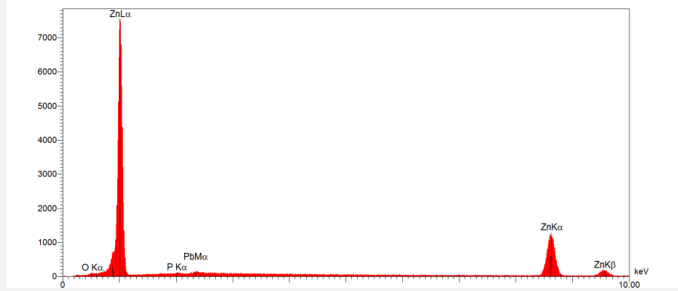
The roof gutter element is composed of Zn with P and Pb at lower concentrations (Fig. 5). The latter is probably originating from the solder that was applied to adjoin several metal sheets for the roof gutter.

Fig. 5: Chemical composition of the metal. Method of analysis: SEM-EDS. Lab. of Electronic Microscopy and Microanalysis, Néode, HEI Arc,

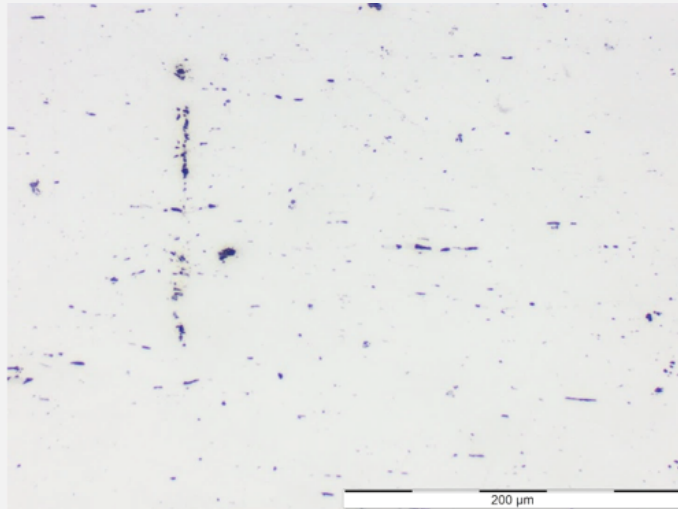
Fig. 6: Micrograph of the metal sample from Fig. 4 (detail). Unetched, bright field,

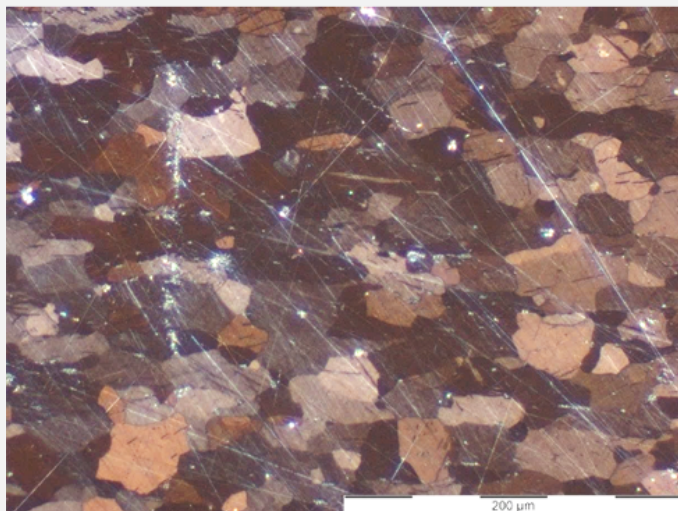
The metal appears white to light grey under bright field (Fig. 6). Under polarized light however (Fig. 78), the microstructure of the metal is visible as small polygonal grains appearing in various shades of brown, a coloured effect due to the anisotropic properties of the metal (Scott 1991: 49). In the SEM-image, white elongated inclusions are visible (Fig. 8) consisting mainly of Zn and Pb with some O (Fig. 90).

Fig. 7: Micrograph similar to Fig. 6, but under polarized light. The microstructure of the metal shows the presence of small and polygonal grains in shape,

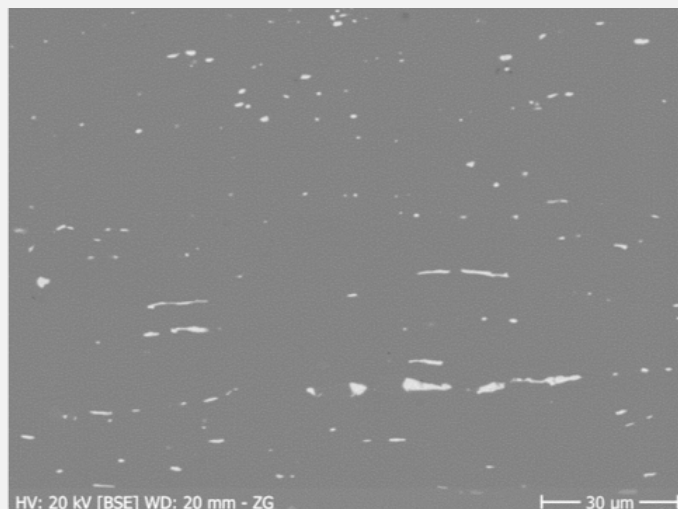
Fig. 8: SEM-image (BSE-mode) of the metal sample from Fig. 4 (detail) showing the white elongated inclusions,

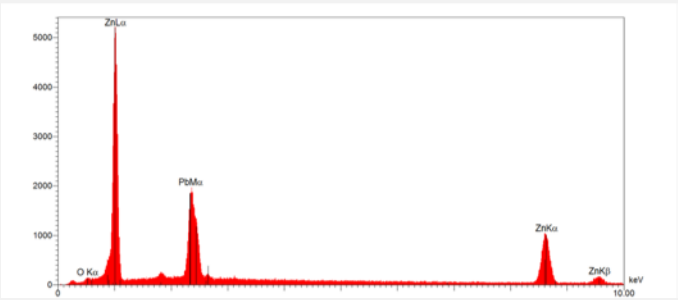
Fig. 9: SEM-EDS spectrum showing the composition of the elongated inclusions from Fig. 8. Method of analysis: SEM-EDS. Lab. of Electronic Microscopy and Microanalysis, Néode, HEI Arc,

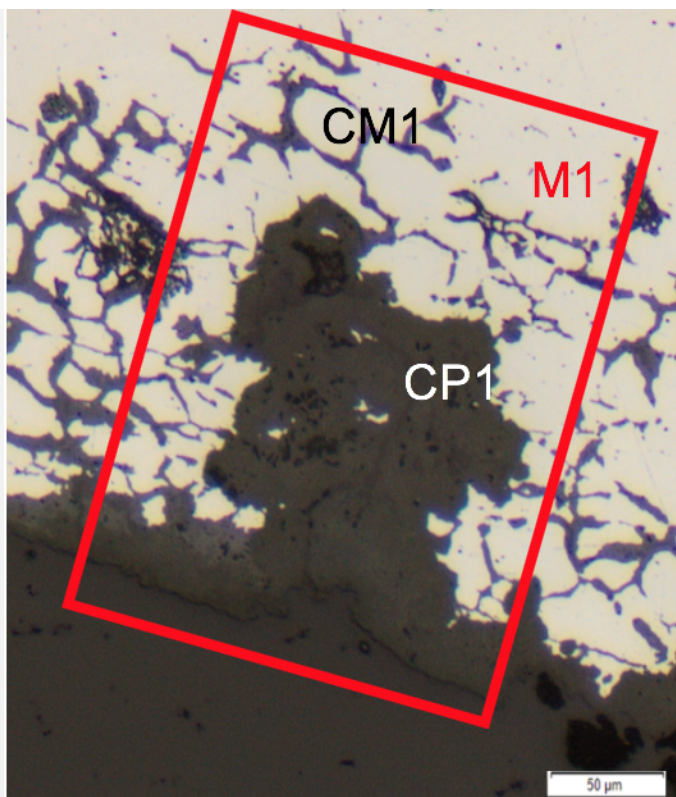
The metal is suffering from intergranular corrosion visible as a white corrosion product (CP1) located within crevices and along the grain boundaries (Figs. 10 and 11). The porous and powdery corrosion product (CP1) appears dark grey in bright field (Fig. 10) and white-grey under polarized light (Fig. 11). It consists of Zn and O (Table 1). The external corrosion product (CP1) contains some S (and not Pb as suggested by Table 1 and Fig. 13) which is probably due to atmospheric pollution. The structural composition of the corrosion product was determined by crystallographic analysis (XRD) to consist of a mixture of zincite (ZnO) and pure zinc (Zn) (Table 2, Fig 12). Mapping of the corroded area by SEM-EDS displays a similar composition but shows additionally the presence of Cl in some of the veins of the corroded metal (Fig. 13). S1 (soil material) is found on the very top of CP1.

Elements mass %*	C	O	Zn	Pb	S	Al	Si	Fe	Cu	Sn
Stratum										
CP1, white corrosion product	7	33	51	3	5	-	<1	<1	<1	<1
CM1, intergranular corrosion	6	22	68	3	<1	<1	<1	<1	<1	<1

Table 1: Chemical composition of the corrosion layers from Fig. 10. Method of analysis: SEM-EDS. Lab. of Electronic Microscopy and Microanalysis, Néode, HEI Arc, credit MiCorr_HEI Arc, C.Csefalvay. *The amount is the calculated average of three analyses of the same feature, but in different areas.

Fig. 10: Micrograph of the metal sample from Fig. 4 (detail). Unetched, bright field. The corrosion product (CP1) is located at the surface of the metal and in its crevices. Intergranular corrosion (CM1) is visible as thin grey lines in between the metal grains (M1). The corrosion structure is to compare to the stratigraphy representation of Fig. 14. The area selected for elemental chemical distribution (Fig. 13) is marked by a red rectangle,

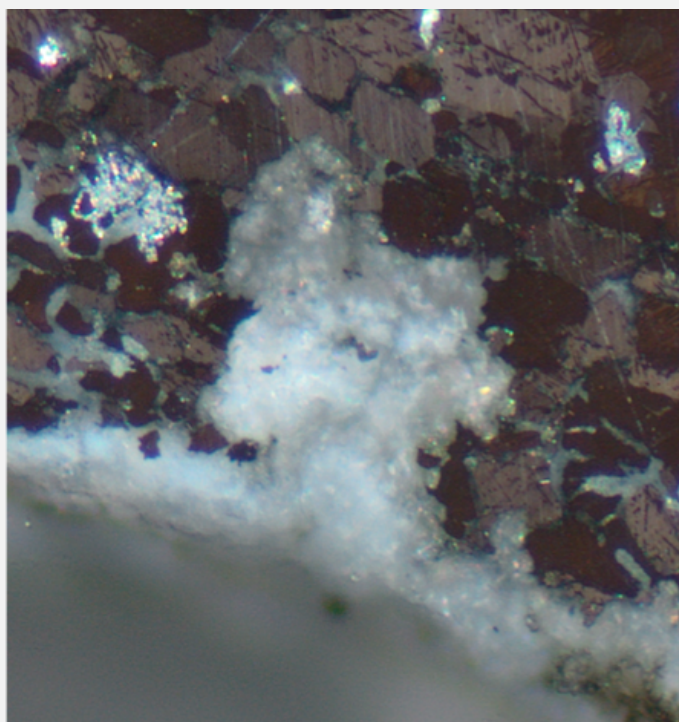
Fig. 11: Micrograph similar to Fig. 10 but under polarized light, the corrosion product (CP1) and the corroded metal (CM1) appear white,

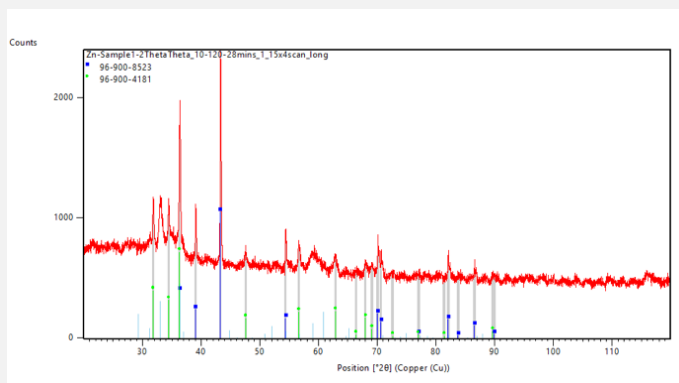
Table 2: Summary of the results from the crystallographic analysis of the white corrosion product (CP1). A representative spectrum is given in Fig. 12. Method of analysis: XRD. Center of X-ray Analytics, Empa-Swiss Federal Laboratories for Materials Science and Technology (Dübendorf), credit MiCorr_Empa, Z.Balogh-Michels. *The results are based on the analysis of two powder samples from different areas (see Fig. 2 for sample locations).

Fig. 12: XRD-spectrum for the analysis of powder sample 1. Ref. 96-900-8523 (in blue) corresponds to pure zinc and 96-900-4181 (in green) to zincite (ZnO),

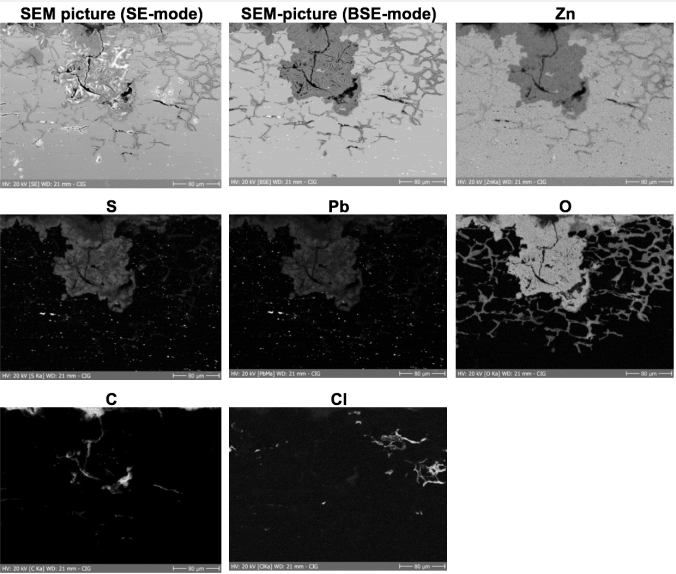
Fig. 13: SEM image and elemental chemical distribution of a selected area of Fig. 10 (rotated almost 180° and reversed). Method of analysis: SEM-EDS. Lab. of Electronic Microscopy and Microanalysis, Néode, HEI Arc,

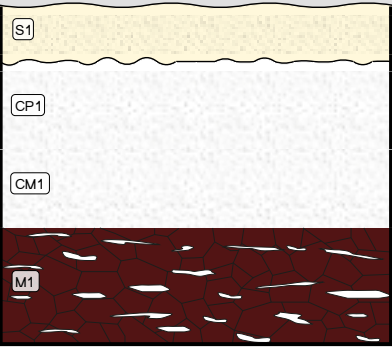
Fig. 14: Stratigraphic representation of the sample taken from the roof gutter (surface "b") in cross-section (dark field) using the MiCorr application. The characteristics of the strata are only accessible by clicking on the drawing that redirects you to the search tool by stratigraphy representation. This representation can be compared to Figs. 10 and 11, Credit UiO-IAKH, M.Hovind.
