# ROOF GUTTER ELEMENT – ZN ALLOY – MODERN TIMES – FRANCE

Artefact name	Roof gutter element
Authors	Christian. Degriigny (HE-Arc CR, Neuchâtel, Neuchâtel, Switzerland) & Mathea. Hovind (University of Oslo, Department of archaeology, conservation and history (IAKH-UiO), Oslo, Oslo, Norway)
Url	/artefacts/1258/

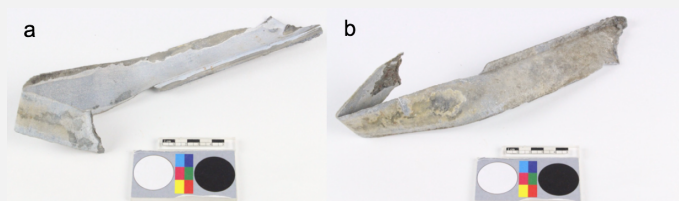
Fig. 1: Roof gutter element having different appearances on each of its surfaces: "a" on the left and "b" on the right,

Description of the artefact	A roof gutter element with remains of lead solder (Fig. 1). Its surfaces are covered by a white, strongly adherent oxide layer. Surface "b" is slightly darker in colour than surface "a" due to the presence of soil particles. Dimensions: L = 265mm; W = 47mm; T = 1mm; WT = 93g.
Type of artefact	Architectural element
Origin	Château de Germolles (14th century), Mellecey, Bourgogne, France
Recovering date	Unknown
Chronology category	Modern Times
chronology tpq	1900 A.D. ▼
chronology taq	2000 A.D. ▼
Chronology comment	19th-20th century
Burial conditions / environment	Outdoor atmosphere
Artefact location	HE-Arc CR, Neuchâtel, Neuchâtel
Owner	Château de Germolles, Mellecey, Bourgogne
Inv. number	None

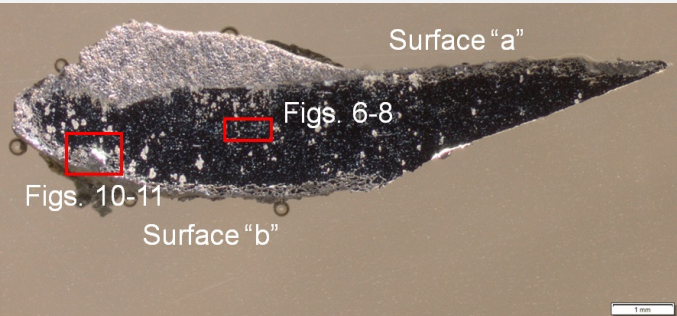
Fig. 4: Micrograph of the sample taken from the roof gutter showing the locations of Figs. 6-8 and 10-11. The uppermost area (in white) is remains of solder, while the zinc metal appears dark grey to black (the white patches are due to secondary oxidation of the sample),

<b>Description of sample</b>	A cross-section (Fig. 4) was cut out where the metal is at an angle of approximately 90° to the flat surface. Its upper edge corresponds to surface “a” and contains remains of solder, while the lower edge corresponds to surface “b”.
<b>Alloy</b>	Zn Alloy
<b>Technology</b>	Annealed after (hot) rolling
<b>Lab number of sample</b>	ZG2018 (zinc gutter sampled in 2018)
<b>Sample location</b>	HE-Arc CR, Neuchâtel, Neuchâtel
<b>Responsible institution</b>	HE-Arc CR, Neuchâtel, Neuchâtel
<b>Date and aim of sampling</b>	March 2018, metallography and chemical analyses

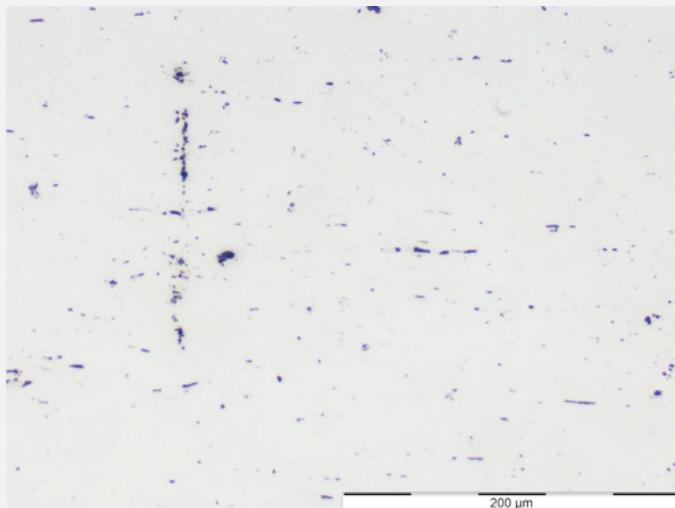
The metal appears white to light grey under bright field (Fig. 6). Under polarized light however (Fig. 78), the microstructure of the metal is visible as small polygonal grains appearing in various shades of brown, a coloured effect due to the anisotropic properties of the metal (Scott 1991: 49). In the SEM-image, white elongated inclusions are visible (Fig. 8) consisting mainly of Zn and Pb with some O (Fig. 90).

Fig. 6: Micrograph of the metal sample from Fig. 4 (detail). Unetched, bright field,

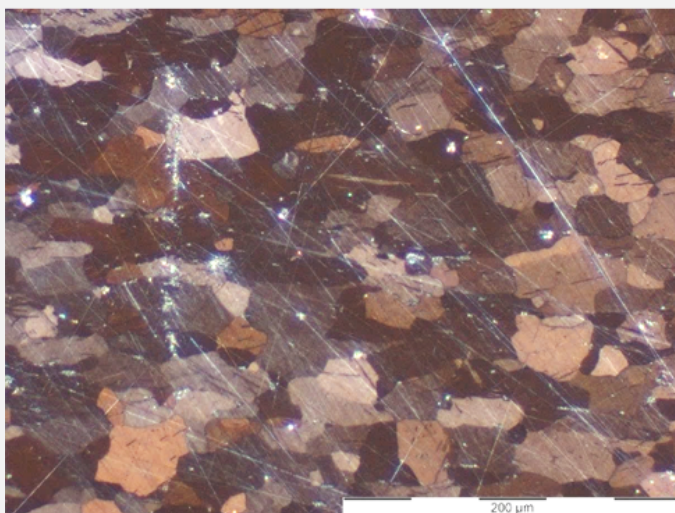
Fig. 7: Micrograph similar to Fig. 6, but under polarized light. The microstructure of the metal shows the presence of small and polygonal grains in shape,

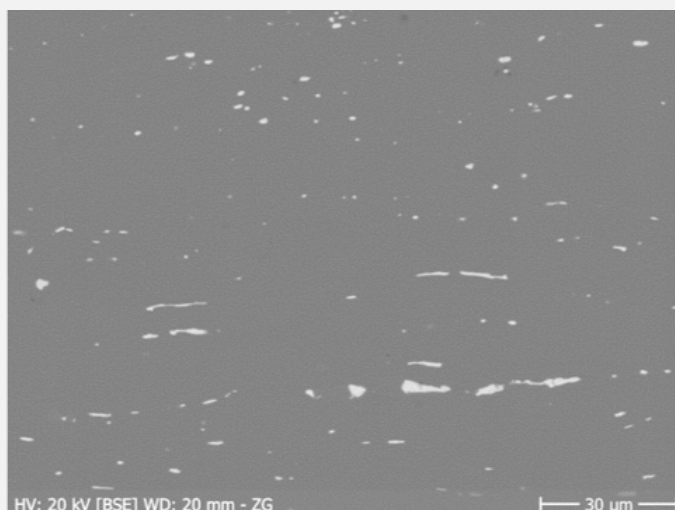
Fig. 8: SEM-image (BSE-mode) of the metal sample from Fig. 4 (detail) showing the white elongated inclusions,

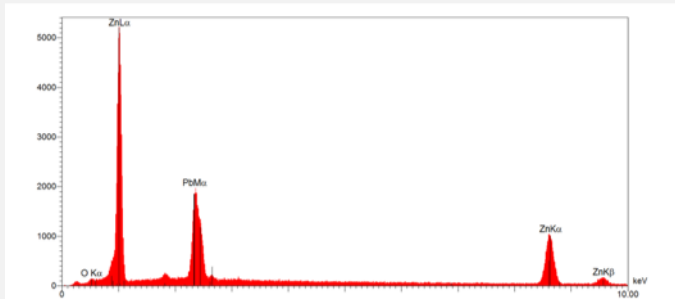
Fig. 9: SEM-EDS spectrum showing the composition of the elongated inclusions from Fig. 8. Method of analysis: SEM-EDS. Lab. of Electronic Microscopy and Microanalysis, Néode, HEI Arc,

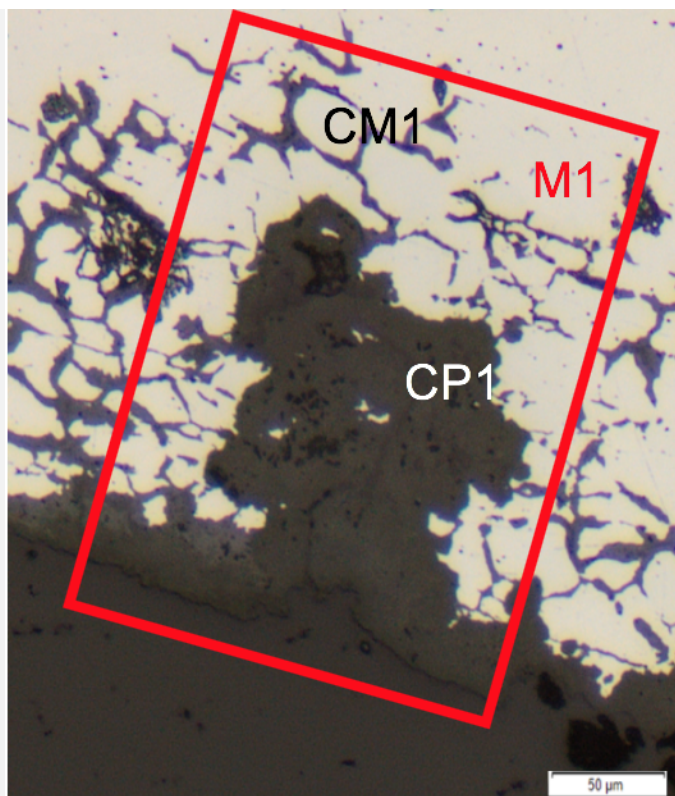
The metal is suffering from intergranular corrosion visible as a white corrosion product (CP1) located within crevices and along the grain boundaries (Figs. 10 and 11). The porous and powdery corrosion product (CP1) appears dark grey in bright field (Fig. 10) and white-grey under polarized light (Fig. 11). It consists of Zn and O (Table 1). The external corrosion product (CP1) contains some S (and not Pb as suggested by Table 1 and Fig. 13) which is probably due to atmospheric pollution. The structural composition of the corrosion product was determined by crystallographic analysis (XRD) to consist of a mixture of zincite (ZnO) and pure zinc (Zn) (Table 2, Fig 12). Mapping of the corroded area by SEM-EDS displays a similar composition but shows additionally the presence of Cl in some of the veins of the corroded metal (Fig. 13). S1 (soil material) is found on the very top of CP1.

Fig. 10: Micrograph of the metal sample from Fig. 4 (detail). Unetched, bright field. The corrosion product (CP1) is located at the surface of the metal and in its crevices. Intergranular

corrosion (CM1) is visible as thin grey lines in between the metal grains (M1). The corrosion structure is to compare to the stratigraphy representation of Fig. 14. The area selected for elemental chemical distribution (Fig. 13) is marked by a red rectangle,

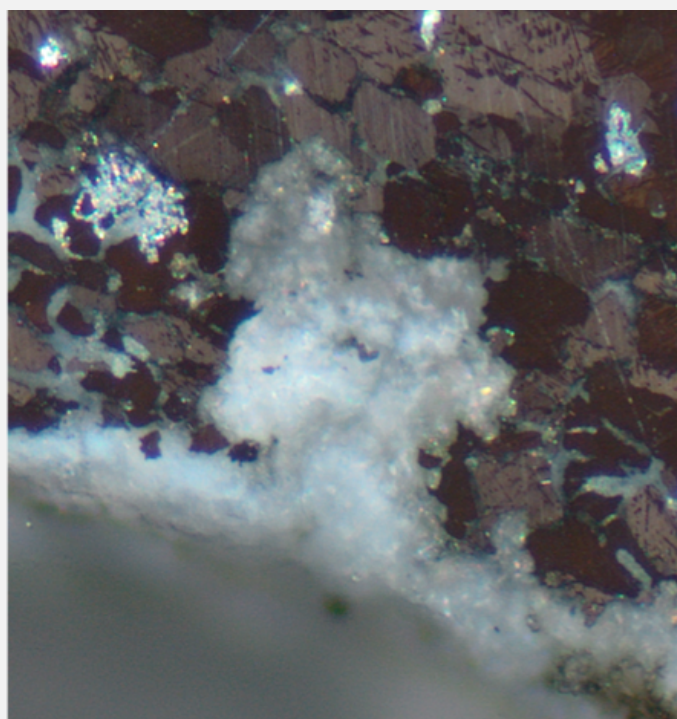
Fig. 11: Micrograph similar to Fig. 10 but under polarized light, the corrosion product (CP1) and the corroded metal (CM1) appear white,

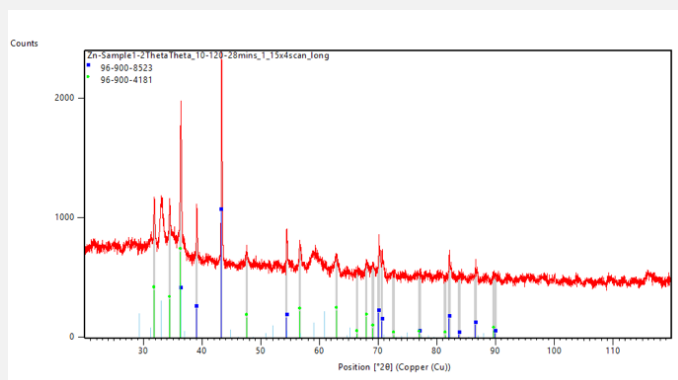
Table 2: Summary of the results from the crystallographic analysis of the white corrosion product (CP1). A representative spectrum is given in Fig. 12. Method of analysis: XRD. Center of X-ray Analytics, Empa-Swiss Federal Laboratories for Materials Science and Technology (Dübendorf), credit MiCorr\_Empa, Z.Balogh-Michels. \*The results are based on the analysis of two powder samples from different areas (see Fig. 2 for sample locations).

Fig. 12: XRD-spectrum for the analysis of powder sample 1. Ref. 96-900-8523 (in blue) corresponds to pure zinc and 96-900-4181 (in green) to zincite (ZnO),

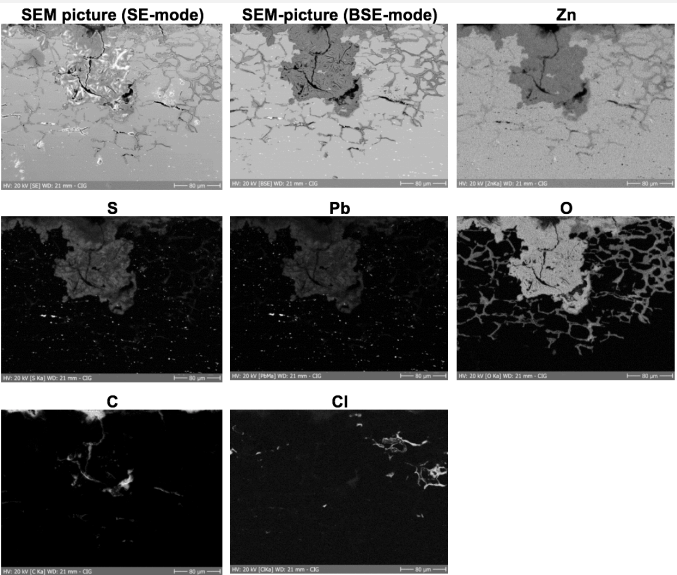
Fig. 13: SEM image and elemental chemical distribution of a selected area of Fig. 10 (rotated almost 180° and reversed). Method of analysis: SEM-EDS. Lab. of Electronic Microscopy and Microanalysis, Néode, HEI Arc,

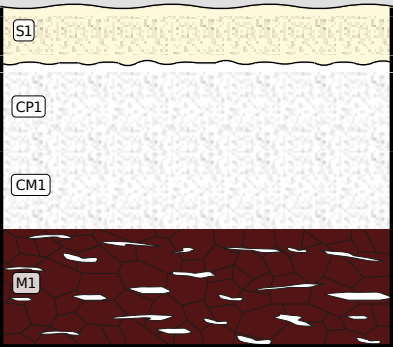
Fig. 14: Stratigraphic representation of the sample taken from the roof gutter (surface "b") in cross-section (dark field) using the MiCorr application. The characteristics of the strata are only accessible by clicking on the drawing that redirects you to the search tool by stratigraphy representation. This representation can be compared to Figs. 10 and 11, Credit UiO-IAKH, M.Hovind.
