ROOF GUTTER ELEMENT – ZN ALLOY – MODERN TIMES – FRANCE

Artefact name	Roof gutter element
Authors	Christian. Degriigny (HE-Arc CR, Neuchâtel, Neuchâtel, Switzerland) & Mathea. Hovind (University of Oslo, Department of archaeology, conservation and history (IAKH-UiO), Oslo, Oslo, Norway)
Url	/artefacts/1258/

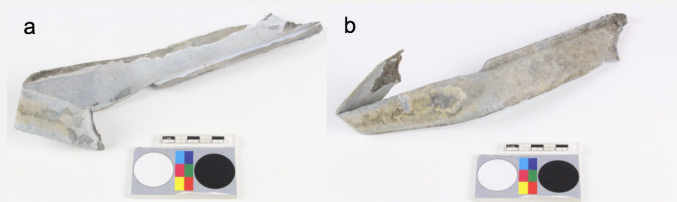
Fig. 1: Roof gutter element having different appearances on each of its surfaces: "a" on the left and "b" on the right,

Description of the artefact	A roof gutter element with remains of lead solder (Fig. 1). Its surfaces are covered by a white, strongly adherent oxide layer. Surface "b" is slightly darker in colour than surface "a" due to the presence of soil particles. Dimensions: L = 265mm; W = 47mm; T = 1mm; WT = 93g.
Type of artefact	Architectural element
Origin	Château de Germolles (14th century), Mellecey, Bourgogne, France
Recovering date	Unknown
Chronology category	Modern Times
chronology tpq	<input type="text" value="1900"/> A.D. ▼
chronology taq	<input type="text" value="2000"/> A.D. ▼
Chronology comment	19th-20th century
Burial conditions / environment	Outdoor atmosphere
Artefact location	HE-Arc CR, Neuchâtel, Neuchâtel
Owner	Château de Germolles, Mellecey, Bourgogne
Inv. number	None

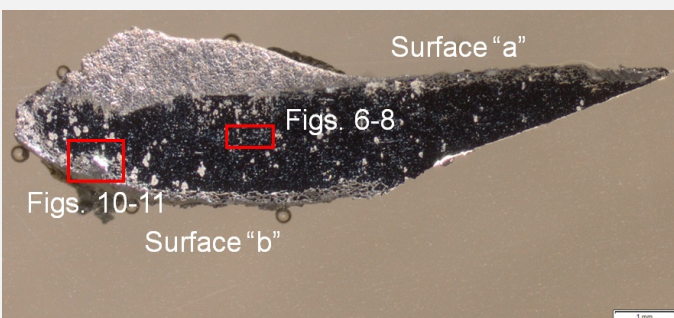
Fig. 4: Micrograph of the sample taken from the roof gutter showing the locations of Figs. 6-8 and 10-11. The uppermost area (in white) is remains of solder, while the zinc metal appears dark grey to black (the white patches are due to secondary oxidation of the sample),

Description of sample	A cross-section (Fig. 4) was cut out where the metal is at an angle of approximately 90° to the flat surface. Its upper edge corresponds to surface “a” and contains remains of solder, while the lower edge corresponds to surface “b”.
Alloy	Zn Alloy
Technology	Annealed after (hot) rolling
Lab number of sample	ZG2018 (zinc gutter sampled in 2018)
Sample location	HE-Arc CR, Neuchâtel, Neuchâtel
Responsible institution	HE-Arc CR, Neuchâtel, Neuchâtel
Date and aim of sampling	March 2018, metallography and chemical analyses

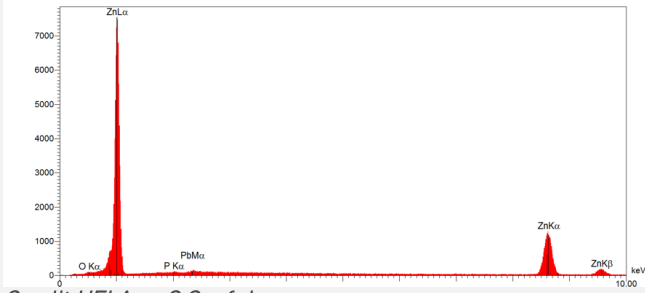
The roof gutter element is composed of Zn with P and Pb at lower concentrations (Fig. 5). The latter is probably originating from the solder that was applied to adjoin several metal sheets for the roof gutter.

Fig. 5: Chemical composition of the metal. Method of analysis: SEM-EDS. Lab. of Electronic Microscopy and Microanalysis, Néode, HEI Arc,

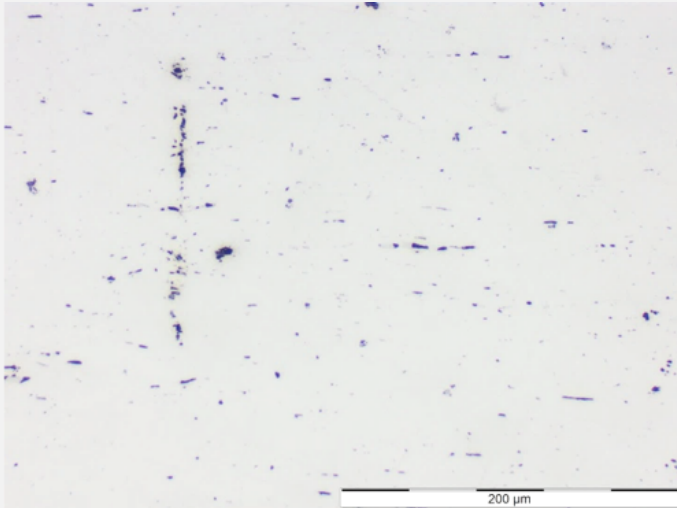
Fig. 6: Micrograph of the metal sample from Fig. 4 (detail). Unetched, bright field,

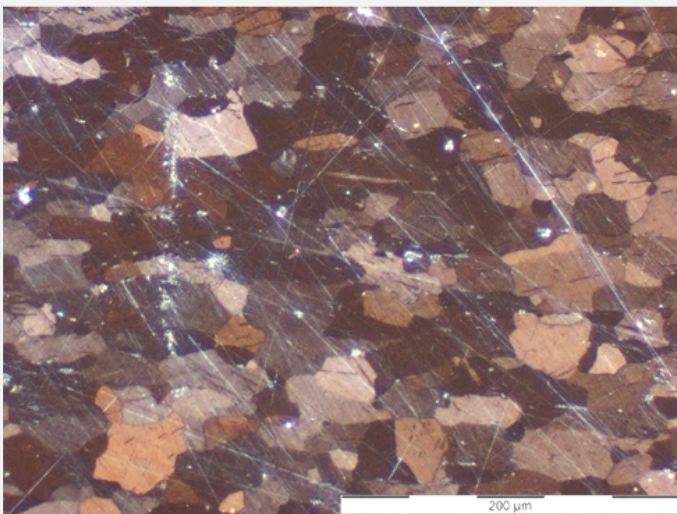
The metal appears white to light grey under bright field (Fig. 6). Under polarized light however (Fig. 78), the microstructure of the metal is visible as small polygonal grains appearing in various shades of brown, a coloured effect due to the anisotropic properties of the metal (Scott 1991: 49). In the SEM-image, white elongated inclusions are visible (Fig. 8) consisting mainly of Zn and Pb with some O (Fig. 90).

Fig. 7: Micrograph similar to Fig. 6, but under polarized light. The microstructure of the metal shows the presence of small and polygonal grains in shape,

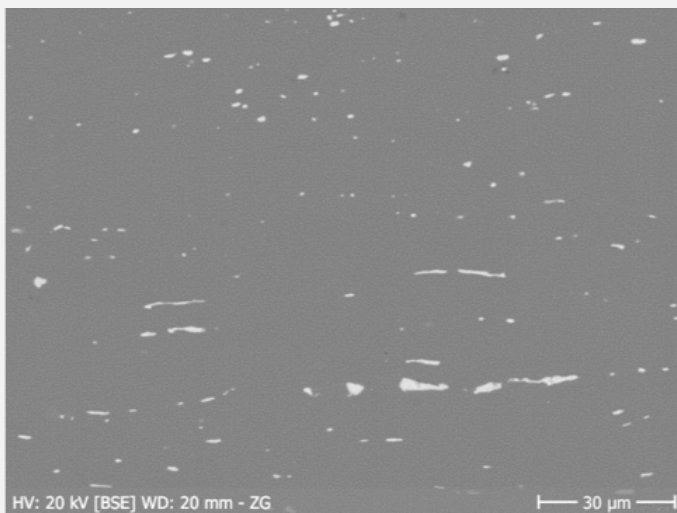
Fig. 8: SEM-image (BSE-mode) of the metal sample from Fig. 4 (detail) showing the white elongated inclusions,

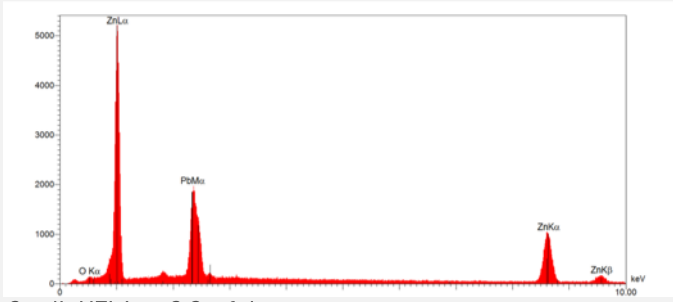
Fig. 9: SEM-EDS spectrum showing the composition of the elongated inclusions from Fig. 8. Method of analysis: SEM-EDS. Lab. of Electronic Microscopy and Microanalysis, Néode, HEI Arc,

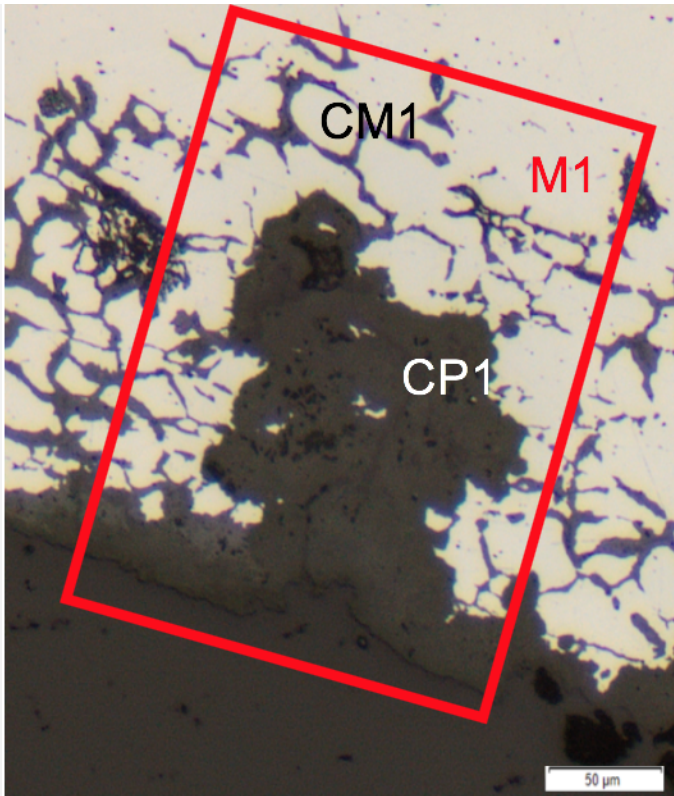
The metal is suffering from intergranular corrosion visible as a white corrosion product (CP1) located within crevices and along the grain boundaries (Figs. 10 and 11). The porous and powdery corrosion product (CP1) appears dark grey in bright field (Fig. 10) and white-grey under polarized light (Fig. 11). It consists of Zn and O (Table 1). The external corrosion product (CP1) contains some S (and not Pb as suggested by Table 1 and Fig. 13) which is probably due to atmospheric pollution. The structural composition of the corrosion product was determined by crystallographic analysis (XRD) to consist of a mixture of zincite (ZnO) and pure zinc (Zn) (Table 2, Fig 12). Mapping of the corroded area by SEM-EDS displays a similar composition but shows additionally the presence of Cl in some of the veins of the corroded metal (Fig. 13). S1 (soil material) is found on the very top of CP1.

Table 1: Chemical composition of the corrosion layers from Fig. 10. Method of analysis: SEM-EDS. Lab. of Electronic Microscopy and Microanalysis, Néode, HEI Arc, credit MiCorr_HEI Arc, C.Csefalvay. *The amount is the calculated average of three analyses of the same feature, but in different areas.

Fig. 10: Micrograph of the metal sample from Fig. 4 (detail). Unetched, bright field. The corrosion product (CP1) is located at the surface of the metal and in its crevices. Intergranular

corrosion (CM1) is visible as thin grey lines in between the metal grains (M1). The corrosion structure is to compare to the stratigraphy representation of Fig. 14. The area selected for elemental chemical distribution (Fig. 13) is marked by a red rectangle,

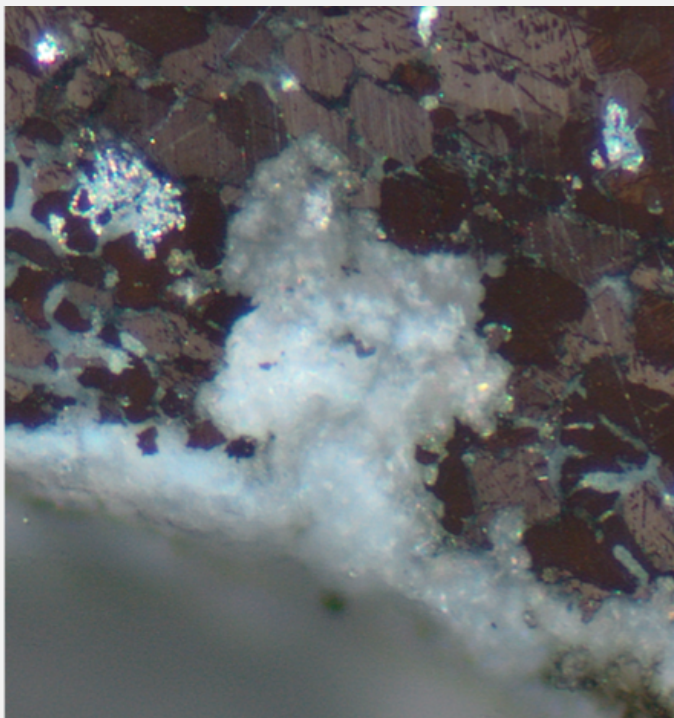
Fig. 11: Micrograph similar to Fig. 10 but under polarized light, the corrosion product (CP1) and the corroded metal (CM1) appear white,

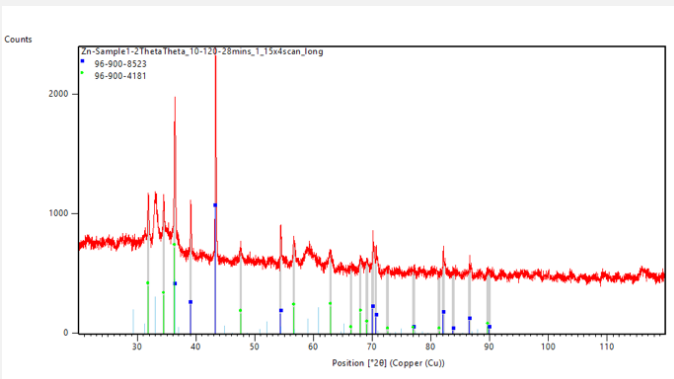
Table 2: Summary of the results from the crystallographic analysis of the white corrosion product (CP1). A representative spectrum is given in Fig. 12. Method of analysis: XRD. Center of X-ray Analytics, Empa-Swiss Federal Laboratories for Materials Science and Technology (Dübendorf), credit MiCorr_Empa, Z.Balogh-Michels. *The results are based on the analysis of two powder samples from different areas (see Fig. 2 for sample locations).

Fig. 12: XRD-spectrum for the analysis of powder sample 1. Ref. 96-900-8523 (in blue) corresponds to pure zinc and 96-900-4181 (in green) to zincite (ZnO),

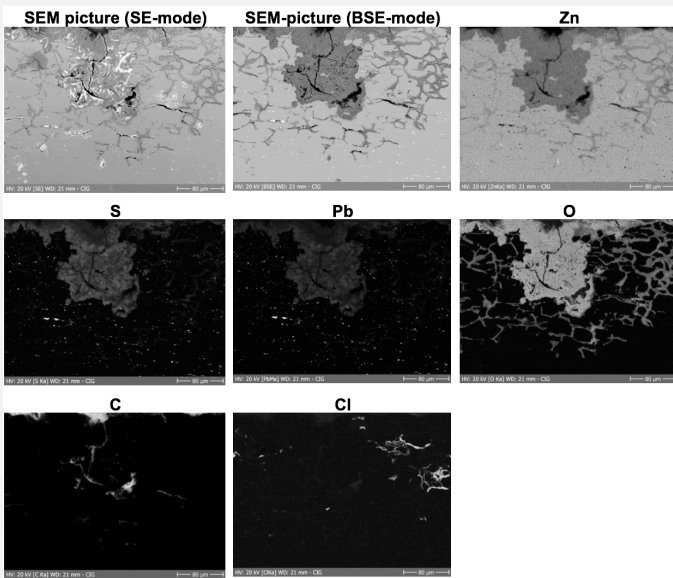
Fig. 13: SEM image and elemental chemical distribution of a selected area of Fig. 10 (rotated almost 180° and reversed). Method of analysis: SEM-EDS. Lab. of Electronic Microscopy and Microanalysis, Néode, HEI Arc,

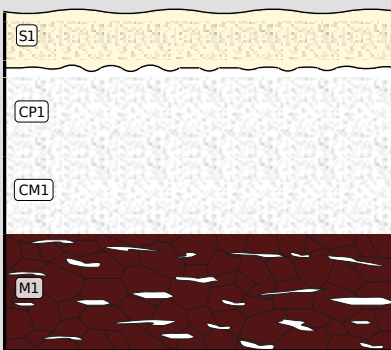
Fig. 14: Stratigraphic representation of the sample taken from the roof gutter (surface "b") in cross-section (dark field) using the MiCorr application. The characteristics of the strata are only accessible by clicking on the drawing that redirects you to the search tool by stratigraphy representation. This representation can be compared to Figs. 10 and 11, Credit UiO-IAKH, M.Hovind.
