# RAIN GUTTER FRAGMENT – GREY CAST IRON – MODERN TIMES – FRANCE

Artefact name Rain gutter fragment

Authors Christian. Degrigny (HE-Arc CR, Neuchâtel, Neuchâtel, Switzerland) & Mathea. Hovind (University of Oslo,

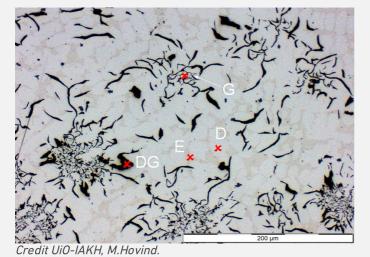
The metal is a P-rich grey cast iron with Si and Mn (Fig. 5). Its microstructure is characterized by evenly distributed graphite flakes in a matrix composed of dendrites and an interdendritic eutectic phase (Fig. 6). What appears to be irregular graphite flakes / porosity is in fact deformed graphite flakes; graphite is soft and prone to destruction by smearing and/or preferential removal during polishing (Scott 1991).

The dendrites appear light grey under polarized light, while the eutectic phase appear light brown (Fig. 6). The eutectic phase is rich in Fe and P and contains small amounts of C and Si, whereas the dendritic phase contains much less P (Table 1).

Fig. 6: Micrograph of the metal sample from Fig. 4 (detail). Unetched, bright field. Graphite flakes (G) in black, the dendrites (D) in light grey and the eutectoid phase (E) in light brown. Deformed graphite (DG) flakes are visible as irregular black inclusions,
