RAIN GUTTER FRAGMENT - GREY CAST IRON - MODERN TIMES - FRANCE

Artefact name Rain gutter fragment

Authors Christian. Degrigny (HE-Arc CR, Neuchâtel, Neuchâtel, Switzerland) & Mathea. Hovind (University of Oslo, Department of archaeology, conservation and history (IAKH-UiO), Oslo, Oslo, Norway)

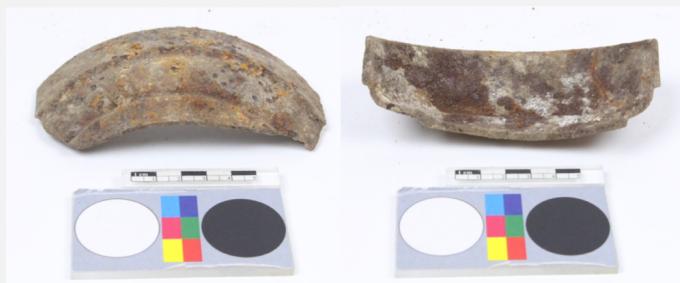
Fig. 1: Rain gutter fragment, exterior and interior faces (to the left and right, respectively),

Rain gutter fragment (Fig. 1), possibly part of the extension of a roof drain pipe. Both the exterior and interior surfaces are covered by heterogeneous corrosion crusts. The underlying metal seems however to be well preserved, including features such as a difference in thickness etc. Dimensions: L = 55mm; W (interior) = 120mm; Tmax. = 6mm; WT = 176g.

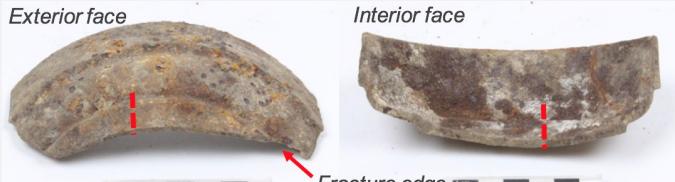
Fig. 2: The exterior and interior faces before sampling. The dotted line represents the sample location (a cross-section of the metal). The fracture edge corresponds to the edge that was formerly attached to the remaining artefact,

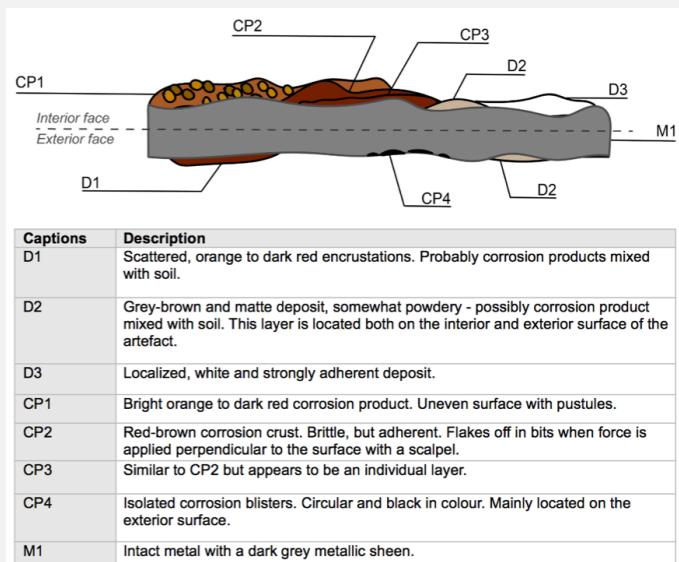
The schematic representation below (Fig. 3) gives an overview of the strata encountered by visual macroscopic observation.

Fig. 3: Preliminary stratigraphy of the corrosion structure based on visual microscopic observation,

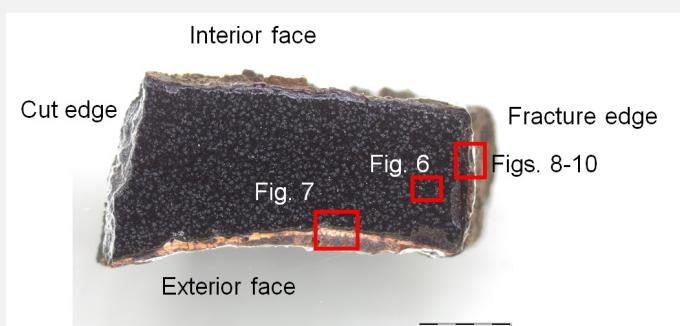
The sample consists of a rectangular section (Fig. 4) which was cut out from the fractured edge of the gutter fragment. It is representative of three surfaces: the exterior and interior surface, as well as the fracture edge. Dimensions: L = 7mm; Wmax. = 5mm; Tmax. = 4mm (approx.).

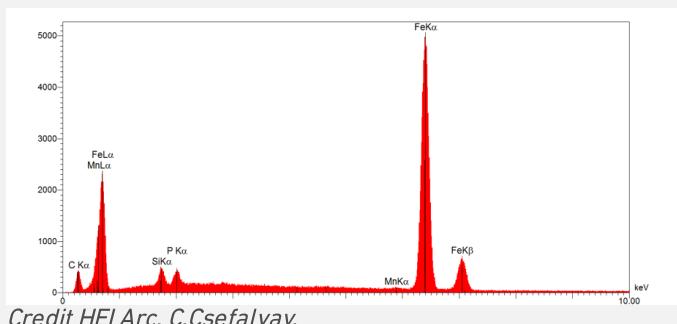
The metal is a P-rich grey cast iron with Si and Mn (Fig. 5). Its microstructure is characterized by evenly distributed graphite flakes in a matrix composed of dendrites and an interdendritic eutectic phase (Fig. 6). What appears to be irregular graphite flakes / porosity is in fact deformed graphite flakes; graphite is soft and prone to destruction by smearing and/or preferential removal during polishing (Scott 1991).

Fig. 5: EDS-spectrum showing the chemical composition of the metal. Method of analysis: SEM-EDS. Lab. of Electronic Microscopy and Microanalysis, Néode, HEI Arc, C.Csefalvay.

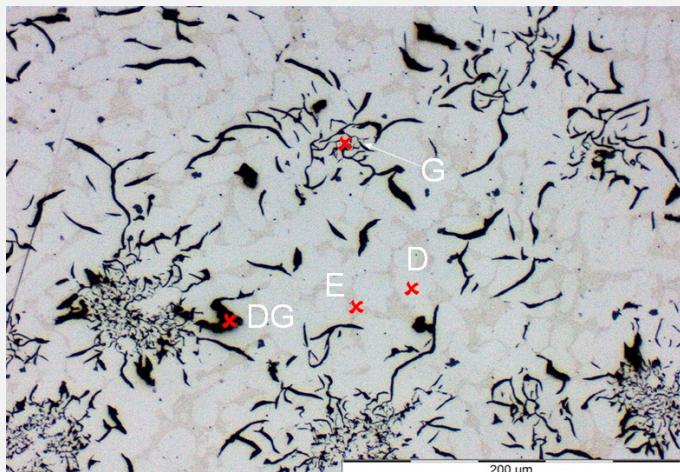
The dendrites appear light grey under polarized light, while the eutectic phase appear light brown (Fig. 6). The eutectic phase is rich in Fe and P and contains small amounts of C and Si, whereas the dendritic phase contains much less P (Table 1).

Fig. 6: Micrograph of the metal sample from Fig. 4 (detail). Unetched, bright field. Graphite flakes (G) in black, the dendrites (D) in light grey and the eutectoid phase (E) in light brown. Deformed graphite (DG) flakes are visible as irregular black inclusions,

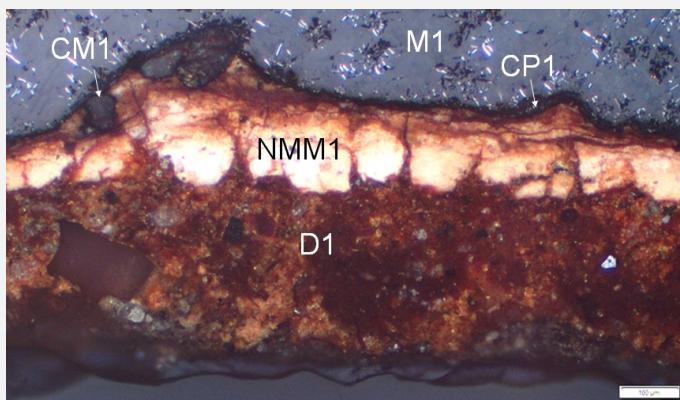
The exterior face (Figs. 2, 4 and 7) consists of a white / light yellow cracked layer (NMM1 in Fig. 7) superimposed by a layer of deposit mixed with orange-red corrosion products (D1 in Fig. 7). Local analysis by SEM-EDS (Table 2) revealed that the white / light yellow layer is rich in Ba, O, S, Fe, C and Zn. It has a chemical composition similar to Lithopone ($\text{BaSO}_4\text{,ZnS}$), a preparatory paint layer. Fe is probably a contamination from the superimposed porous deposit / corrosion product D1 (Table 2). The latter (D1) is Fe- and O-rich and contains Si, Al and some Ca, in addition to a range of elements (K, P, Na, Cl, S and Ti) present in minor amounts (Table 2). A thin layer of corrosion products (CP1) is located just beneath the paint layer, appearing dark grey under polarized light (Fig. 7). This layer is followed by a corroded metal phase (CM1). Their exact composition was not analyzed but is likely to correspond to the corroded metal phase of the fracture edge, described below.

Fig. 7: Micrograph of the metal sample from Fig. 4 (detail), unetched, polarized light, 5x. Stratigraphy of the exterior surface, to be compared to Fig. 11 and from top to bottom: the metal (M1) in grey, a layer of corroded metal (CM1) followed by a thin layer of CP1, and a white cracked layer (NMM1) superimposed by a porous dark-red deposit (D1),

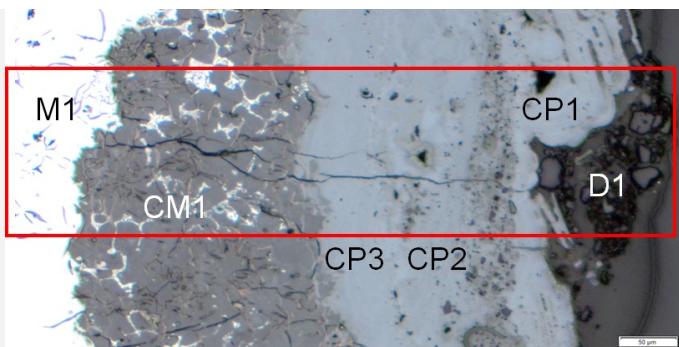
The interior face (Figs. 2 and 4) shows similar characteristics but does not include a white layer similar to NMM1. The fracture edge however (Figs. 2, 4 and 8), shows a more complex stratigraphy consisting of a dense product layer which can be further divided into two individual strata (CP3 and CP2), superimposed by a porous corrosion crust appearing orange under polarized light (CP1) (Fig. 9). The corroded metal (CM1) is located just beneath CP3 and contains remnants of the P-rich eutectic phase (Figs. 8-10). The M/CP ratio (metal to corrosion products) is rather high, implying extensive internal corrosion. Furthermore, cracks are traversing the whole corrosion layers – indicating a fragilization of the structure. As for the composition of the corrosion products CP1, CP2 and CP3, they all contain Fe and O (Fig. 10). A marbling effect within CP2 and CP3 indicates a variation in the concentration of Fe and O (particularly visible in bright field - Fig. 8). The white deposit (D1 in Figs. 8 and 9) might originate from exposure to calcareous water (Table 2). The presence of exogenous elements such as Si, Ca, Al, Na and O (Table 2) was confirmed by elemental mapping (Fig. 10).

Fig. 8: Micrograph of the metal sample from Fig. 4 (detail), unetched, bright field. Stratigraphy of the fracture edge, to be compared to Fig. 12 and from left to right: intact metal (M1) in white, followed by preferentially corroded metal (CM1) and dense product layers (CP3 and CP2) in various shades of grey. CP1 is slightly porous and covered by grain-like particles (D1). The area selected for elemental chemical distribution (Fig. 12) is marked by a red rectangle,

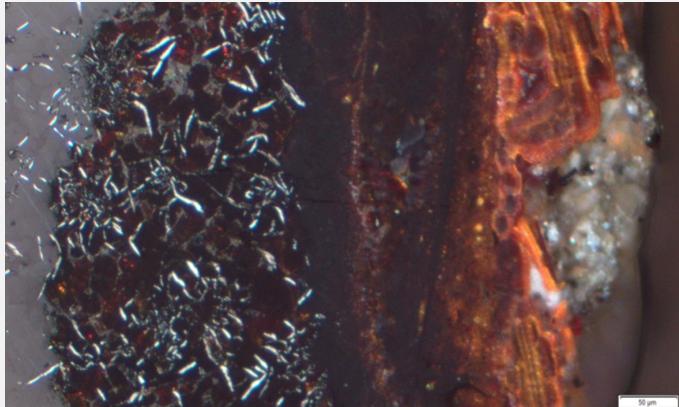
Fig. 9: Micrograph similar to Fig. 8 but under polarized light. The external deposit (D1) appears grey-white, CP1 in bright orange, while CP2 and CP3 appear dark red to brown. The corroded metal (CM1) contains remnants of graphite flakes (in white) and the P-rich eutectic (in grey),

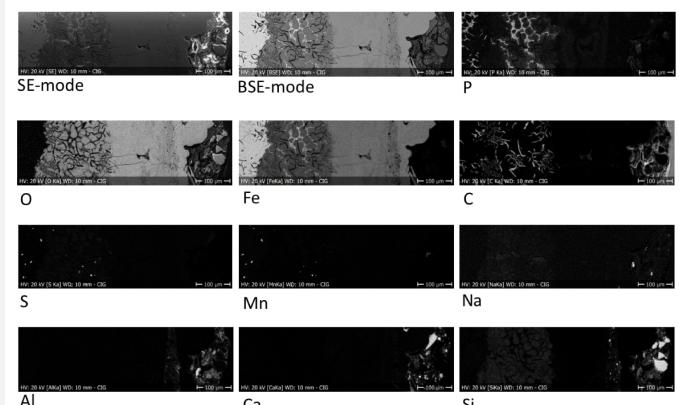
Fig. 10: SEM image and elemental chemical distribution of the selected area from Fig. 8. Method of analysis: SEM-EDS. Lab. of Electronic Microscopy and Microanalysis, Néode, HEI Arc,

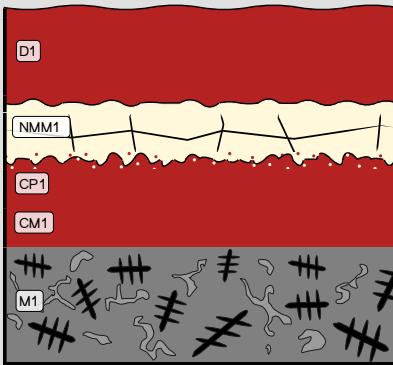
Fig. 11: Stratigraphic representation of the sample taken from the rain gutter fragment in cross-section (dark field) using the MiCorr application. The characteristics of the strata are only accessible by clicking on the drawing that redirects you to the search tool by stratigraphy representation. This representation can be compared to Fig. 7 (exterior surface). CP1 corresponds to CP2 in Fig. 3, Credit UiO-IAKH, M.Hovind.

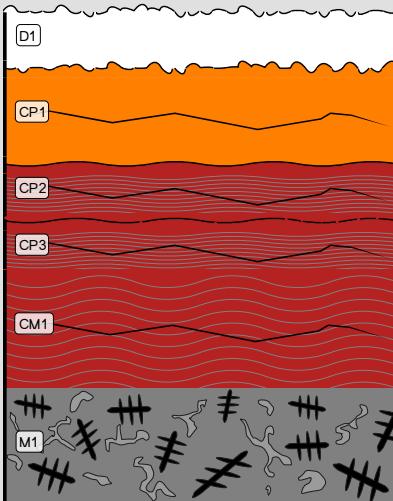
Fig. 12: Stratigraphic representation of the sample taken from the rain gutter fragment in cross-section (dark field) using the MiCorr application. The characteristics of the strata are only accessible by clicking on the drawing that redirects you to the search tool by stratigraphy representation. This representation can be compared to Figs. 8 and 9 (fracture edge). D1 corresponds to D3 in Fig. 3, Credit UiO-IAKH, M.Hovind.

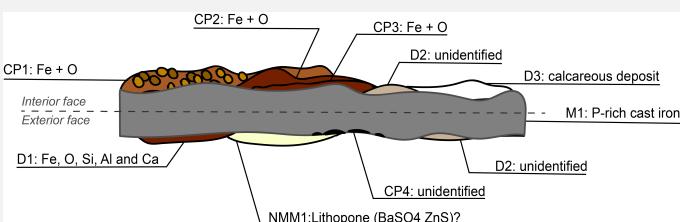
Fig. 13: Improved stratigraphic representation of the rain gutter fragment based on analysis from cross-section and visual microscopic observation,

The rain gutter fragment is a grey cast iron with a microstructure consisting of graphite flakes and a P-rich eutectic phase. The corrosion layers of the exterior surface contains a preparatory paint layer, located beneath a layer of iron corrosion products mixed with soil. It seems likely that the cast iron gutter has been covered with a protective paint layer (e.g. Lithopone) to slow down the rate of atmospheric corrosion. The presence of Lithopone reinforces the suggested dating of the artefact (20th century) as this pigment was developed and used from the 1880s and onwards (Lithopone 2007). However, it seems that the protective layer has none or only very limited effect as (pitting) corrosion is present also in these areas.

The corrosion layers consist mainly of Fe and O, indicating atmospheric corrosion with presence of only a very small amount of contaminants/pollution. The scattered white deposit is possibly originating from exposure to calcareous

water as it is localized mainly on the interior face of the fragment, where rain water would hit the metal before entering the ground.
