RAIN GUTTER FRAGMENT – GREY CAST IRON – MODERN TIMES – FRANCE

Artefact name	Rain gutter fragment
Authors	Christian. Degriigny (HE-Arc CR, Neuchâtel, Neuchâtel, Switzerland) & Mathea. Hovind (University of Oslo, Department of archaeology, conservation and history (IAKH-UiO), Oslo, Oslo, Norway)
Url	/artefacts/1261/

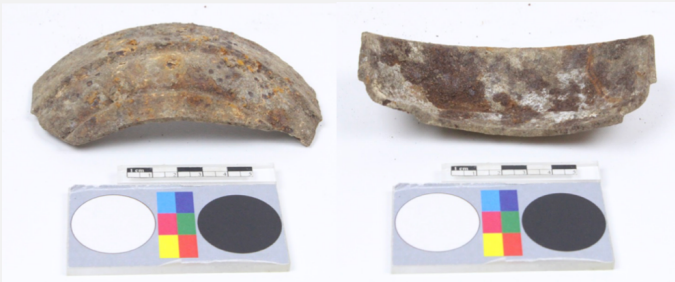
Fig. 1: Rain gutter fragment, exterior and interior faces (to the left and right, respectively),

Description of the artefact	Rain gutter fragment (Fig. 1), possibly part of the extension of a roof drain pipe. Both the exterior and interior surfaces are covered by heterogeneous corrosion crusts. The underlying metal seems however to be well preserved, including features such as a difference in thickness etc. Dimensions: L = 55mm; W (interior) = 120mm; Tmax. = 6mm; WT = 176g.
Type of artefact	Architectural element
Origin	Château de Germolles, Mellecey, Bourgogne, France
Recovering date	Unknown
Chronology category	Modern Times
chronology tpq	<input type="text" value="1801"/> A.D. ▼
chronology taq	<input type="text" value="2000"/> A.D. ▼
Chronology comment	19th - 20th century

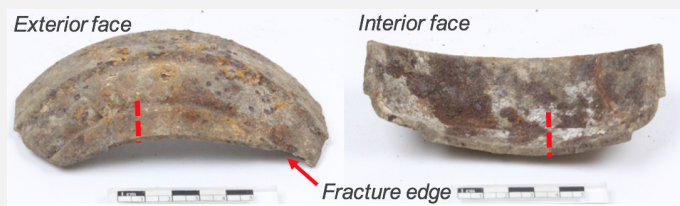
Fig. 2: The exterior and interior faces before sampling. The dotted line represents the sample location (a cross-section of the metal). The fracture edge corresponds to the edge that was formerly attached to the remaining artefact,

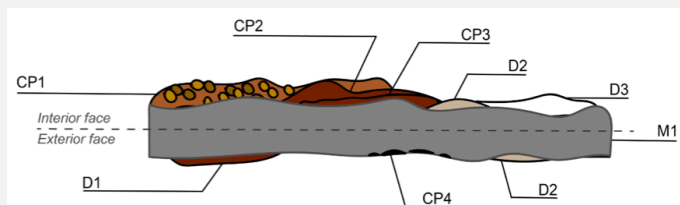
Fig. 3: Preliminary stratigraphy of the corrosion structure based on visual microscopic observation,

Captions	Description
D1	Scattered, orange to dark red encrustations. Probably corrosion products mixed with soil.
D2	Grey-brown and matte deposit, somewhat powdery - possibly corrosion product mixed with soil. This layer is located both on the interior and exterior surface of the artefact.
D3	Localized, white and strongly adherent deposit.
CP1	Bright orange to dark red corrosion product. Uneven surface with pustules.
CP2	Red-brown corrosion crust. Brittle, but adherent. Flakes off in bits when force is applied perpendicular to the surface with a scalpel.
CP3	Similar to CP2 but appears to be an individual layer.
CP4	Isolated corrosion blisters. Circular and black in colour. Mainly located on the exterior surface.
M1	Intact metal with a dark grey metallic sheen.

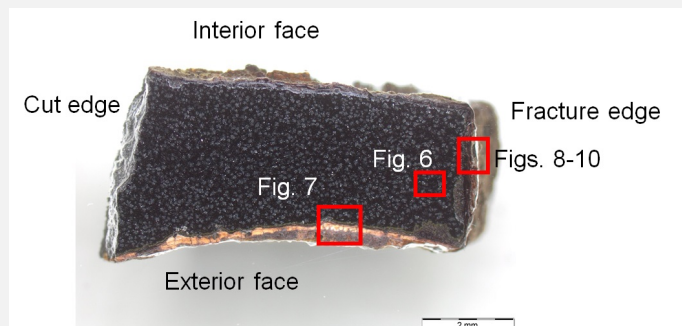
Fig. 4: Micrograph of the sample taken from the rain gutter fragment showing its orientation relative to the artefact and the locations of Figs. 6-10,

The sample consists of a rectangular section (Fig. 4) which was cut out from the fractured edge of the gutter fragment. It is representative of three surfaces: the exterior and interior surface, as well as the fracture edge. Dimensions: L = 7mm; Wmax. = 5mm; Tmax. = 4mm (approx.).

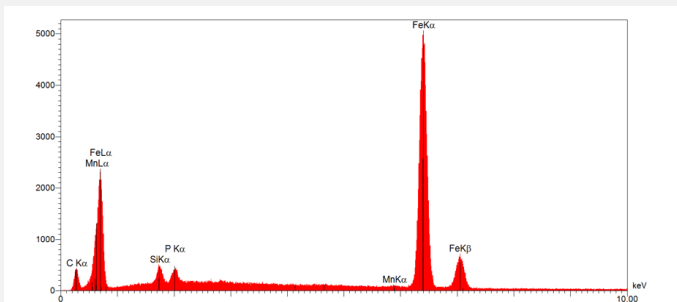
The metal is a P-rich grey cast iron with Si and Mn (Fig. 5). Its microstructure is characterized by evenly distributed graphite flakes in a matrix composed of dendrites and an interdendritic eutectic phase (Fig. 6). What appears to be irregular graphite flakes / porosity is in fact deformed graphite flakes; graphite is soft and prone to destruction by smearing and/or preferential removal during polishing (Scott 1991).

Fig. 5: EDS-spectrum showing the chemical composition of the metal. Method of analysis: SEM-EDS. Lab. of Electronic Microscopy and Microanalysis, Néode, HEI Arc,

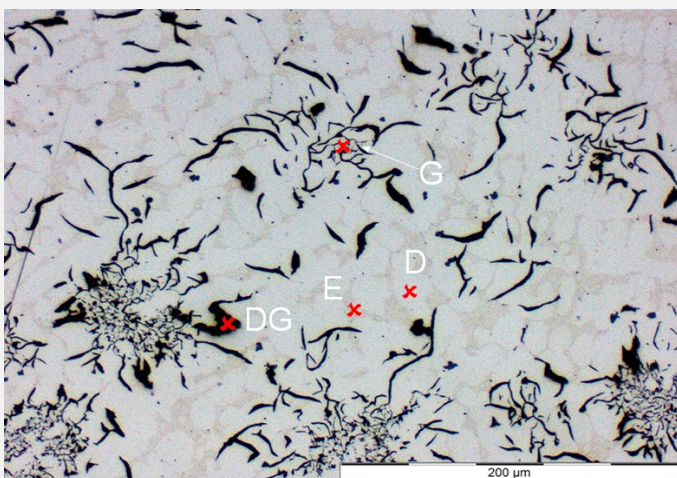
The dendrites appear light grey under polarized light, while the eutectic phase appear light brown (Fig. 6). The eutectic phase is rich in Fe and P and contains small amounts of C and Si, whereas the dendritic phase contains much less P (Table 1).

Fig. 6: Micrograph of the metal sample from Fig. 4 (detail). Unetched, bright field. Graphite flakes (G) in black, the dendrites (D) in light grey and the eutectoid phase (E) in light brown. Deformed graphite (DG) flakes are visible as irregular black inclusions,

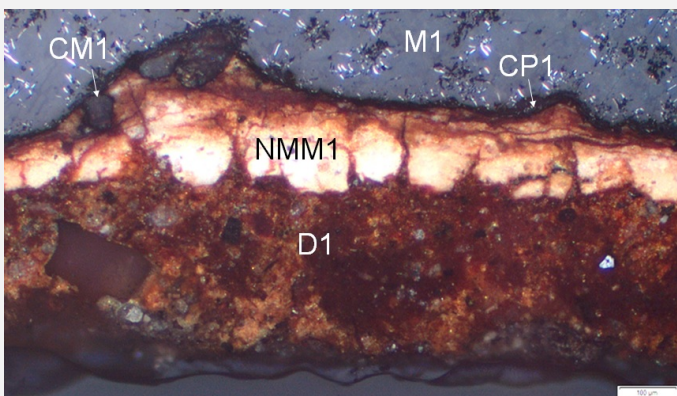
The exterior face (Figs. 2, 4 and 7) consists of a white / light yellow cracked layer (NMM1 in Fig. 7) superimposed by a layer of deposit mixed with orange-red corrosion products (D1 in Fig. 7). Local analysis by SEM-EDS (Table 2) revealed that the white / light yellow layer is rich in Ba, O, S, Fe, C and Zn. It has a chemical composition similar to Lithopone ($\text{BaSO}_4, \text{ZnS}$), a preparatory paint layer. Fe is probably a contamination from the superimposed porous deposit / corrosion product D1 (Table 2). The latter (D1) is Fe- and O-rich and contains Si, Al and some Ca, in addition to a range of elements (K, P, Na, Cl, S and Ti) present in minor amounts (Table 2). A thin layer of corrosion products (CP1) is located just beneath the paint layer, appearing dark grey under polarized light (Fig. 7). This layer is followed by a corroded metal phase (CM1). Their exact composition was not analyzed but is likely to correspond to the corroded metal phase of the fracture edge, described below.

Fig. 7: Micrograph of the metal sample from Fig. 4 (detail), unetched, polarized light, 5x. Stratigraphy of the exterior surface, to be compared to Fig. 11 and from top to bottom: the metal (M1) in grey, a layer of corroded metal (CM1) followed by a thin layer of CP1, and a white cracked layer (NMM1) superimposed by a porous dark-red deposit (D1),

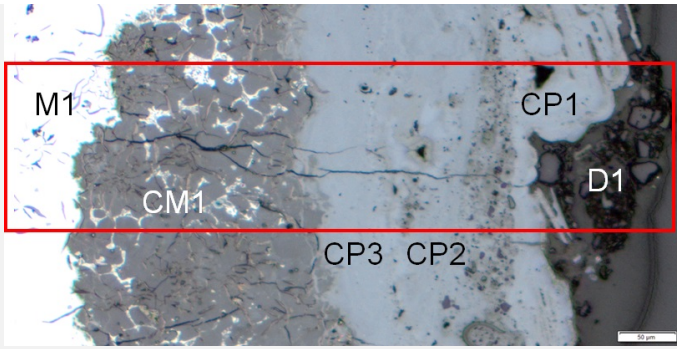
The interior face (Figs. 2 and 4) shows similar characteristics but does not include a white layer similar to NMM1. The fracture edge however (Figs. 2, 4 and 8), shows a more complex stratigraphy consisting of a dense product layer which can be further divided into two individual strata (CP3 and CP2), superimposed by a porous corrosion crust appearing orange under polarized light (CP1) (Fig. 9). The corroded metal (CM1) is located just beneath CP3 and contains remnants of the P-rich eutectic phase (Figs. 8-10). The M/CP ratio (metal to corrosion products) is rather high, implying extensive internal corrosion. Furthermore, cracks are traversing the whole corrosion layers – indicating a fragilization of the structure. As for the composition of the corrosion products CP1, CP2 and CP3, they all contain Fe and O (Fig. 10). A marbling effect within CP2 and CP3 indicates a variation in the concentration of Fe and O (particularly visible in bright field - Fig. 8). The white deposit (D1 in Figs. 8 and 9) might originate from exposure to calcareous water (Table 2). The presence of exogenous elements such as Si, Ca, Al, Na and O (Table 2) was confirmed by elemental mapping (Fig. 10).

Fig. 8: Micrograph of the metal sample from Fig. 4 (detail), unetched, bright field. Stratigraphy of the fracture edge, to be compared to Fig. 12 and from left to right: intact metal (M1) in white, followed by preferentially corroded metal (CM1) and dense product layers (CP3 and CP2) in various shades of grey. CP1 is slightly porous and covered by grain-like particles (D1). The area selected for elemental chemical distribution (Fig. 12) is marked by a red rectangle,

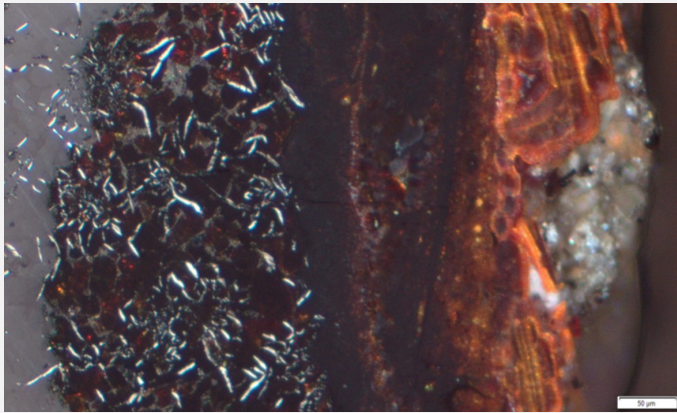
Fig. 9: Micrograph similar to Fig. 8 but under polarized light. The external deposit (D1) appears grey-white, CP1 in bright orange, while CP2 and CP3 appear dark red to brown. The corroded metal (CM1) contains remnants of graphite flakes (in white) and the P-rich eutectic (in grey),

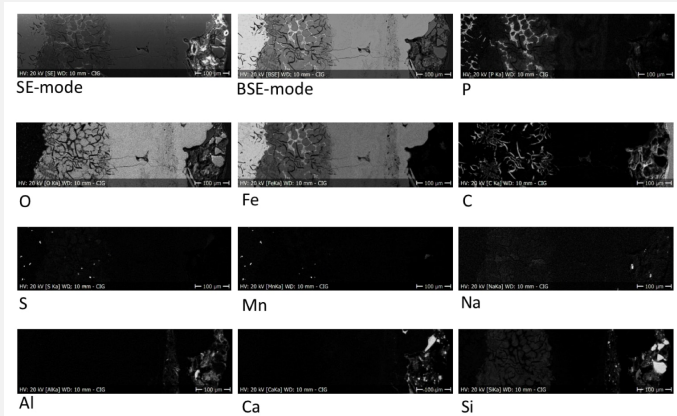
Fig. 10: SEM image and elemental chemical distribution of the selected area from Fig. 8. Method of analysis: SEM-EDS. Lab. of Electronic Microscopy and Microanalysis, Néode, HEI Arc,

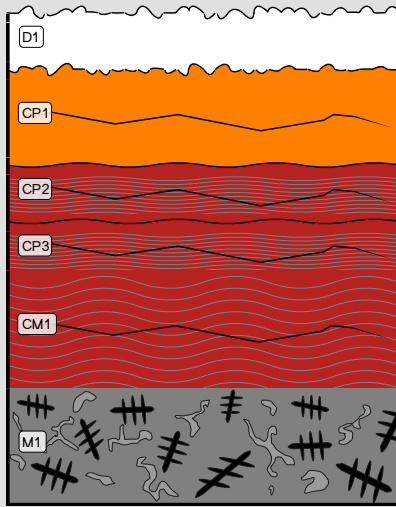
Fig. 12: Stratigraphic representation of the sample taken from the rain gutter fragment in cross-section (dark field) using the MiCorr application. The characteristics of the strata are only accessible by clicking on the drawing that redirects you to the search tool by stratigraphy representation. This representation can be compared to Figs. 8 and 9 (fracture edge). D1 corresponds to D3 in Fig. 3, Credit UiO-IAKH, M.Hovind.

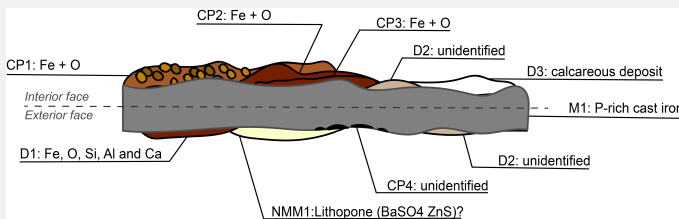
Fig. 13: Improved stratigraphic representation of the rain gutter fragment based on analysis from cross-section and visual microscopic observation,

The rain gutter fragment is a grey cast iron with a microstructure consisting of graphite flakes and a P-rich eutectic phase. The corrosion layers of the exterior surface contains a preparatory paint layer, located beneath a layer of iron corrosion products mixed with soil. It seems likely that the cast iron gutter has been covered with a protective paint layer (e.g. Lithopone) to slow down the rate of atmospheric corrosion. The presence of Lithopone reinforces the suggested dating of the artefact (20th century) as this pigment was developed and used from the 1880s and onwards (Lithopone 2007). However, it seems that the protective layer has none or only very limited effect as (pitting) corrosion is present also in these areas.

The corrosion layers consist mainly of Fe and O, indicating atmospheric corrosion with presence of only a very small amount of contaminants/pollution. The scattered white deposit is possibly originating from exposure to calcareous water as it is localized mainly on the interior face of the fragment, where rain water would hit the metal before entering the ground.
