RAIN GUTTER FRAGMENT – GREY CAST IRON – MODERN TIMES – FRANCE

Artefact name	Rain gutter fragment
Authors	Christian. Degriigny (HE-Arc CR, Neuchâtel, Neuchâtel, Switzerland) & Mathea. Hovind (University of Oslo, Department of archaeology, conservation and history (IAKH-UiO), Oslo, Oslo, Norway)
Url	/artefacts/1261/

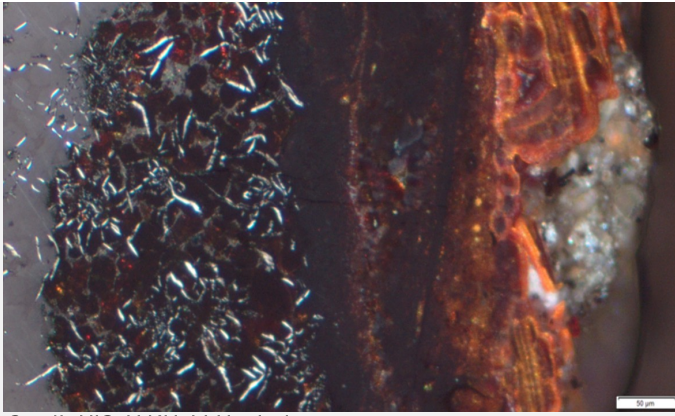
Fig. 9: Micrograph similar to Fig. 8 but under polarized light. The external deposit (D1) appears grey-white, CP1 in bright orange, while CP2 and CP3 appear dark red to brown. The corroded metal (CM1) contains remnants of graphite flakes (in white) and the P-rich eutectic (in grey),

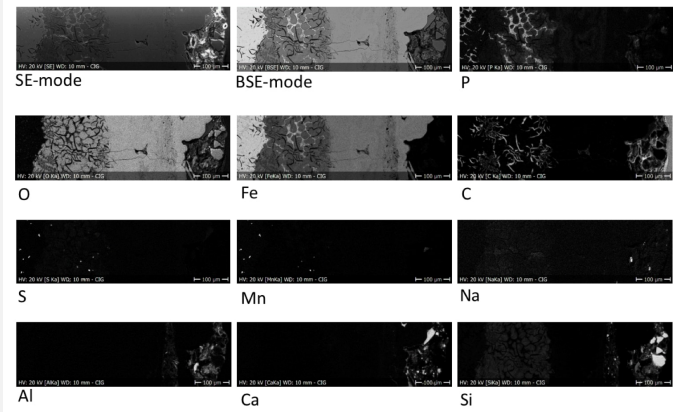
Fig. 10: SEM image and elemental chemical distribution of the selected area from Fig. 8. Method of analysis: SEM-EDS. Lab. of Electronic Microscopy and Microanalysis, Néode, HEI Arc,

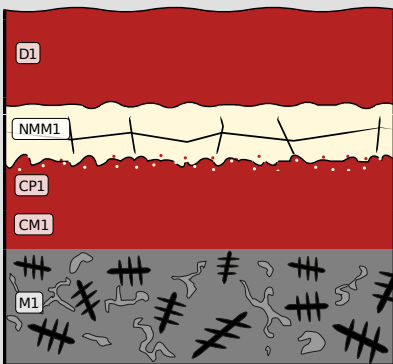
Fig. 11: Stratigraphic representation of the sample taken from the rain gutter fragment in cross-section (dark field) using the MiCorr application. The characteristics of the strata are only accessible by clicking on the drawing that redirects you to the search tool by stratigraphy representation. This representation can be compared to Fig. 7 (exterior surface). CP1 corresponds to CP2 in Fig. 3, Credit UiO-IAKH, M.Hovind.

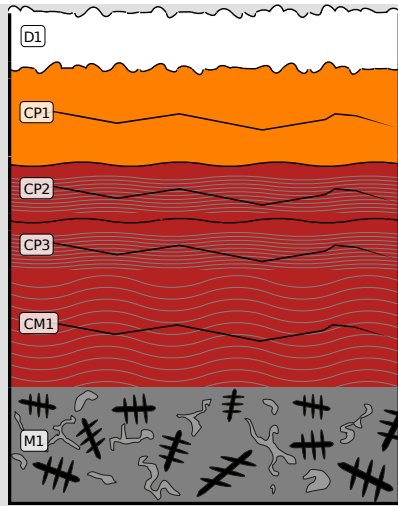
Fig. 12: Stratigraphic representation of the sample taken from the rain gutter fragment in cross-section (dark field) using the MiCorr application. The characteristics of the strata are only accessible by clicking on the drawing that redirects you to the search tool by stratigraphy representation. This representation can be compared to Figs. 8 and 9 (fracture

edge). D1 corresponds to D3 in Fig. 3, Credit UiO-IAKH, M.Hovind.

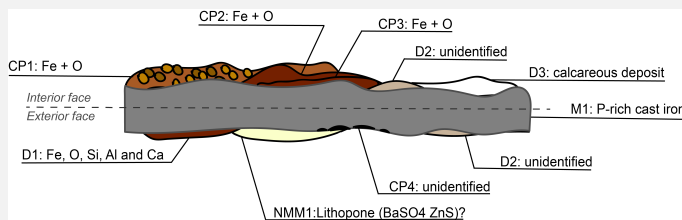
Fig. 13: Improved stratigraphic representation of the rain gutter fragment based on analysis from cross-section and visual microscopic observation,

The rain gutter fragment is a grey cast iron with a microstructure consisting of graphite flakes and a P-rich eutectic phase. The corrosion layers of the exterior surface contains a preparatory paint layer, located beneath a layer of iron corrosion products mixed with soil. It seems likely that the cast iron gutter has been covered with a protective paint layer (e.g. Lithopone) to slow down the rate of atmospheric corrosion. The presence of Lithopone reinforces the suggested dating of the artefact (20th century) as this pigment was developed and used from the 1880s and onwards (Lithopone 2007). However, it seems that the protective layer has none or only very limited effect as (pitting) corrosion is present also in these areas.

The corrosion layers consist mainly of Fe and O, indicating atmospheric corrosion with presence of only a very small amount of contaminants/pollution. The scattered white deposit is possibly originating from exposure to calcareous water as it is localized mainly on the interior face of the fragment, where rain water would hit the metal before entering the ground.
