# RAIN GUTTER FRAGMENT – GREY CAST IRON – MODERN TIMES – FRANCE

<b>Artefact name</b>	Rain gutter fragment
<b>Authors</b>	Christian. Degriigny (HE-Arc CR, Neuchâtel, Neuchâtel, Switzerland) & Mathea. Hovind (University of Oslo, Department of archaeology, conservation and history (IAKH-UiO), Oslo, Oslo, Norway)
<b>Url</b>	/artefacts/1261/

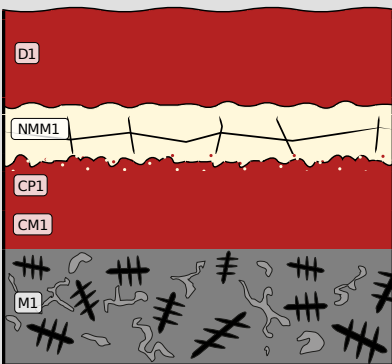
Fig. 11: Stratigraphic representation of the sample taken from the rain gutter fragment in cross-section (dark field) using the MiCorr application. The characteristics of the strata are only accessible by clicking on the drawing that redirects you to the search tool by stratigraphy representation. This representation can be compared to Fig. 7 (exterior surface). CP1 corresponds to CP2 in Fig. 3, Credit UiO-IAKH, M.Hovind.

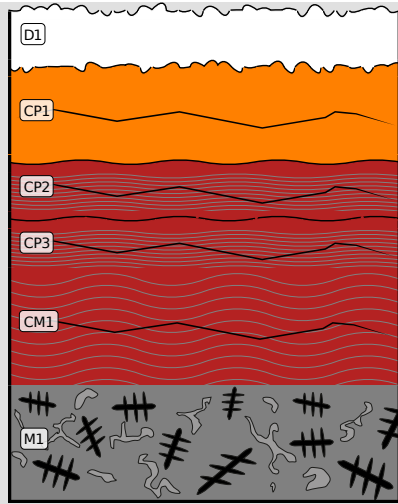
Fig. 12: Stratigraphic representation of the sample taken from the rain gutter fragment in cross-section (dark field) using the MiCorr application. The characteristics of the strata are only accessible by clicking on the drawing that redirects you to the search tool by stratigraphy representation. This representation can be compared to Figs. 8 and 9 (fracture

edge). D1 corresponds to D3 in Fig. 3, Credit UiO-IAKH, M.Hovind.
