RAIN GUTTER FRAGMENT – GREY CAST IRON – MODERN TIMES – FRANCE

Artefact name	Rain gutter fragment
Authors	Christian. Degriigny (HE-Arc CR, Neuchâtel, Neuchâtel, Switzerland) & Mathea. Hovind (University of Oslo, Department of archaeology, conservation and history (IAKH-UiO), Oslo, Oslo, Norway)
Url	/artefacts/1261/

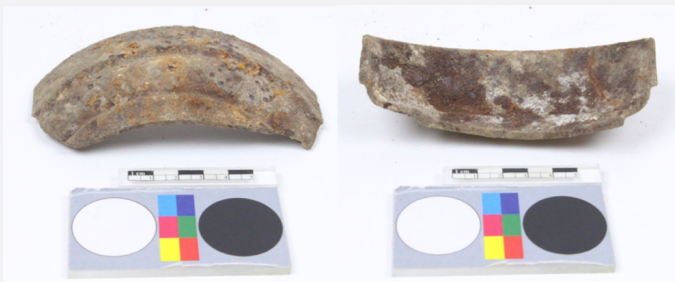
Fig. 1: Rain gutter fragment, exterior and interior faces (to the left and right, respectively),

Description of the artefact	Rain gutter fragment (Fig. 1), possibly part of the extension of a roof drain pipe. Both the exterior and interior surfaces are covered by heterogeneous corrosion crusts. The underlying metal seems however to be well preserved, including features such as a difference in thickness etc. Dimensions: L = 55mm; W (interior) = 120mm; Tmax. = 6mm; WT = 176g.
Type of artefact	Architectural element
Origin	Château de Germolles (14th century), Mellecey, Bourgogne, France
Recovering date	Unknown
Chronology category	Modern Times
chronology tpq	1801 A.D. ▼
chronology taq	2000 A.D. ▼
Chronology comment	19th - 20th century
Burial conditions / environment	Outdoor atmosphere

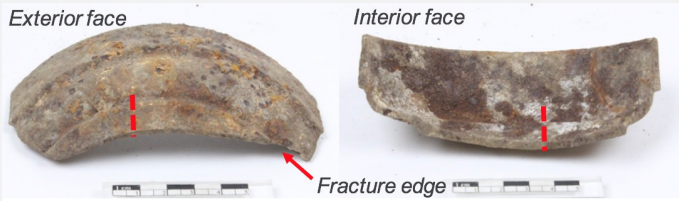
Fig. 2: The exterior and interior faces before sampling. The dotted line represents the sample location (a cross-section of the metal). The fracture edge corresponds to the edge that was formerly attached to the remaining artefact,

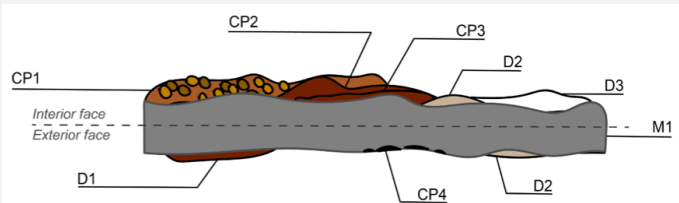
Fig. 3: Preliminary stratigraphy of the corrosion structure based on visual microscopic observation,

Captions	Description
D1	Scattered, orange to dark red encrustations. Probably corrosion products mixed with soil.
D2	Grey-brown and matte deposit, somewhat powdery - possibly corrosion product mixed with soil. This layer is located both on the interior and exterior surface of the artefact.
D3	Localized, white and strongly adherent deposit.
CP1	Bright orange to dark red corrosion product. Uneven surface with pustules.
CP2	Red-brown corrosion crust. Brittle, but adherent. Flakes off in bits when force is applied perpendicular to the surface with a scalpel.
CP3	Similar to CP2 but appears to be an individual layer.
CP4	Isolated corrosion blisters. Circular and black in colour. Mainly located on the exterior surface.
M1	Intact metal with a dark grey metallic sheen.

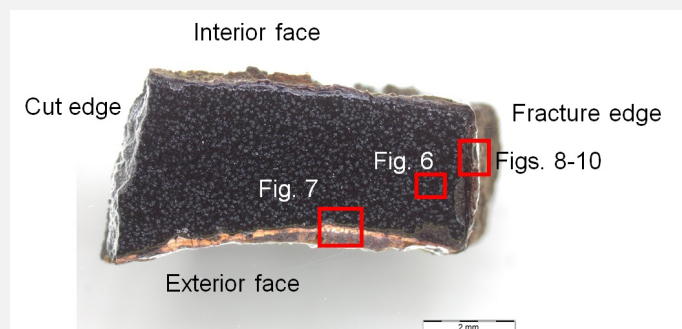
Fig. 4: Micrograph of the sample taken from the rain gutter fragment showing its orientation relative to the artefact and the locations of Figs. 6-10,

The sample consists of a rectangular section (Fig. 4) which was cut out from the fractured edge of the gutter fragment. It is representative of three surfaces: the exterior and interior surface, as well as the fracture edge. Dimensions: L = 7mm; Wmax. = 5mm; Tmax. = 4mm (approx.).

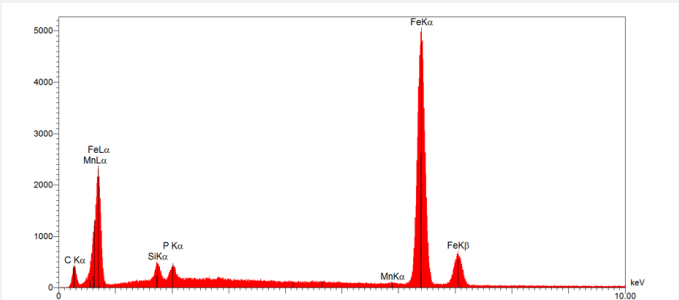
The metal is a P-rich grey cast iron with Si and Mn (Fig. 5). Its microstructure is characterized by evenly distributed graphite flakes in a matrix composed of dendrites and an interdendritic eutectic phase (Fig. 6). What appears to be irregular graphite flakes / porosity is in fact deformed graphite flakes; graphite is soft and prone to destruction by smearing and/or preferential removal during polishing (Scott 1991).

Fig. 5: EDS-spectrum showing the chemical composition of the metal. Method of analysis: SEM-EDS. Lab. of Electronic Microscopy and Microanalysis, Néode, HEI Arc,

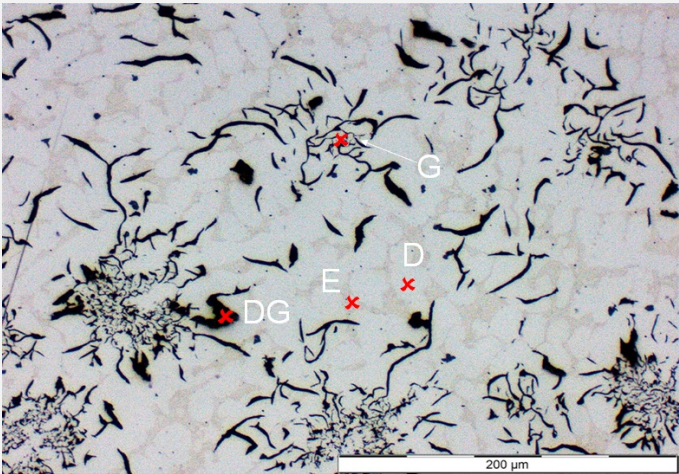
The dendrites appear light grey under polarized light, while the eutectic phase appear light brown (Fig. 6). The eutectic phase is rich in Fe and P and contains small amounts of C and Si, whereas the dendritic phase contains much less P (Table 1).

Fig. 6: Micrograph of the metal sample from Fig. 4 (detail). Unetched, bright field. Graphite flakes (G) in black, the dendrites (D) in light grey and the eutectoid phase (E) in light brown. Deformed graphite (DG) flakes are visible as irregular black inclusions,

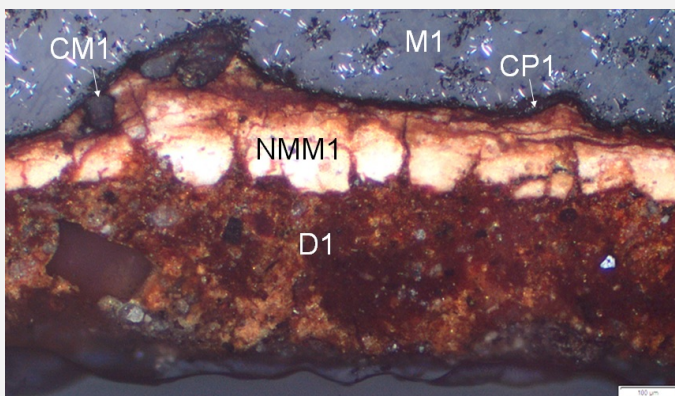
The exterior face (Figs. 2, 4 and 7) consists of a white / light yellow cracked layer (NMM1 in Fig. 7) superimposed by a layer of deposit mixed with orange-red corrosion products (D1 in Fig. 7). Local analysis by SEM-EDS (Table 2) revealed that the white / light yellow layer is rich in Ba, O, S, Fe, C and Zn. It has a chemical composition similar to Lithopone ($\text{BaSO}_4\cdot\text{ZnS}$), a preparatory paint layer. Fe is probably a contamination from the superimposed porous deposit / corrosion product D1 (Table 2). The latter (D1) is Fe- and O-rich and contains Si, Al and some Ca, in addition to a range of elements (K, P, Na, Cl, S and Ti) present in minor amounts (Table 2). A thin layer of corrosion products (CP1) is located just beneath the paint layer, appearing dark grey under polarized light (Fig. 7). This layer is followed by a corroded metal phase (CM1). Their exact composition was not analyzed but is likely to correspond to the corroded metal phase of the fracture edge, described below.

Fig. 7: Micrograph of the metal sample from Fig. 4 (detail), unetched, polarized light, 5x. Stratigraphy of the exterior surface, to be compared to Fig. 11 and from top to bottom: the metal (M1) in grey, a layer of corroded metal (CM1) followed by a thin layer of CP1, and a white cracked layer (NMM1) superimposed by a porous dark-red deposit (D1),

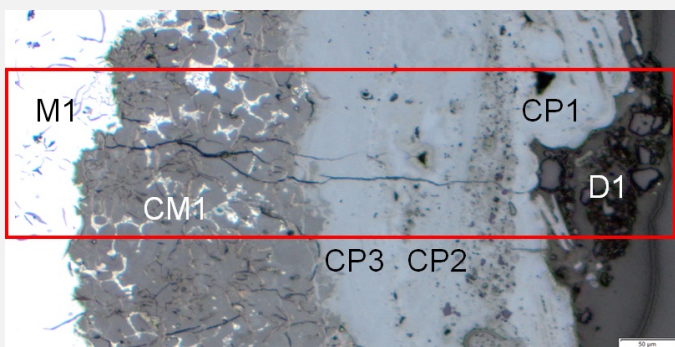
The interior face (Figs. 2 and 4) shows similar characteristics but does not include a white layer similar to NMM1. The fracture edge however (Figs. 2, 4 and 8), shows a more complex stratigraphy consisting of a dense product layer which can be further divided into two individual strata (CP3 and CP2), superimposed by a porous corrosion crust appearing orange under polarized light (CP1) (Fig. 9). The corroded metal (CM1) is located just beneath CP3 and contains remnants of the P-rich eutectic phase (Figs. 8-10). The M/CP ratio (metal to corrosion products) is rather high, implying extensive internal corrosion. Furthermore, cracks are traversing the whole corrosion layers – indicating a fragilization of the structure. As for the composition of the corrosion products CP1, CP2 and CP3, they all contain Fe and O (Fig. 10). A marbling effect within CP2 and CP3 indicates a variation in the concentration of Fe and O (particularly visible in bright field - Fig. 8). The white deposit (D1 in Figs. 8 and 9) might originate from exposure to calcareous water (Table 2). The presence of exogenous elements such as Si, Ca, Al, Na and O (Table 2) was confirmed by elemental mapping (Fig. 10).

Fig. 8: Micrograph of the metal sample from Fig. 4 (detail), unetched, bright field. Stratigraphy of the fracture edge, to be compared to Fig. 12 and from left to right: intact metal (M1) in white, followed by preferentially corroded metal (CM1) and dense product layers (CP3 and CP2) in various shades of grey. CP1 is slightly porous and covered by grain-like particles (D1). The area selected for elemental chemical distribution (Fig. 12) is marked by a red rectangle,

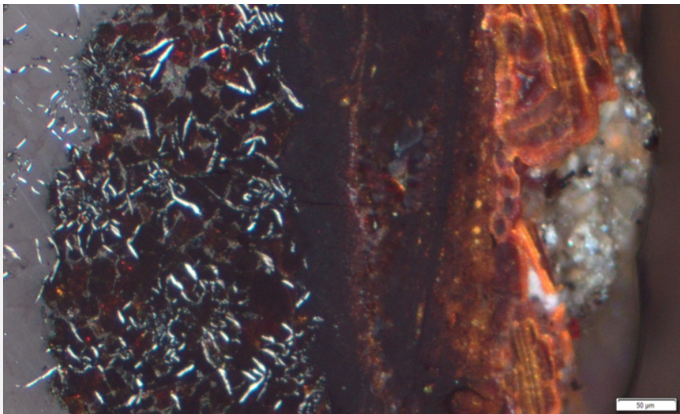
Fig. 9: Micrograph similar to Fig. 8 but under polarized light. The external deposit (D1) appears grey-white, CP1 in bright orange, while CP2 and CP3 appear dark red to brown. The corroded metal (CM1) contains remnants of graphite flakes (in white) and the P-rich eutectic (in grey),

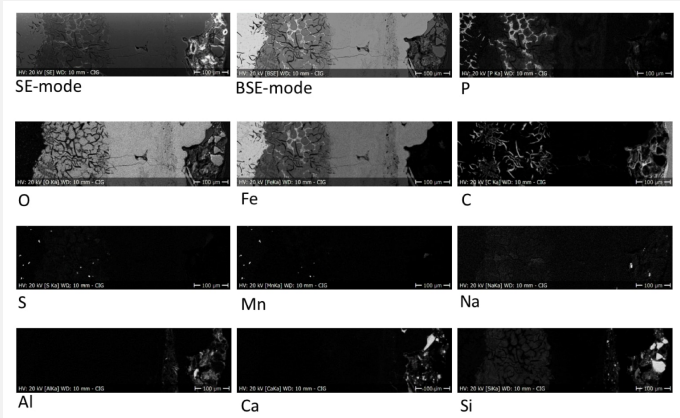
Fig. 10: SEM image and elemental chemical distribution of the selected area from Fig. 8. Method of analysis: SEM-EDS. Lab. of Electronic Microscopy and Microanalysis, Néode, HEI Arc,

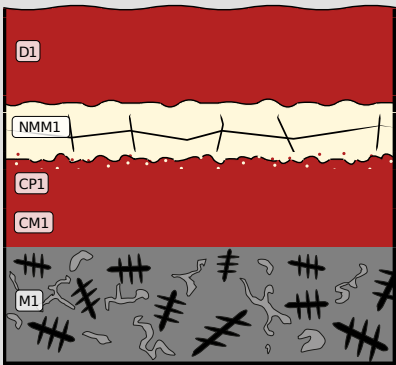
Fig. 11: Stratigraphic representation of the sample taken from the rain gutter fragment in cross-section (dark field) using the MiCorr application. The characteristics of the strata are only accessible by clicking on the drawing that redirects you to the search tool by stratigraphy representation. This representation can be compared to Fig. 7 (exterior surface). CP1 corresponds to CP2 in Fig. 3, Credit UiO-IAKH, M.Hovind.

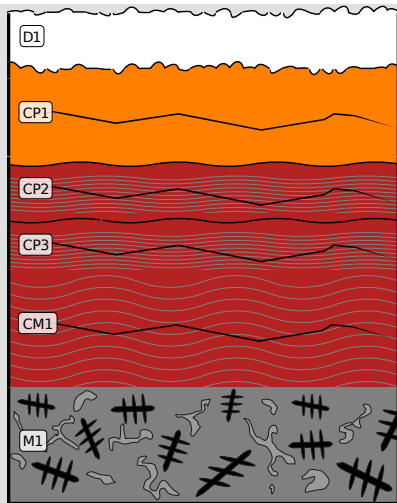
Fig. 12: Stratigraphic representation of the sample taken from the rain gutter fragment in cross-section (dark field) using the MiCorr application. The characteristics of the strata are only accessible by clicking on the drawing that redirects you to the search tool by stratigraphy representation. This representation can be compared to Figs. 8 and 9 (fracture

edge). D1 corresponds to D3 in Fig. 3, Credit UiO-IAKH, M.Hovind.

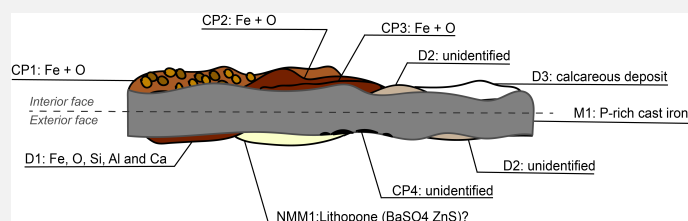
Fig. 13: Improved stratigraphic representation of the rain gutter fragment based on analysis from cross-section and visual microscopic observation,

The rain gutter fragment is a grey cast iron with a microstructure consisting of graphite flakes and a P-rich eutectic phase. The corrosion layers of the exterior surface contains a preparatory paint layer, located beneath a layer of iron corrosion products mixed with soil. It seems likely that the cast iron gutter has been covered with a protective paint layer (e.g. Lithopone) to slow down the rate of atmospheric corrosion. The presence of Lithopone reinforces the suggested dating of the artefact (20th century) as this pigment was developed and used from the 1880s and onwards (Lithopone 2007). However, it seems that the protective layer has none or only very limited effect as (pitting) corrosion is present also in these areas.

The corrosion layers consist mainly of Fe and O, indicating atmospheric corrosion with presence of only a very small amount of contaminants/pollution. The scattered white deposit is possibly originating from exposure to calcareous water as it is localized mainly on the interior face of the fragment, where rain water would hit the metal before entering the ground.
