RAIN GUTTER FRAGMENT – GREY CAST IRON – MODERN TIMES – FRANCE

Artefact name	Rain gutter fragment
Authors	Christian. Degriigny (HE-Arc CR, Neuchâtel, Neuchâtel, Switzerland) & Mathea. Hovind (University of Oslo, Department of archaeology, conservation and history (IAKH-UiO), Oslo, Oslo, Norway)
Url	/artefacts/1261/

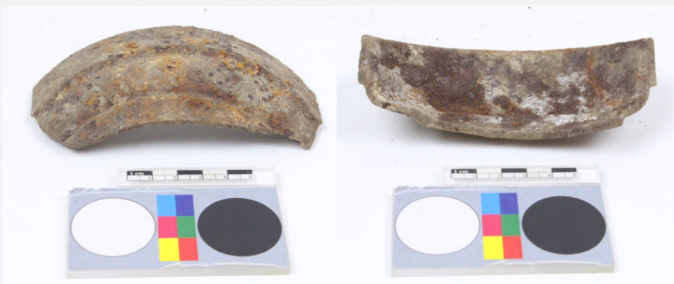
Fig. 1: Rain gutter fragment, exterior and interior faces (to the left and right, respectively),

Description of the artefact	Rain gutter fragment (Fig. 1), possibly part of the extension of a roof drain pipe. Both the exterior and interior surfaces are covered by heterogeneous corrosion crusts. The underlying metal seems however to be well preserved, including features such as a difference in thickness etc. Dimensions: L = 55mm; W (interior) = 120mm; Tmax. = 6mm; WT = 176g.
Type of artefact	Architectural element
Origin	Château de Germolles (14th century), Mellecey, Bourgogne, France
Recovering date	Unknown
Chronology category	Modern Times
chronology tpq	<input type="text" value="1801"/> A.D. ∨
chronology taq	<input type="text" value="2000"/> A.D. ∨
Chronology comment	19th - 20th century
Burial conditions / environment	Outdoor atmosphere

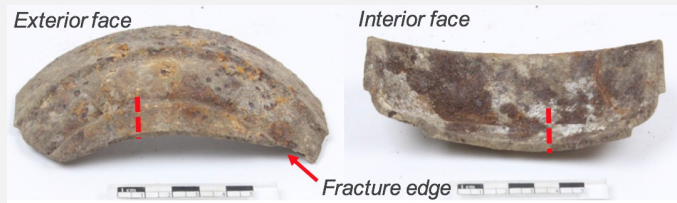
Fig. 2: The exterior and interior faces before sampling. The dotted line represents the sample location (a cross-section of the metal). The fracture edge corresponds to the edge that was formerly attached to the remaining artefact,

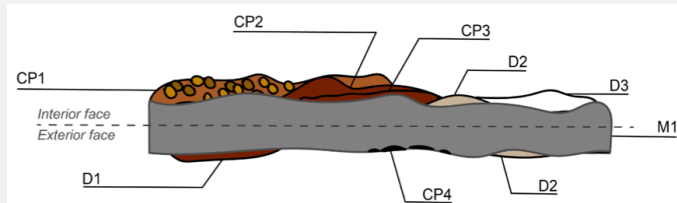
Fig. 3: Preliminary stratigraphy of the corrosion structure based on visual microscopic observation,

Captions	Description
D1	Scattered, orange to dark red encrustations. Probably corrosion products mixed with soil.
D2	Grey-brown and matte deposit, somewhat powdery - possibly corrosion product mixed with soil. This layer is located both on the interior and exterior surface of the artefact.
D3	Localized, white and strongly adherent deposit.
CP1	Bright orange to dark red corrosion product. Uneven surface with pustules.
CP2	Red-brown corrosion crust. Brittle, but adherent. Flakes off in bits when force is applied perpendicular to the surface with a scalpel.
CP3	Similar to CP2 but appears to be an individual layer.
CP4	Isolated corrosion blisters. Circular and black in colour. Mainly located on the exterior surface.
M1	Intact metal with a dark grey metallic sheen.

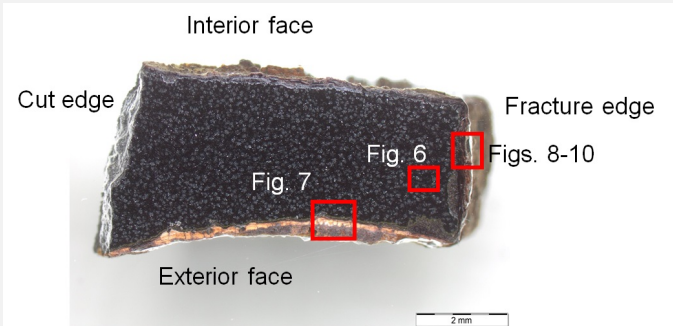
Fig. 4: Micrograph of the sample taken from the rain gutter fragment showing its orientation relative to the artefact and the locations of Figs. 6-10,

The sample consists of a rectangular section (Fig. 4) which was cut out from the fractured edge of the gutter fragment. It is representative of three surfaces: the exterior and interior surface, as well as the fracture edge. Dimensions: L = 7mm; Wmax. = 5mm; Tmax. = 4mm (approx.).

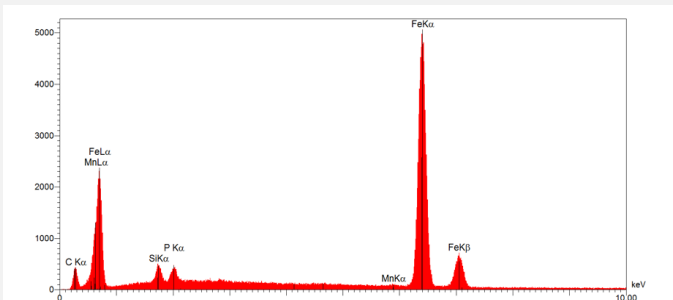
The metal is a P-rich grey cast iron with Si and Mn (Fig. 5). Its microstructure is characterized by evenly distributed graphite flakes in a matrix composed of dendrites and an interdendritic eutectic phase (Fig. 6). What appears to be irregular graphite flakes / porosity is in fact deformed graphite flakes; graphite is soft and prone to destruction by smearing and/or preferential removal during polishing (Scott 1991).

Fig. 5: EDS-spectrum showing the chemical composition of the metal. Method of analysis: SEM-EDS. Lab. of Electronic Microscopy and Microanalysis, Néode, HEI Arc,

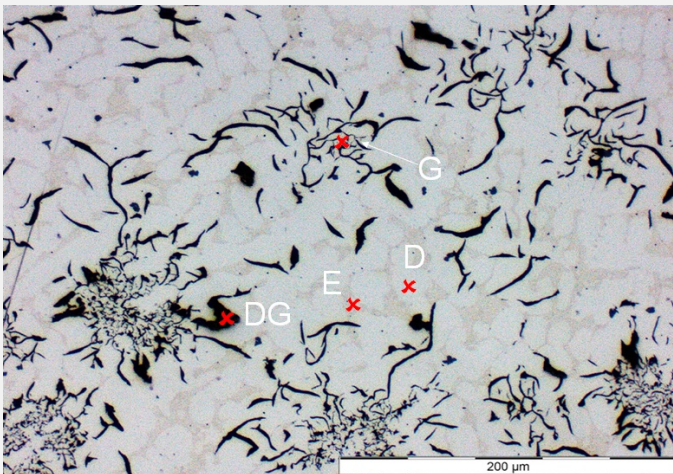
The dendrites appear light grey under polarized light, while the eutectic phase appear light brown (Fig. 6). The eutectic phase is rich in Fe and P and contains small amounts of C and Si, whereas the dendritic phase contains much less P (Table 1).

Fig. 6: Micrograph of the metal sample from Fig. 4 (detail). Unetched, bright field. Graphite flakes (G) in black, the dendrites (D) in light grey and the eutectoid phase (E) in light brown. Deformed graphite (DG) flakes are visible as irregular black inclusions,

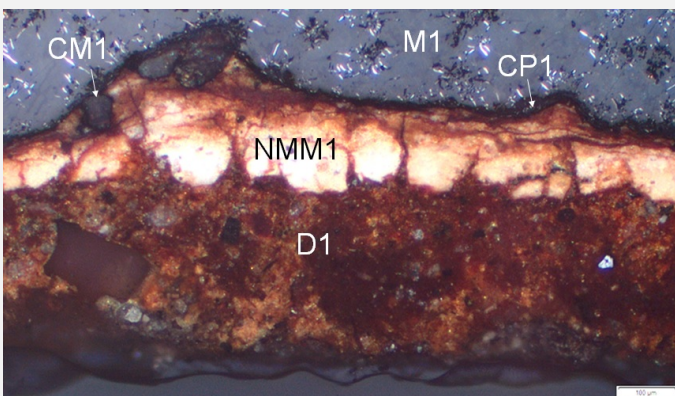
The exterior face (Figs. 2, 4 and 7) consists of a white / light yellow cracked layer (NMM1 in Fig. 7) superimposed by a layer of deposit mixed with orange-red corrosion products (D1 in Fig. 7). Local analysis by SEM-EDS (Table 2) revealed that the white / light yellow layer is rich in Ba, O, S, Fe, C and Zn. It has a chemical composition similar to Lithopone ($BaSO_4, ZnS$), a preparatory paint layer. Fe is probably a contamination from the superimposed porous deposit / corrosion product D1 (Table 2). The latter (D1) is Fe- and O-rich and contains Si, Al and some Ca, in addition to a range of elements (K, P, Na, Cl, S and Ti) present in minor amounts (Table 2). A thin layer of corrosion products (CP1) is located just beneath the paint layer, appearing dark grey under polarized light (Fig. 7). This layer is followed by a corroded metal phase (CM1). Their exact composition was not analyzed but is likely to correspond to the corroded metal phase of the fracture edge, described below.

Fig. 7: Micrograph of the metal sample from Fig. 4 (detail), unetched, polarized light, 5x. Stratigraphy of the exterior surface, to be compared to Fig. 11 and from top to bottom: the metal (M1) in grey, a layer of corroded metal (CM1) followed by a thin layer of CP1, and a white cracked layer (NMM1) superimposed by a porous dark-red deposit (D1),

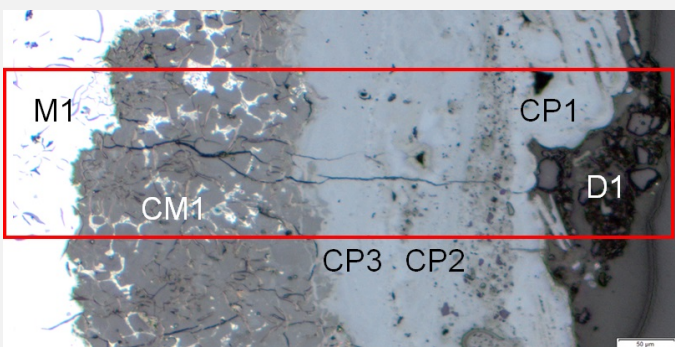
The interior face (Figs. 2 and 4) shows similar characteristics but does not include a white layer similar to NMM1. The fracture edge however (Figs. 2, 4 and 8), shows a more complex stratigraphy consisting of a dense product layer which can be further divided into two individual strata (CP3 and CP2), superimposed by a porous corrosion crust appearing orange under polarized light (CP1) (Fig. 9). The corroded metal (CM1) is located just beneath CP3 and contains remnants of the P-rich eutectic phase (Figs. 8-10). The M/CP ratio (metal to corrosion products) is rather high, implying extensive internal corrosion. Furthermore, cracks are traversing the whole corrosion layers – indicating a fragilization of the structure. As for the composition of the corrosion products CP1, CP2 and CP3, they all contain Fe and O (Fig. 10). A marbling effect within CP2 and CP3 indicates a variation in the concentration of Fe and O (particularly visible in bright field - Fig. 8). The white deposit (D1 in Figs. 8 and 9) might originate from exposure to calcareous water (Table 2). The presence of exogenous elements such as Si, Ca, Al, Na and O (Table 2) was confirmed by elemental mapping (Fig. 10).

Fig. 8: Micrograph of the metal sample from Fig. 4 (detail), unetched, bright field. Stratigraphy of the fracture edge, to be compared to Fig. 12 and from left to right: intact metal (M1) in white, followed by preferentially corroded metal (CM1) and dense product layers (CP3 and CP2) in various shades of grey. CP1 is slightly porous and covered by grain-like particles (D1). The area selected for elemental chemical distribution (Fig. 12) is marked by a red rectangle,

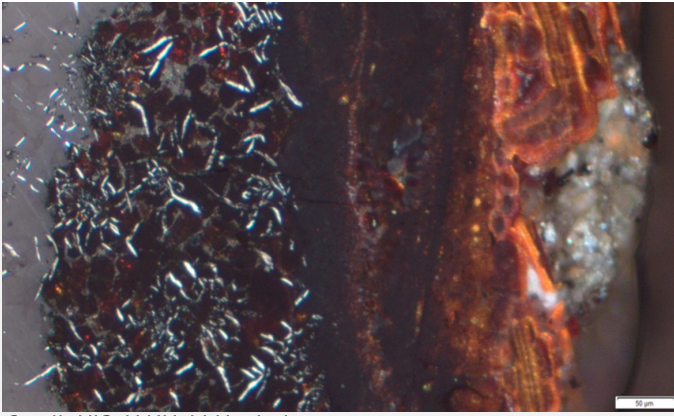
Fig. 9: Micrograph similar to Fig. 8 but under polarized light. The external deposit (D1) appears grey-white, CP1 in bright orange, while CP2 and CP3 appear dark red to brown. The corroded metal (CM1) contains remnants of graphite flakes (in white) and the P-rich eutectic (in grey),

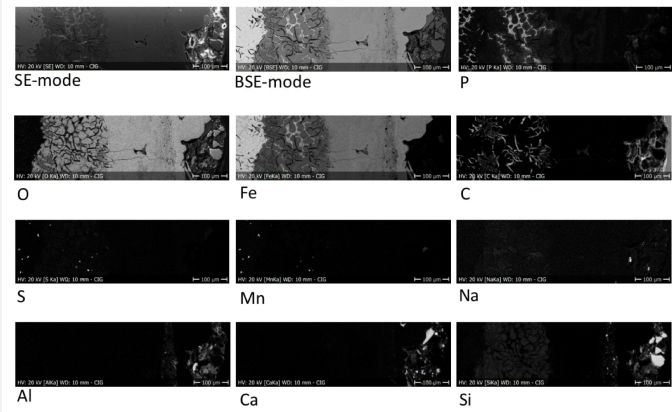
Fig. 10: SEM image and elemental chemical distribution of the selected area from Fig. 8. Method of analysis: SEM-EDS. Lab. of Electronic Microscopy and Microanalysis, Néode, HEI Arc,

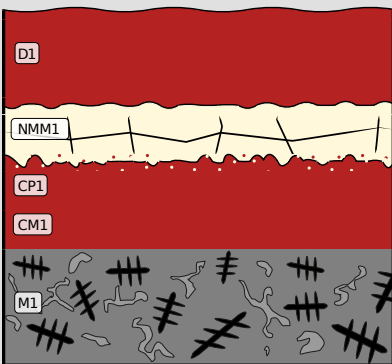
Fig. 11: Stratigraphic representation of the sample taken from the rain gutter fragment in cross-section (dark field) using the MiCorr application. The characteristics of the strata are only accessible by clicking on the drawing that redirects you to the search tool by stratigraphy representation. This representation can be compared to Fig. 7 (exterior surface). CP1 corresponds to CP2 in Fig. 3, Credit UiO-IAKH, M.Hovind.

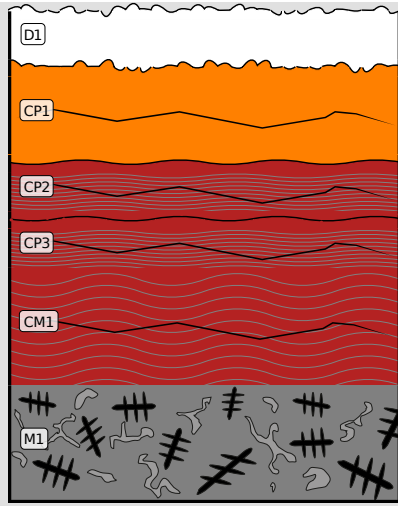
Fig. 12: Stratigraphic representation of the sample taken from the rain gutter fragment in cross-section (dark field) using the MiCorr application. The characteristics of the strata are only accessible by clicking on the drawing that redirects you to the search tool by stratigraphy representation. This representation can be compared to Figs. 8 and 9 (fracture

edge). D1 corresponds to D3 in Fig. 3, Credit UiO-IAKH, M.Hovind.

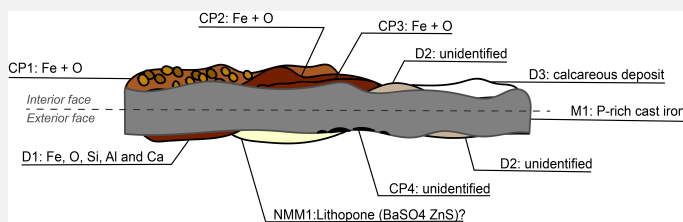
Fig. 13: Improved stratigraphic representation of the rain gutter fragment based on analysis from cross-section and visual microscopic observation,

The rain gutter fragment is a grey cast iron with a microstructure consisting of graphite flakes and a P-rich eutectic phase. The corrosion layers of the exterior surface contains a preparatory paint layer, located beneath a layer of iron corrosion products mixed with soil. It seems likely that the cast iron gutter has been covered with a protective paint layer (e.g. Lithopone) to slow down the rate of atmospheric corrosion. The presence of Lithopone reinforces the suggested dating of the artefact (20th century) as this pigment was developed and used from the 1880s and onwards (Lithopone 2007). However, it seems that the protective layer has none or only very limited effect as (pitting) corrosion is present also in these areas.

The corrosion layers consist mainly of Fe and O, indicating atmospheric corrosion with presence of only a very small amount of contaminants/pollution. The scattered white deposit is possibly originating from exposure to calcareous water as it is localized mainly on the interior face of the fragment, where rain water would hit the metal before entering the ground.
