# FUNERAL MASK IVC 11595 - CU/AG, WITH SURFACE ENRICHMENT (AG) - UNKNOWN

Artefact name Funeral mask IVc 11595

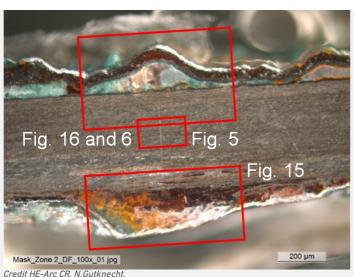
Fig. 4: Micrograph of the cross-section of the sample temporarily taken from the detached fragment of Fig. 2 showing the locations of Figs. 15 (corresponding to the front of the funeral mask), 16 (back of the funeral mask), 5 and 6,

Description of sample A polished section was made from an already detached fragment that was temporarily embedded in resin (Fig. 2). On Fig. 4 the

upper part of the sample corresponds to the back face of the funeral mask while the lower part corresponds to its front face. Both

sides have developed subsequent layers of corrosion. In areas, these have buckled and become detached.

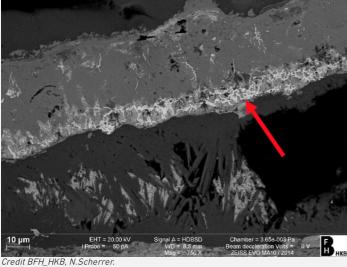
The SEM/EDS analysis of the core metal shows that there are Cu-rich phases alternating with Ag-rich phases. There are inclusions of Pb and As (Fig. 5). The surface of the metal has been decuprified (Fig. 6) according to the tumbaga making process (Scott 2000 and McEwan 2000). This pre-Columbian repeatedly hammered and annealed the metal, which would create a copper oxide scale on the surface. The latter was then dissolved in acidic plant juices (Scott 2000). This process was repeated until the surface was enriched with silver, giving it the appearance of a silver artefact.

A layer of mercury can be seen with EDS (Figs. 6 and 7). Mercury was not used by the pre-Columbians in metallic form (Scott 2000 and McEwan 2000) but was common as a pigment in form of mercury sulfide (cinnabar).

Fig. 6: SEM image (BSE-mode) of the metal sample from Fig. 4 with detail (Fig. 7) indicated by the left red rectangle. The selected area for elemental chemical distribution (Fig. 8) is marked by the right red rectangle,

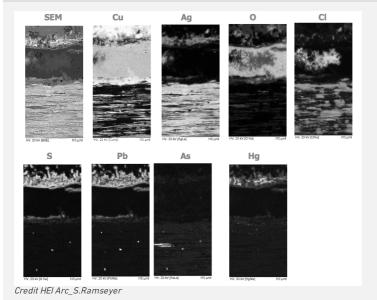
The remaining metal shows a preferential corrosion of copper and the presence of chlorides throughout the entier corroded metal, most likely in the form of Cu and Ag corrosion products (Fig. 8, Table 1). There is a preferential corrosion of copper that has fragilized the structure of the sheet metal.

Fig. 8: SEM image (BSE-mode) and elemental chemical distribution of the selected area on Fig. 6. Method of examination: SEM/EDS,

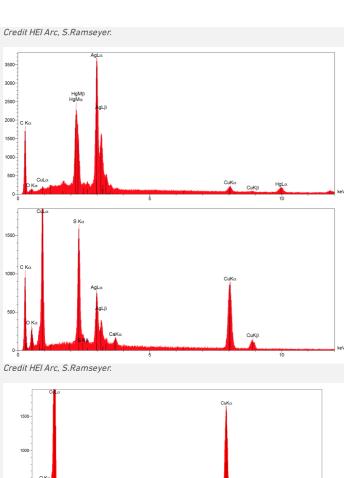
Figs. 10: EDS analysis of the layer that appears light grey under polarized light, situated below the red layer (Fig. 4). Method of analysis: SEM-EDS, Lab of Electronic Microscopy and Microanalysis, IMA (Néode), HEI Arc,

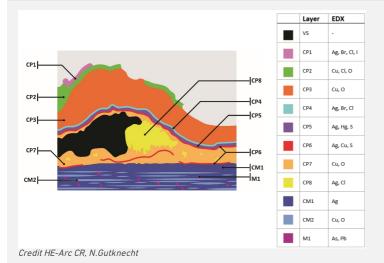
Fig. 17: Improved stratigraphic representation of the funeral mask (Fig. 3) based on the results from the SEM-EDS analyses,

The artefact is a repeatedly hammered, annealed and pickled Cu-Ag tumbaga. The cuprite and hydroxicarbonate layers and the presence of chlorides are typical for the corrosion of tumbaga alloys in an archaeological context. Cinnabar has been identified as pigment applied to the surface before burial. Over the centuries, it was partially incorporated into the growing copper corrosion layers.

Close to the enriched silver surface and below the cuprite layer a silver- and mercury-rich stratum has formed. Only one publication mentions the reaction of cinnabar with a gold-enriched tumbaga surface but does not go into details about the possible mechanism involved (Masuda 1997).

The presence of a silver-sulphur compound below this silver-mercury stratum could indicate that the cinnabar was reduced by electrochemical processes to mercury, releasing sulphur that reacted with the silver enriched surface. The mercury itself formed a silver-mercury layer above the latter. More research is needed to fully comprehend this phenomenon.
