# FUNERAL MASK IVC 11595 – CU/AG, WITH SURFACE ENRICHMENT (AG) – UNKNOWN

Artefact name	Funeral mask IVC 11595
Authors	Christian. Degryny (HE-Arc CR, Neuchâtel, Neuchâtel, Switzerland) & Naima. Gutknecht (HE-Arc CR, Neuchâtel, Neuchâtel, Switzerland) & Valentin. Boissonnas (HE-Arc CR, Neuchâtel, Neuchâtel, Switzerland)
Url	/artefacts/1262/

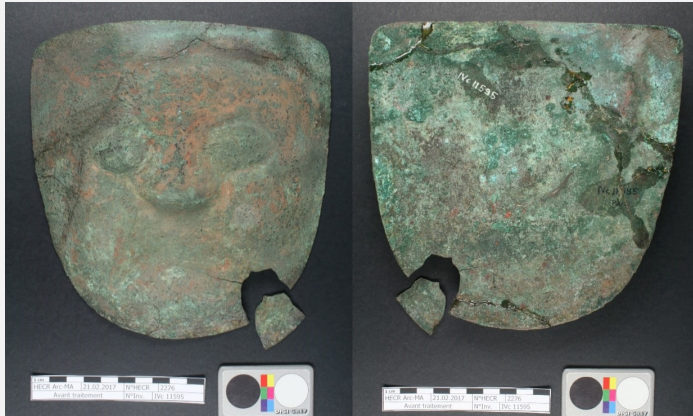
Fig. 1: Funeral mask, front and back face to the left and right respectively,

Description of the artefact	Peruvian funeral mask (Fig. 1). There are remains of red pigment and of a mineralised textile on both sides of the object. It is heavily corroded in green and red corrosion layers. It is deformed and broken. Dimensions: Length = 180mm; Width = 170mm; Height = 20 mm; WT = 158,6g.
Type of artefact	Funeral mask
Origin	Peru, north coast
Recovering date	Date of excavation unknown, acquisition in 1967
Chronology category	Unknown
chronology tpq	<input type="text"/> ---- ▼
chronology taq	<input type="text"/> 1500 A.D. ▼
Chronology comment	Tpq: unknown.
Burial conditions / environment	Unknown
Artefact location	Museum der Kulturen, Basel
Owner	Museum der Kulturen, Basel
Inv. number	IVC 11595
Recorded conservation data	N/A

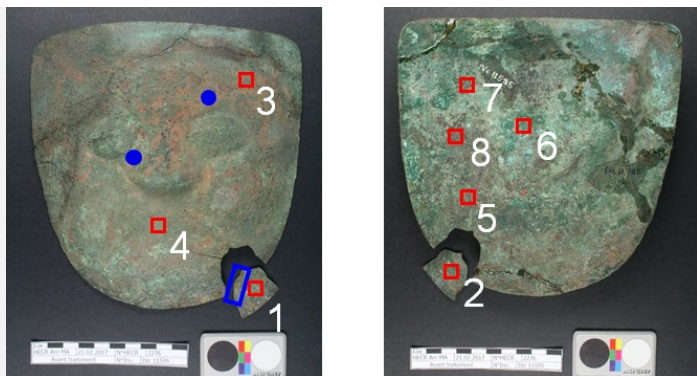
Fig. 2: Front (left) and back (right) faces showing the location of XRF analyses (red squares), sampling areas for SEM-EDS (blue points) and sampling area for examination on cross-section (blue rectangle),

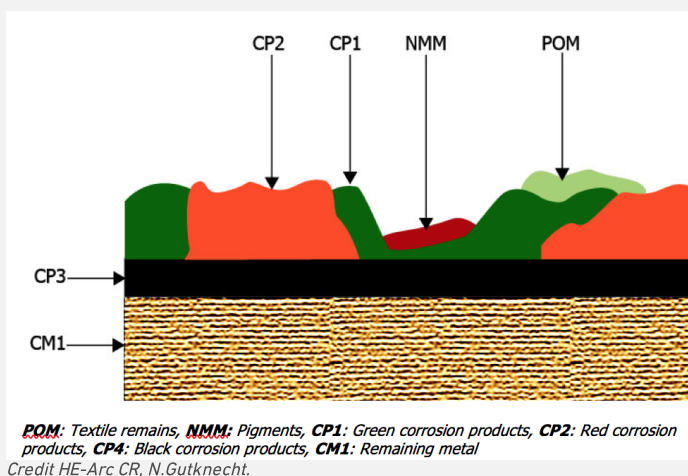
Fig. 3a: Stratigraphic representation of the front face of the funeral mask by visual macroscopic observation,

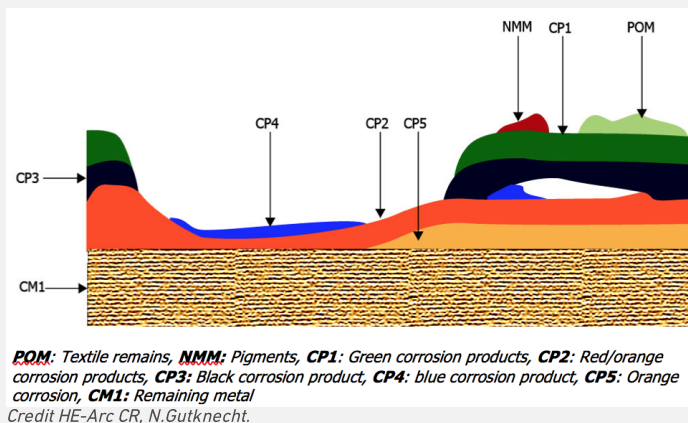
Fig. 3b: Stratigraphic representation of the back face of the funeral mask by visual macroscopic observation,

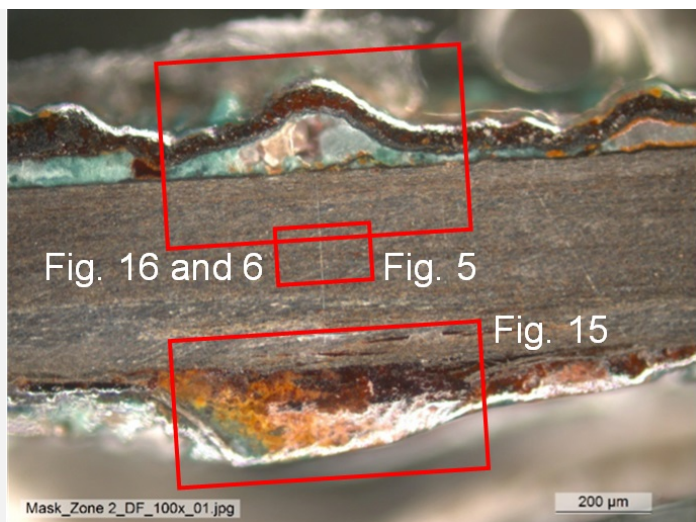
Fig. 4: Micrograph of the cross-section of the sample temporarily taken from the detached fragment of Fig. 2 showing the locations of Figs. 15 (corresponding to the front of the funeral mask), 16 (back of the funeral mask), 5 and 6,

A polished section was made from an already detached fragment that was temporarily embedded in resin (Fig. 2). On Fig. 4 the upper part of the sample corresponds to the back face of the funeral mask while the lower part corresponds to its front face. Both sides have developed subsequent layers of corrosion. In areas, these have buckled and become detached.

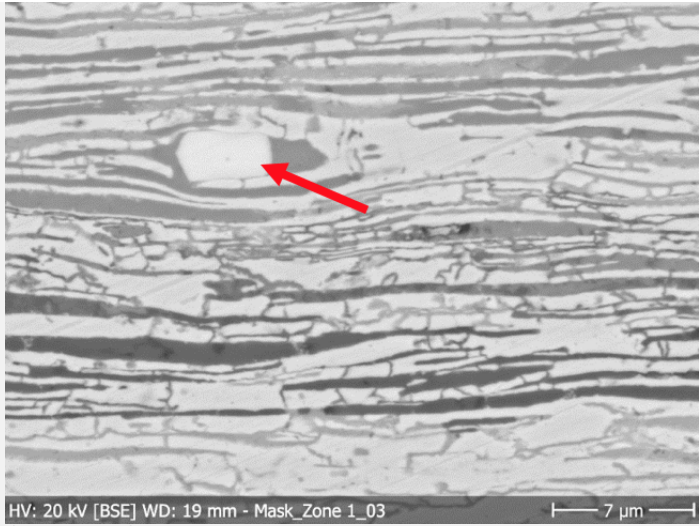
The SEM/EDS analysis of the core metal shows that there are Cu-rich phases alternating with Ag-rich phases. There are inclusions of Pb and As (Fig. 5). The surface of the metal has been decuprified (Fig. 6) according to the tumbaga making process (Scott 2000 and McEwan 2000). This pre-Columbian repeatedly hammered and annealed the metal, which would create a copper oxide scale on the surface. The latter was then dissolved in acidic plant juices (Scott 2000). This process was repeated until the surface was enriched with silver, giving it the appearance of a silver artefact.

Fig. 5: SEM image (BSE-mode) of the metal sample from Fig. 4 (detail), the elongated grains are the result of repeated hammering. Absence of strain lines indicates that the

metal is annealed. The darker areas are Cu-rich phases and the lighter areas are Ag-rich phases. The arrow shows an As- and Pb inclusion,

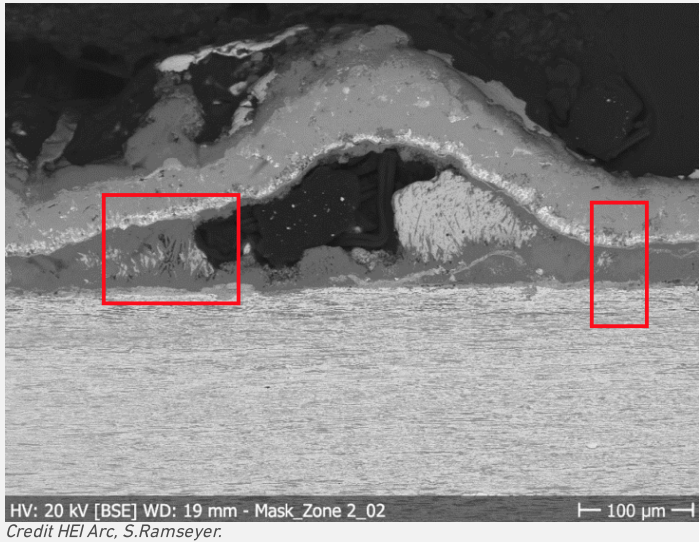
A layer of mercury can be seen with EDS (Figs. 6 and 7). Mercury was not used by the pre-Columbians in metallic form (Scott 2000 and McEwan 2000) but was common as a pigment in form of mercury sulfide (cinnabar).

Fig. 6: SEM image (BSE-mode) of the metal sample from Fig. 4 with detail (Fig. 7) indicated by the left red rectangle. The selected area for elemental chemical distribution (Fig. 8) is marked by the right red rectangle,

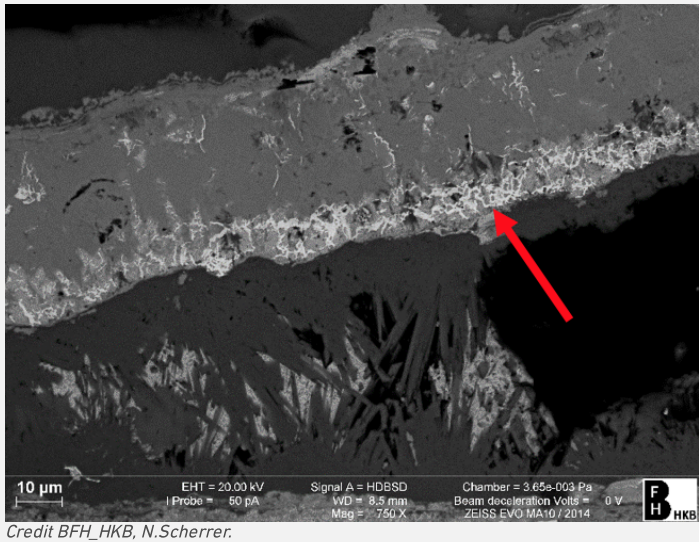
Fig. 7: SEM image of a partially refilled structural void with a silver-, copper- and mercury-rich layer (red arrow),

The silver sulphide (HgS, cinnabar, Fig. 13), present as a red pigment on the silver surface, could have been reduced through an electrochemical process in the presence of chlorides (Keune 2005). The released sulfur recombined with the silver to form black silver sulphide. Above that layer a porous mercury- and silver rich stratum has formed (see Hg & Ag on cartography Fig. 8). It remains unclear if the limitos is located in the silver enriched surface or within this silver-mercury compound (Fig. 7).

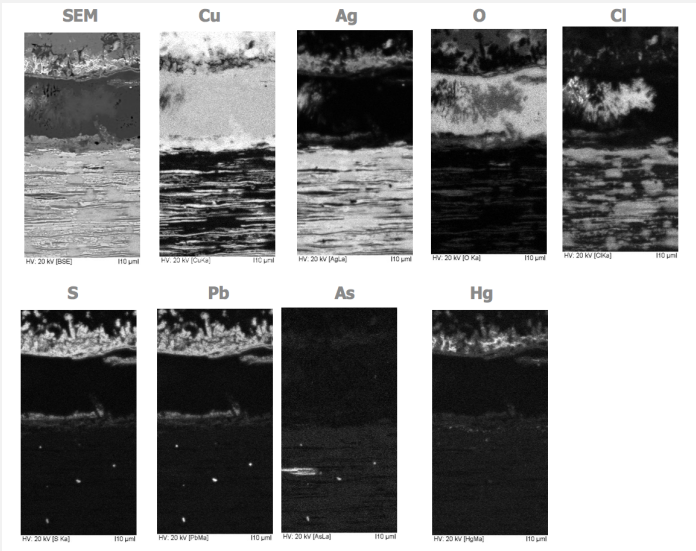
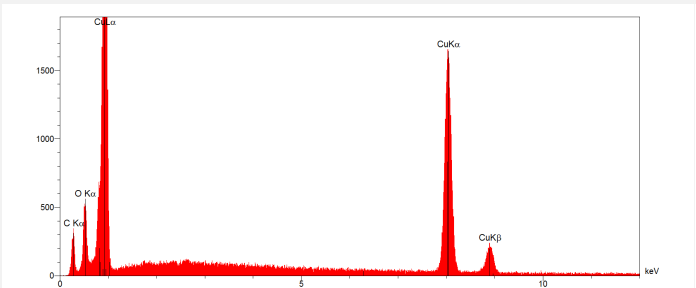
The remaining metal shows a preferential corrosion of copper and the presence of chlorides throughout the entire corroded metal, most likely in the form of Cu and Ag corrosion products (Fig. 8, Table 1). There is a preferential corrosion of copper that has fragilized the structure of the sheet metal.

Fig. 8: SEM image (BSE-mode) and elemental chemical distribution of the selected area on Fig. 6. Method of examination: SEM/EDS,

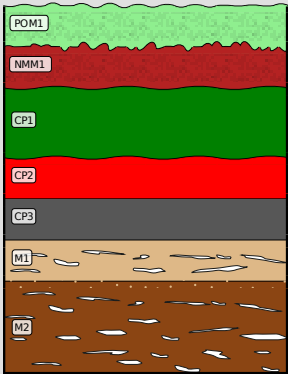
Fig. 15: Stratigraphic representation of the cross-section (dark field) from Figs. 3a or 4 (front of the object) using the MiCorr application. The characteristics of the strata are only accessible by clicking on the drawing that redirects you to the search tool by stratigraphy representation, Credit HE-Arc CR, N. Gutknecht.

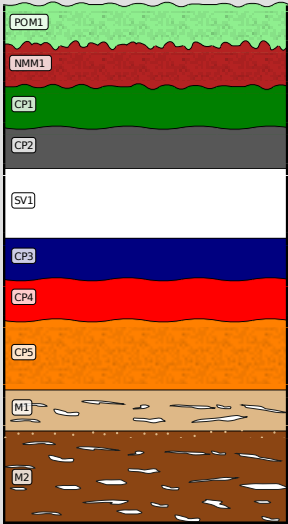
Fig. 16: Stratigraphic representation of the cross-section (dark field) from Figs. 3b and 4 (back of the object) using the MiCorr application. CP2 is CP3 while CP3 is CP4 and CP4 is CP2 in Fig. 3b. The characteristics of the strata are only accessible by clicking on the drawing that redirects you to the search tool by stratigraphy representation, Credit HE-Arc CR, N. Gutknecht.

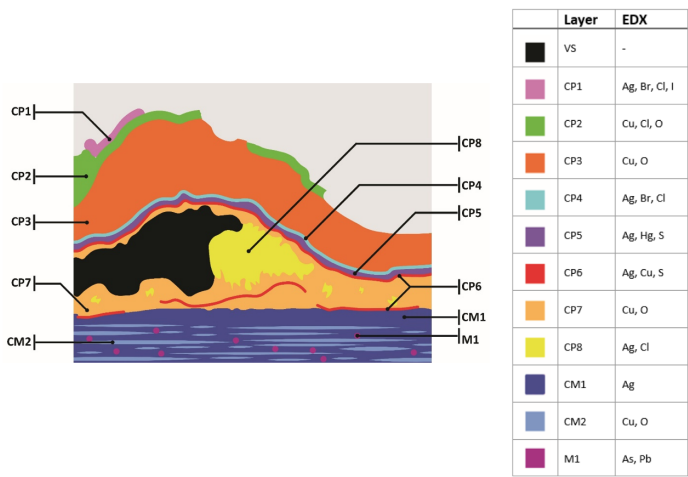
Fig. 17: Improved stratigraphic representation of the funeral mask (Fig. 3) based on the results from the SEM-EDS analyses,

The artefact is a repeatedly hammered, annealed and pickled Cu-Ag tumbaga. The cuprite and hydroxycarbonate layers and the presence of chlorides are typical for the corrosion of tumbaga alloys in an archaeological context. Cinnabar has been identified as pigment applied to the surface before burial. Over the centuries, it was partially incorporated into the growing copper corrosion layers.

The presence of a silver-sulphur compound below this silver-mercury stratum could indicate that the cinnabar was reduced by electrochemical processes to mercury, releasing sulphur that reacted with the silver enriched surface. The mercury itself formed a silver-mercury layer above the latter. More research is needed to fully comprehend this phenomenon.
