FUNERAL MASK IVC 11595 – CU/AG, WITH SURFACE ENRICHMENT (AG) – UNKNOWN

Artefact name	Funeral mask IVC 11595
Authors	Christian. Degriy (HE-Arc CR, Neuchâtel, Neuchâtel, Switzerland) & Naima. Gutknecht (HE-Arc CR, Neuchâtel, Neuchâtel, Switzerland) & Valentin. Boissonnas (HE-Arc CR, Neuchâtel, Neuchâtel, Switzerland)
Url	/artefacts/1262/

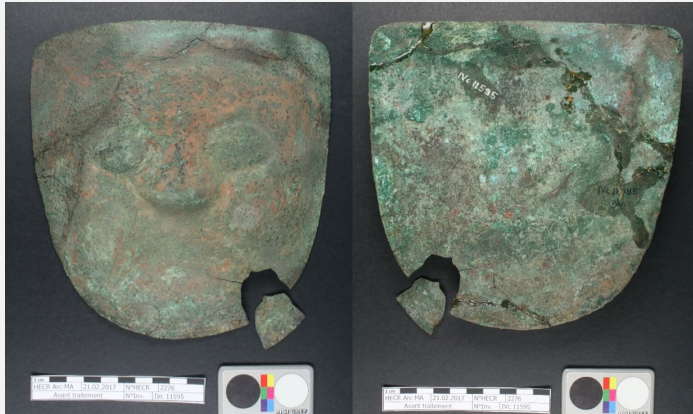
Fig. 1: Funeral mask, front and back face to the left and right respectively,

Description of the artefact	Peruvian funeral mask (Fig. 1). There are remains of red pigment and of a mineralised textile on both sides of the object. It is heavily corroded in green and red corrosion layers. It is deformed and broken. Dimensions: Length = 180mm; Width = 170mm; Height = 20 mm; WT = 158,6g.
Type of artefact	Funeral mask
Origin	Peru, north coast
Recovering date	Date of excavation unknown, acquisition in 1967
Chronology category	Unknown
chronology tpq	<input type="text"/> ---- ▼
chronology taq	<input type="text"/> 1500 A.D. ▼
Chronology comment	Tpq: unknown.
Burial conditions / environment	Unknown
Artefact location	Museum der Kulturen, Basel
Owner	Museum der Kulturen, Basel
Inv. number	IVC 11595
Recorded conservation data	N/A

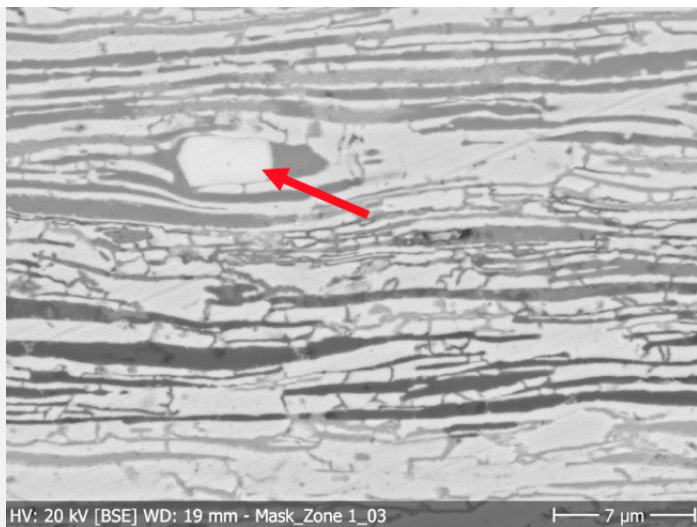
The SEM/EDS analysis of the core metal shows that there are Cu-rich phases alternating with Ag-rich phases. There are inclusions of Pb and As (Fig. 5). The surface of the metal has been decuprified (Fig. 6) according to the tumbaga making process (Scott 2000 and McEwan 2000). This pre-Columbian repeatedly hammered and annealed the metal, which would create a copper oxide scale on the surface. The latter was then dissolved in acidic plant juices (Scott 2000). This process was repeated until the surface was enriched with silver, giving it the appearance of a silver artefact.

Fig. 5: SEM image (BSE-mode) of the metal sample from Fig. 4 (detail), the elongated grains are the result of repeated hammering. Absence of strain lines indicates that the

metal is annealed. The darker areas are Cu-rich phases and the lighter areas are Ag-rich phases. The arrow shows an As- and Pb inclusion,

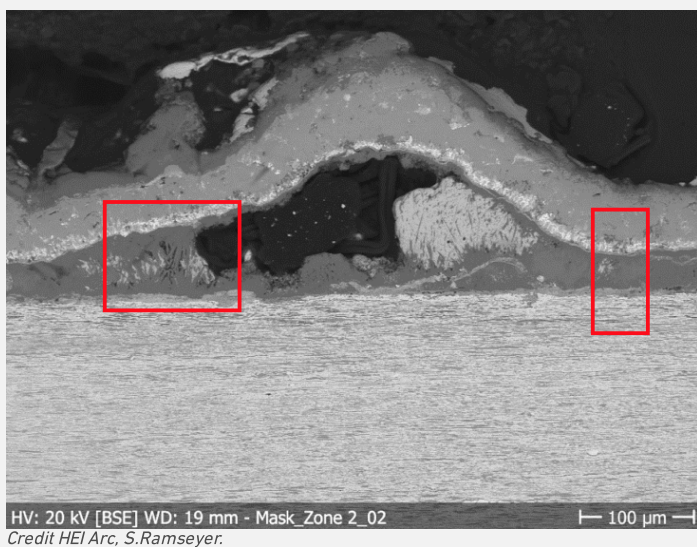
A layer of mercury can be seen with EDS (Figs. 6 and 7). Mercury was not used by the pre-Columbians in metallic form (Scott 2000 and McEwan 2000) but was common as a pigment in form of mercury sulfide (cinnabar).

Fig. 6: SEM image (BSE-mode) of the metal sample from Fig. 4 with detail (Fig. 7) indicated by the left red rectangle. The selected area for elemental chemical distribution (Fig. 8) is marked by the right red rectangle,

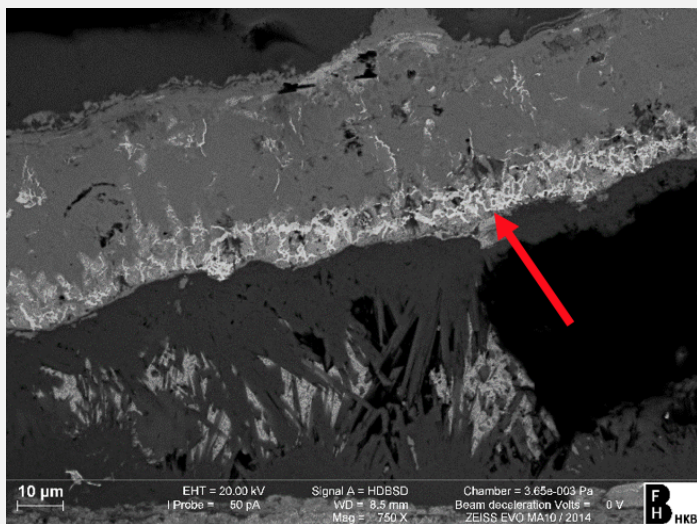
Fig. 7: SEM image of a partially refilled structural void with a silver-, copper- and mercury-rich layer (red arrow),

The silver sulphide (HgS, cinnabar, Fig. 13), present as a red pigment on the silver surface, could have been reduced through an electrochemical process in the presence of chlorides (Keune 2005). The released sulfur recombined with the silver to form black silver sulphide. Above that layer a porous mercury- and silver rich stratum has formed (see Hg & Ag on cartography Fig. 8). It remains unclear if the limitos is located in the silver enriched surface or within this silver-mercury compound (Fig. 7).

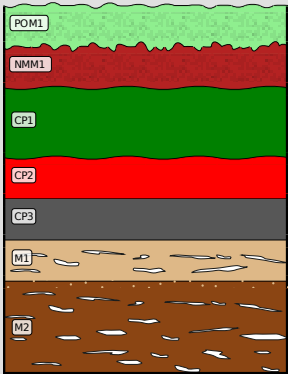
Fig. 15: Stratigraphic representation of the cross-section (dark field) from Figs. 3a or 4 (front of the object) using the MiCorr application. The characteristics of the strata are only accessible by clicking on the drawing that redirects you to the search tool by stratigraphy representation, Credit HE-Arc CR, N. Gutknecht.

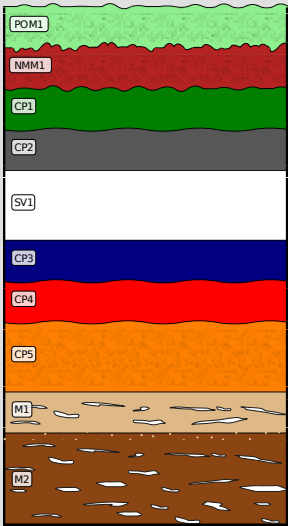
Fig. 16: Stratigraphic representation of the cross-section (dark field) from Figs. 3b and 4 (back of the object) using the MiCorr application. CP2 is CP3 while CP3 is CP4 and CP4 is CP2 in Fig. 3b. The characteristics of the strata are only accessible by clicking on the drawing that redirects you to the search tool by stratigraphy representation, Credit HE-Arc CR, N. Gutknecht.

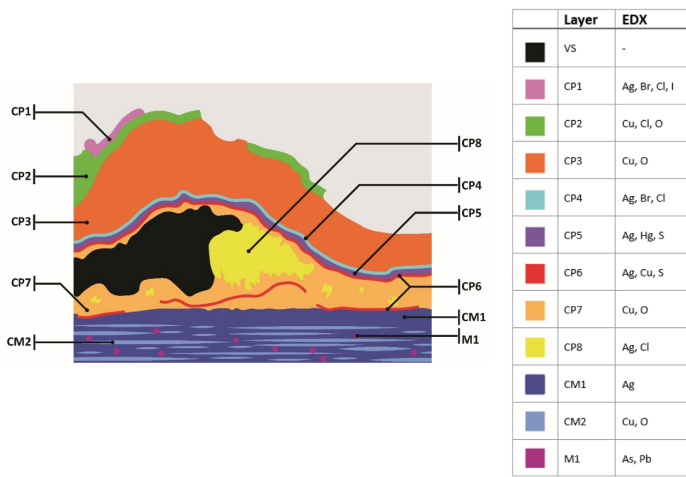
Fig. 17: Improved stratigraphic representation of the funeral mask (Fig. 3) based on the results from the SEM-EDS analyses,

The artefact is a repeatedly hammered, annealed and pickled Cu-Ag tumbaga. The cuprite and hydroxycarbonate layers and the presence of chlorides are typical for the corrosion of tumbaga alloys in an archaeological context. Cinnabar has been identified as pigment applied to the surface before burial. Over the centuries, it was partially incorporated into the growing copper corrosion layers.
