# VOTIVE FIGURE OF A BAT IVB4168 – GILDED BRASS – MODERN TIMES

**Artefact name** Votive figure of a bat IVb4168

**Authors** Christian. Degriigny (HE-Arc CR, Neuchâtel, Neuchâtel, Switzerland) & Naima. Gutknecht (HE-Arc CR, Neuchâtel, Neuchâtel, Switzerland) & Valentin. Boissonnas (HE-Arc CR, Neuchâtel, Neuchâtel, Switzerland)

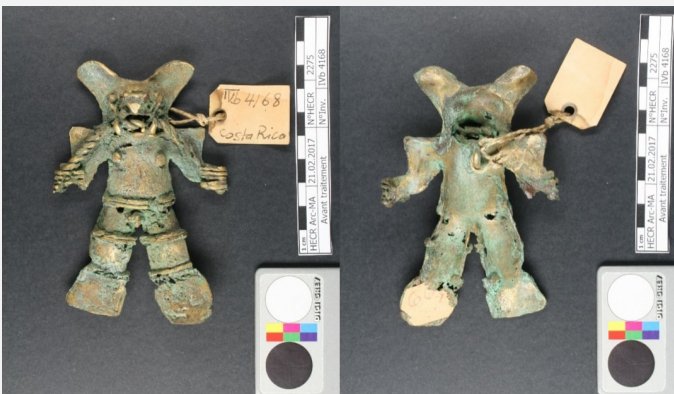
Fig. 1: Votive figure of a bat, front (left) and back (right) view,

**Description of the artefact** The object represents a bat-like figure holding and chewing a rope (Fig. 1). There are remains of a surface gilding. The object has a red-brown adherent layer where the gold has flaked off with a heterogenous green and white loosely bound layer on top. Dimensions: Length = 110 mm; Width = 73mm; Height = 25mm; WT = 60g.

The metal seems to have been heavily attacked (acid dissolution). There are several perforations on the lower part of the object, and where the gold layer is absent the surface is unevenly pitted by corrosion (Figs. 1, 2 and 7). The submetallic core is not visible from the surface.

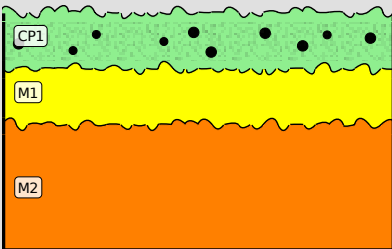
Fig 5: Stratigraphic representation of the corrosion structure of area 1 (Fig. 4) observed macroscopically under binocular microscope using the MiCorr application. The characteristics of the strata are only accessible by clicking on the drawing that redirects you to the search tool by stratigraphy representation, Credit HE-Arc CR, N.Gutknecht.

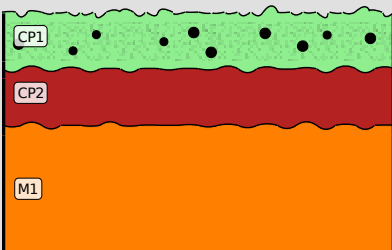
Fig. 6: Stratigraphic representation of the corrosion structure of area 2 (Fig. 4) observed macroscopically under binocular microscope using the MiCorr application. M1 is M2 in Fig. 5. The characteristics of the strata are only accessible by clicking on the drawing that redirects you to the search tool by stratigraphy representation, Credit HE-Arc CR, N.Gutknecht.

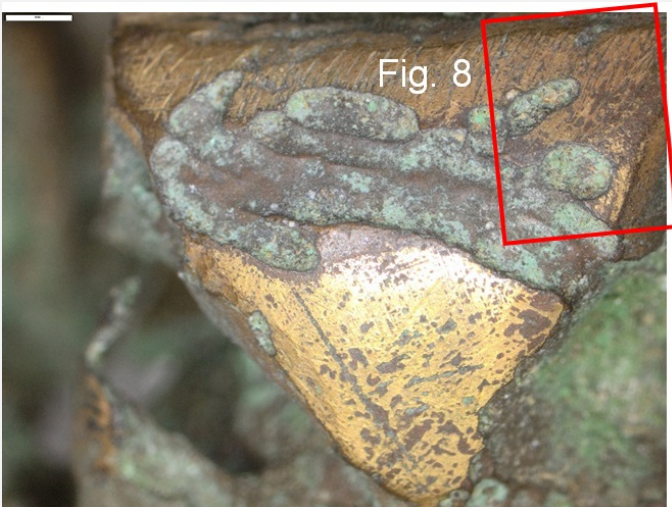
There are two corrosion products (Figs. 7 and 8). The red one (CP2) has a submetallic brightness and is opaque, non-magnetic, compact, hard and adherent. It is very thin (less than a few microns thick) and only appears where the gold layer has been lost. The EDX spectrum (Fig. 9) shows that it is a Cu- and O rich product, probably cuprite ( $\text{Cu}_2\text{O}$ ).

The light green to white corrosion product (CP1) has a waxy consistency and is thin, translucent, non-magnetic, powdery and very soft. It is very loosely bound. It is distributed on the whole object (front and back) as disparate clumps. It is mainly located on the cavities and irregularities of the surface. FTIR analyses (ATR mode) of both green and white areas of CP1 have similar spectra and were identified as copper nitrate (Fig. 10).

Fig. 7: Binocular image of the nose of the bat showing detail of Fig. 8,

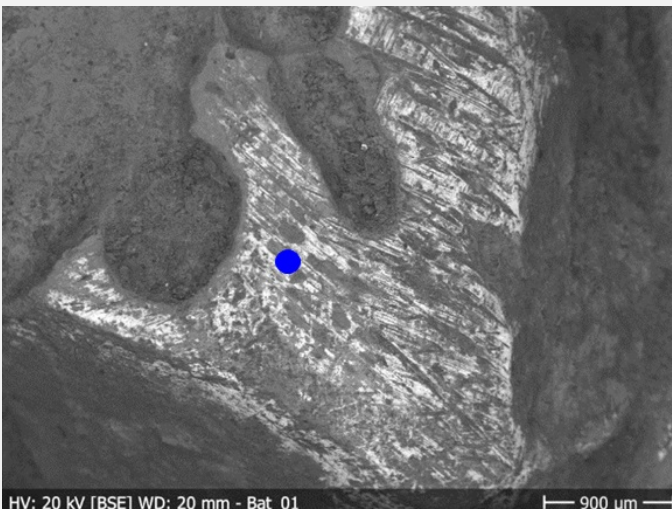
Figs. 8: SEM images of the metal on the nose of the bat. The blue point represents the area for the EDS point analysis (Fig. 9),

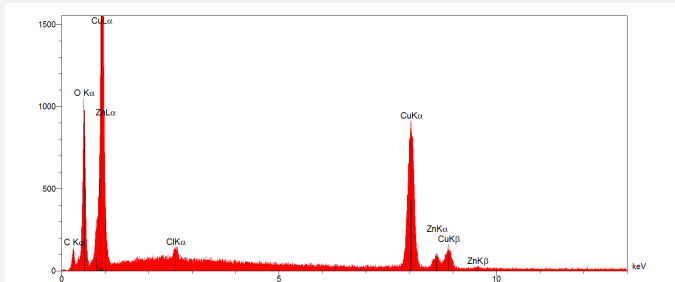
Fig. 9: EDS analysis of the red corrosion product. Method of analysis: SEM-EDS, Lab of Electronic Microscopy and Microanalysis, Néode, HEI Arc,

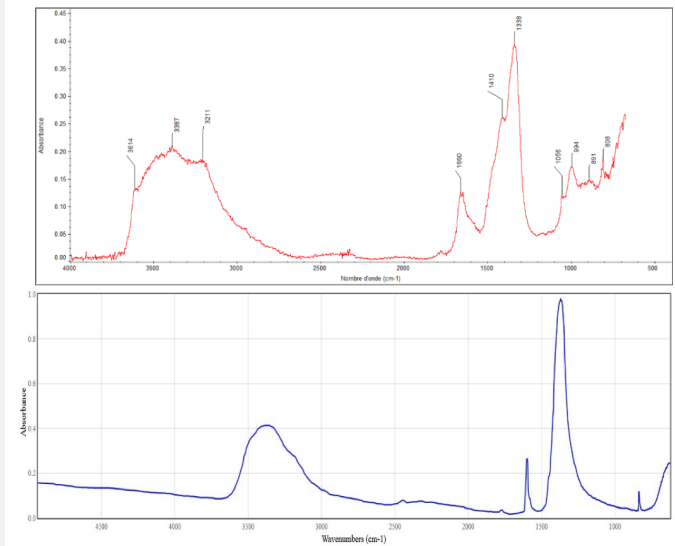
Fig. 10: FTIR spectrum (ATR mode) of the white corrosion product product (top), and of synthesized copper nitrate (Cu(NO3)2 \* 3H2O) (bottom),

FTIR analysis of the green/white corrosion product suggests that it is a copper nitrate, a highly water soluble corrosion product that cannot be found in an archaeological context. However, it has been recorded on artificially patinated copper alloys (Scott 2000; Craddock 2009).

The dissolution of the metal and the subsequent formation of the patina is most likely the result of a forced attack with concentrated nitric acid. The holes and pits in the metal are unnatural for a natural corrosion process which would produce a stratified, adherent and thick corrosion crust (Craddock 2009). The copper nitrates could have formed over time from residual acidic solution that was left on the surface. The lack of an archaeological context, the modern alloy composition and the presence of copper nitrates on the unnaturally pitted surface suggest the object being a forgery made in modern times.
