# LEAD CAMES OF A STAINED GLASS WINDOW 52583 – PB SB ALLOY – UNKNOWN – SWITZERLAND

**Artefact name** Lead comes of a stained glass window 52583

**Authors** Alice Gerber. (Haute École Arc Neuchâtel, Neuchâtel, Neuchâtel, Switzerland)

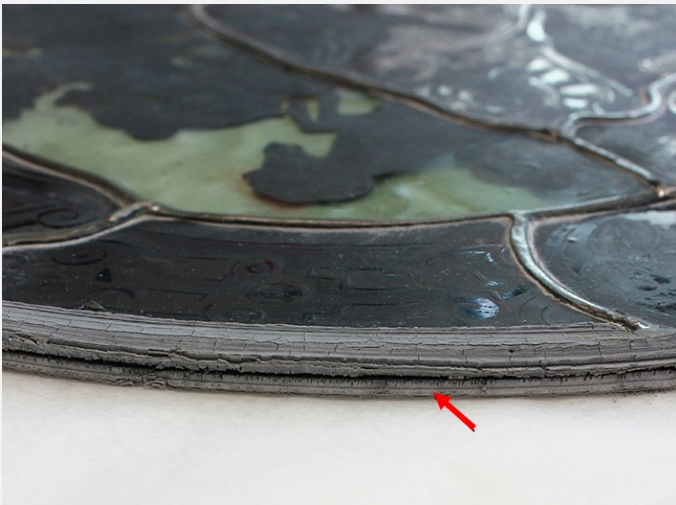
In 2009 two stained glass panels were placed in a showcase for a permanent exhibition, the lead came were then in a good conservation condition. In 2018, the lead showed voluminous efflorescence of white, powdery corrosion products.

The environment of this showcase contained a high level of acetic acid. Lead being sensitive to organic acids, it corroded strongly. This is not new, but what is interesting here is that the two objects corroded in a very heterogeneous way. One lead came may be deformed and completely covered with bulky white efflorescences, and the one next to it shows no corrosion.

The "stokar" window, which is of interest here, was restored in 2008, just before it was put on display. The restoration consisted of replacing some of the lead comes. Thus, while the object is dated to the 16th century, the replaced comes were new when they entered the display case. In 2018, they were completely corroded. In comparison, the other stained glass panel, with older lead comes, was placed in the same display case at the same time. For this second panel, the comes are slightly corroded in 2018, but not as badly as those of the 'Stokar' panel. The metal chosen by the restorer reacted more strongly with the corrosive environment (the display case) than the historical metal.

Fig. 2: Corroded "modern" lead came on the "Stokar" stained glass panel with location of the sampling area,

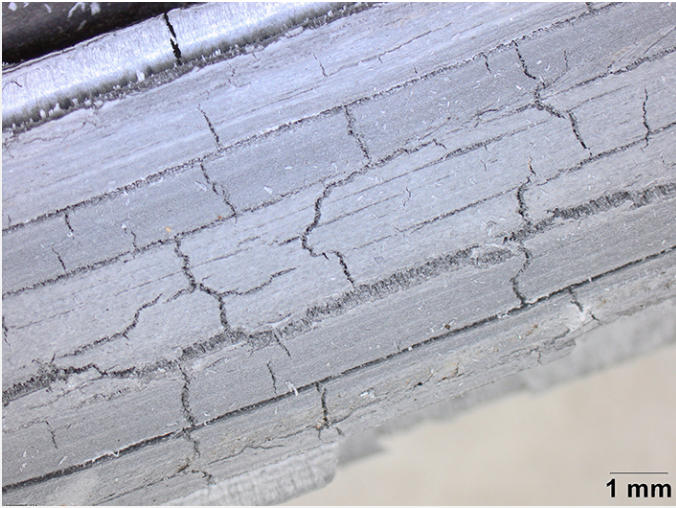
Fig. 3: Detail of the corroded lead came,

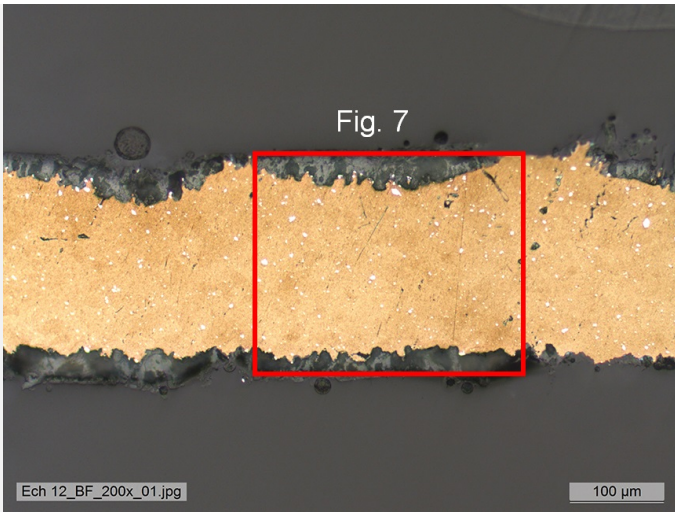
Fig. 5: Micrograph of the cross-section of the corroded lead came with location of Fig. 7, unetched, dark field. The grains of the metal are slightly visible, and the light-coloured dots in the alloy are inclusions,

<b>Description of sample</b>	The sample is a piece of metal taken from the corroded lead came of the stained glass (Fig. 2). This came was replaced during the 2009 restoration. The purpose was to understand why this new metal has been completely corroded in a few years (Fig. 2, 3 and 5), while the historical metal next to it is not affected at all.
<b>Alloy</b>	Pb Sb alloy
<b>Technology</b>	Cast and cold worked
<b>Lab number of sample</b>	None
<b>Sample location</b>	HE-Arc CR, Neuchâtel, Neuchâtel
<b>Responsible institution</b>	HE-Arc CR, Neuchâtel, Neuchâtel
<b>Date and aim of sampling</b>	None

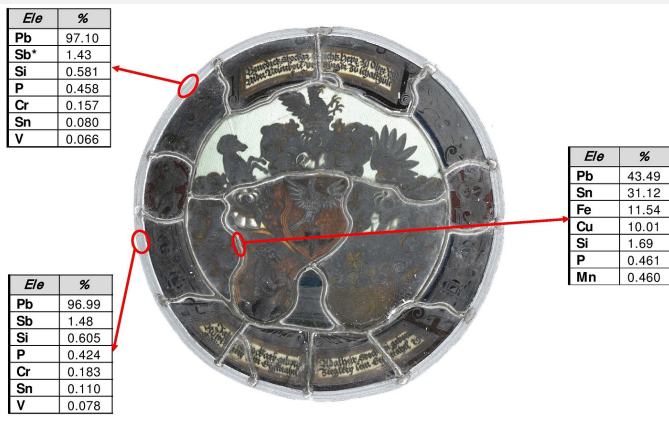
Fig. 6: XRF analyses of a selection of the comes,

XRF analyses of the different lead comes of the "Stokar" stained glass panel showed that the tin (Sn) content is very variable from one came to another (Fig. 6). Those with a very low Sn but a high Sb (1.4%) contents are much more corroded.

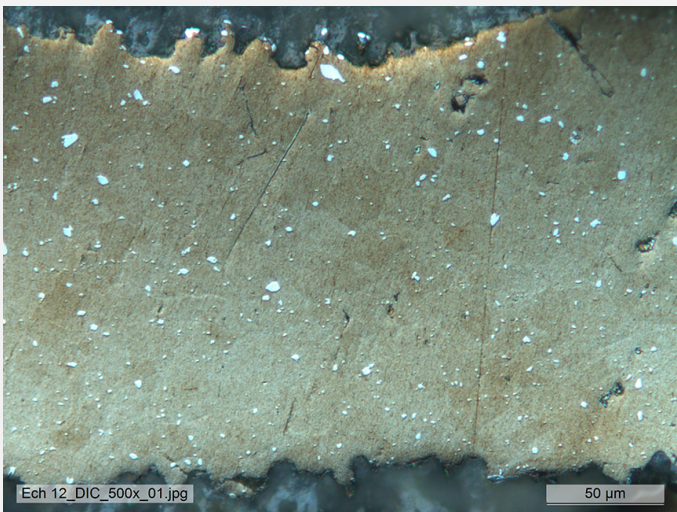
Fig. 7: Micrograph (detail of Fig. 5), unetched, dark field,

The lead alloy contains approximately 1.5% antimony. The grains of the metal are slightly visible, even without etching. The light-coloured dots in the alloy are Sb-rich inclusions (Fig. 7).

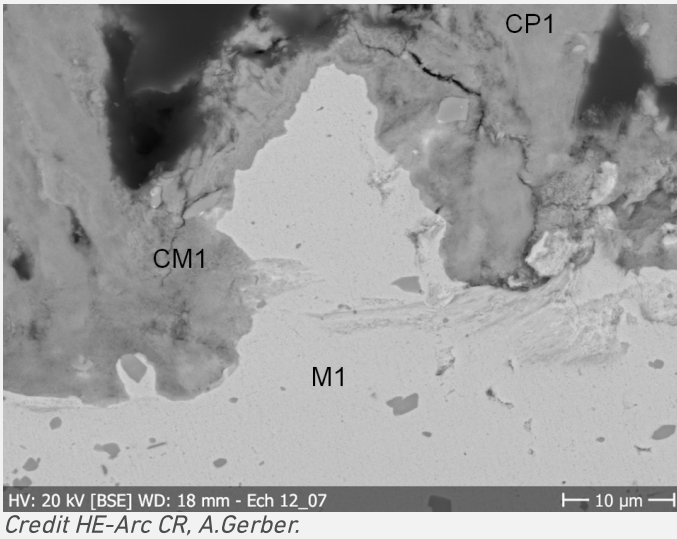
Corrosion develops specifically on comes made of a lead-antimony alloy, where antimony inclusions constitute the cathode (0.150 V/SHE) versus lead (-0.125 V/SHE) which corrodes as an anode in presence of lead acetate (the electrolyte). Fig. 8 shows that corrosion does not attack the antimony nodules in the alloy, it progresses by mineralizing the lead around these nodules.

CP1 seems to be a heterogeneous compound as indicated on Figs. 8 and 9. It is heavily cracked (Fig. 9). EDX analyses do not indicate a significant difference in composition. The attack of lead by organic acids causes the formation of salts, such as lead acetate which are then transformed into basic lead carbonates by the action of CO<sub>2</sub> from the environment as indicated by FTIR analysis of CP1.

Fig. 8: SEM image (BSE mode) of a detail of the cross-section of the corroded lead came. The area in light grey is the metal, the corrosion is in darker grey with a blurred appearance. Sb-dots are dark grey. Corrosion progresses around them, without mineralising them,

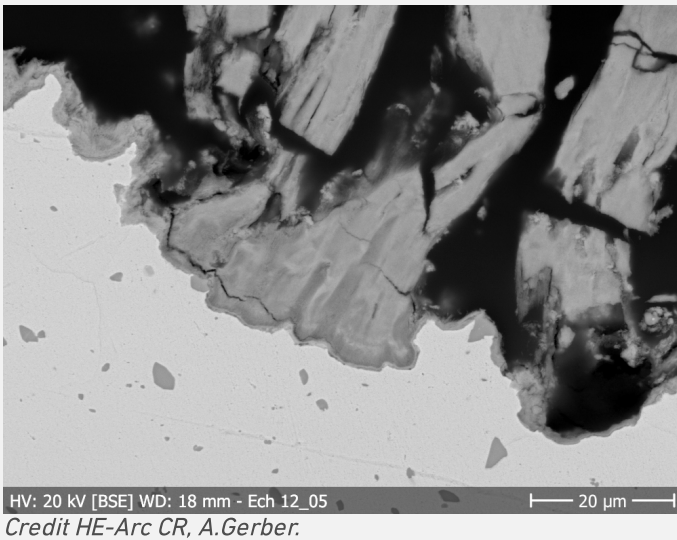
Fig. 9: SEM image (BSE mode) of the cross-section of the corroded lead came,

Fig. 11 shows an optimised stratigraphic representation of the corrosion structure. It is to be noted that CP1, CP2 and CP3 although visible on some cross-sections (Fig. 9) could not be differentiated by analysis.

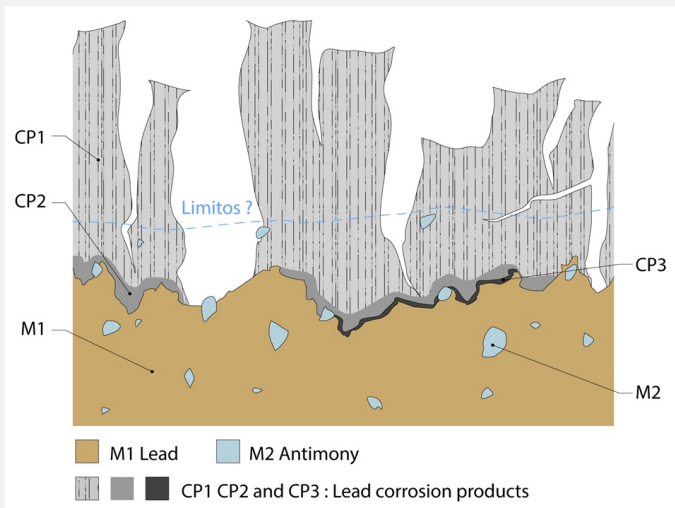
The limit of the original surface lies somewhere in the corrosion layers. Antimony nodules are inferior markers of the limit of the original surface.

Fig. 11: Optimised stratigraphic representation of a corroded lead came integrating additional information based on the analyses carried out,
