LEAD CAMES OF A STAINED GLASS WINDOW 52583 – PB SB ALLOY – UNKNOWN – SWITZERLAND

Artefact name Lead comes of a stained glass window 52583

Authors Alice Gerber. (Haute École Arc Neuchâtel, Neuchâtel, Neuchâtel, Switzerland)

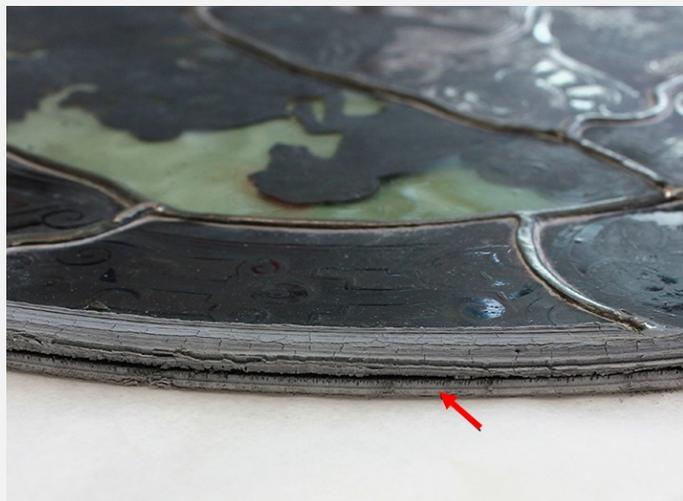
The "stokar" window, which is of interest here, was restored in 2008, just before it was put on display. The restoration consisted of replacing some of the lead came. Thus, while the object is dated to the 16th century, the replaced came were new when they entered the display case. In 2018, they were completely corroded. In comparison, the other stained glass panel, with older lead came, was placed in the same display case at the same time. For this second panel, the came are slightly corroded in 2018, but not as badly as those of the 'Stokar' panel. The metal chosen by the restorer reacted more strongly with the corrosive environment (the display case) than the historical metal.

Fig. 2: Corroded "modern" lead came on the "Stokar" stained glass panel with location of the sampling area,

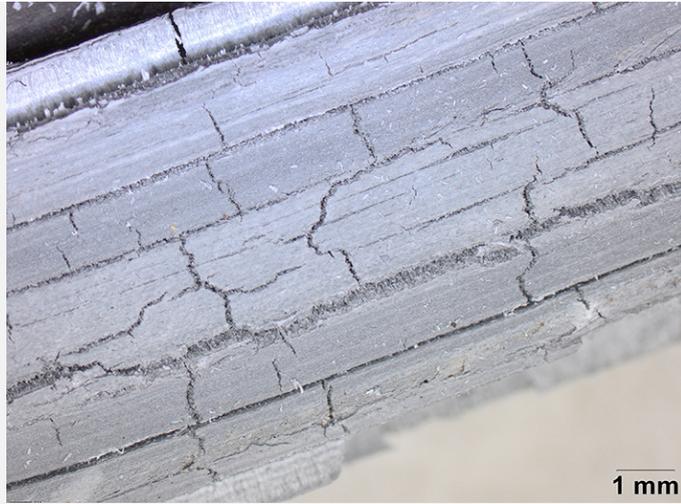
Fig. 3: Detail of the corroded lead came,

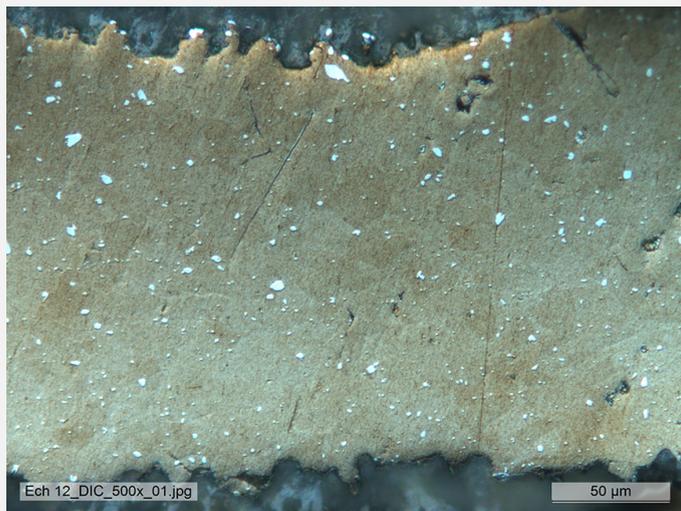
The lead alloy contains approximately 1.5% antimony. The grains of the metal are slightly visible, even without etching. The light-coloured dots in the alloy are Sb-rich inclusions (Fig. 7).

Fig. 7: Micrograph (detail of Fig. 5), unetched, dark field,

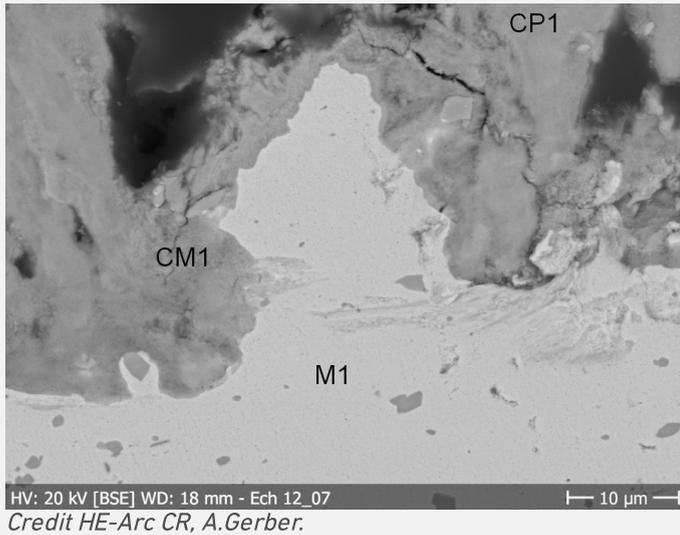
Corrosion develops specifically on comes made of a lead-antimony alloy, where antimony inclusions constitute the cathode (0.150 V/SHE) versus lead (-0.125 V/SHE) which corrodes as an anode in presence of lead acetate (the electrolyte). Fig. 8 shows that corrosion does not attack the antimony nodules in the alloy, it progresses by mineralizing the lead around these nodules.

CP1 seems to be a heterogeneous compound as indicated on Figs. 8 and 9. It is heavily cracked (Fig. 9). EDX analyses do not indicate a significant difference in composition. The attack of lead by organic acids causes the formation of salts, such as lead acetate which are then transformed into basic lead carbonates by the action of CO₂ from the environment as indicated by FTIR analysis of CP1.

Fig. 8: SEM image (BSE mode) of a detail of the cross-section of the corroded lead came. The area in light grey is the metal, the corrosion is in darker grey with a blurred appearance. Sb-dots are dark grey. Corrosion progresses around them, without mineralising them,

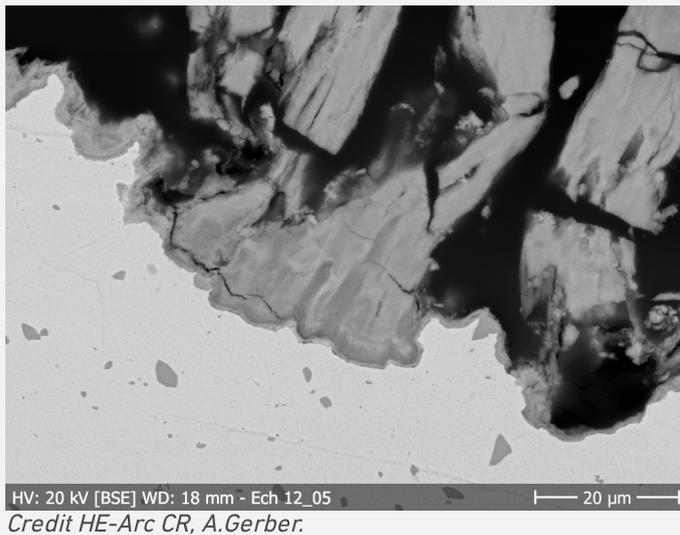
Fig. 9: SEM image (BSE mode) of the cross-section of the corroded lead came,

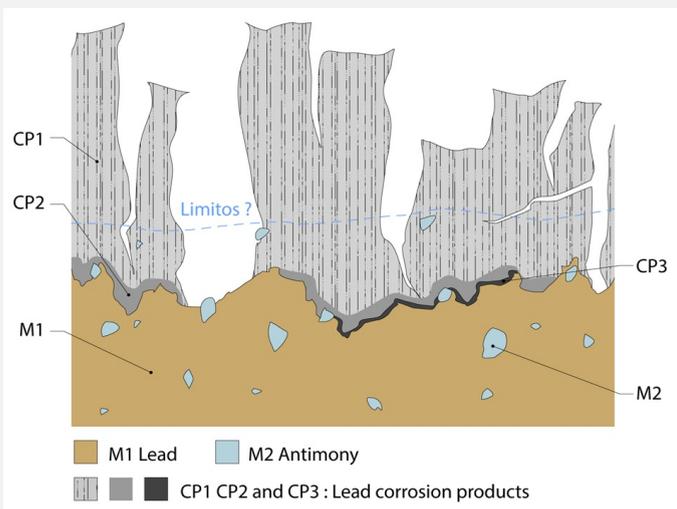
Fig. 11 shows an optimised stratigraphic representation of the corrosion structure. It is to be noted that CP1, CP2 and CP3 although visible on some cross-sections (Fig. 9) could not be differentiated by analysis.

The limit of the original surface lies somewhere in the corrosion layers. Antimony nodules are inferior markers of the limit of the original surface.

Fig. 11: Optimised stratigraphic representation of a corroded lead came integrating additional information based on the analyses carried out,
