LEAD CAMES OF A STAINED GLASS WINDOW 52583 – PB SB ALLOY – UNKNOWN – SWITZERLAND

Artefact name Lead comes of a stained glass window 52583

Authors Alice Gerber. (Haute École Arc Neuchâtel, Neuchâtel, Neuchâtel, Switzerland)

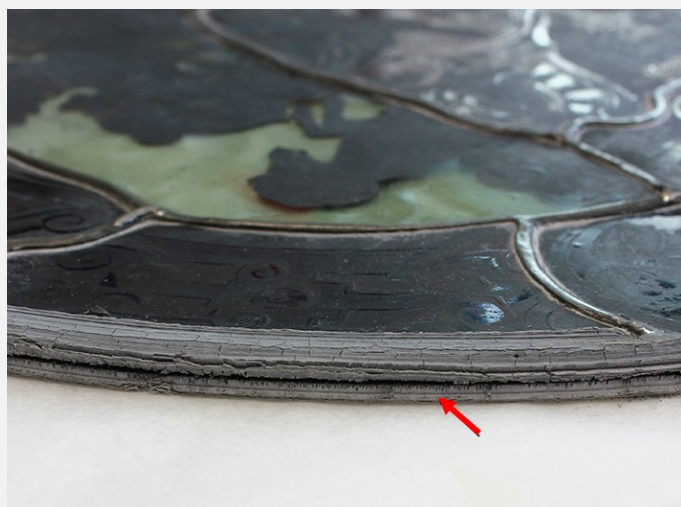
In 2009 two stained glass panels were placed in a showcase for a permanent exhibition, the lead came were then in a good conservation condition. In 2018, the lead showed voluminous efflorescence of white, powdery corrosion products.

The environment of this showcase contained a high level of acetic acid. Lead being sensitive to organic acids, it corroded strongly. This is not new, but what is interesting here is that the two objects corroded in a very heterogeneous way. One lead came may be deformed and completely covered with bulky white efflorescences, and the one next to it shows no corrosion.

The "stokar" window, which is of interest here, was restored in 2008, just before it was put on display. The restoration consisted of replacing some of the lead came. Thus, while the object is dated to the 16th century, the replaced came were new when they entered the display case. In 2018, they were completely corroded. In comparison, the other stained glass panel, with older lead came, was placed in the same display case at the same time. For this second panel, the came are slightly corroded in 2018, but not as badly as those of the 'Stokar' panel. The metal chosen by the restorer reacted more strongly with the corrosive environment (the display case) than the historical metal.

Fig. 2: Corroded "modern" lead came on the "Stokar" stained glass panel with location of the sampling area,

The sample is a piece of metal taken from the corroded lead came of the stained glass (Fig. 2). This came was replaced during the 2009 restoration. The purpose was to understand why this new metal has been completely corroded in a few years (Fig. 2, 3 and 5), while the historical metal next to it is not affected at all.

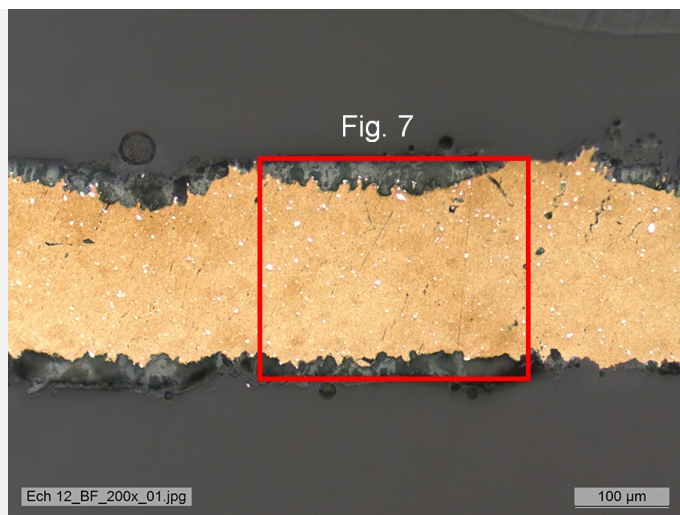
Fig. 5: Micrograph of the cross-section of the corroded lead came with location of Fig. 7, unetched, dark field. The grains of the metal are slightly visible, and the light-coloured dots in the alloy are inclusions,

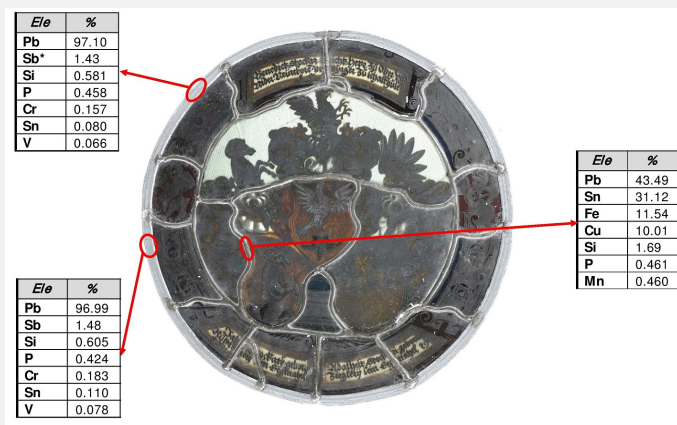
XRF analyses of the different lead comes of the "Stokar" stained glass panel showed that the tin (Sn) content is very variable from one came to another (Fig. 6). Those with a very low Sn but a high Sb (1.4%) contents are much more corroded.

Fig. 6: XRF analyses of a selection of the comes,

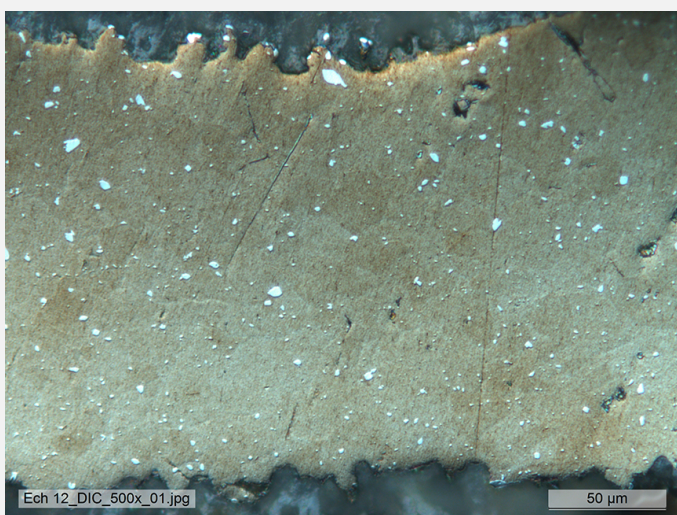
The lead alloy contains approximately 1.5% antimony. The grains of the metal are slightly visible, even without etching. The light-coloured dots in the alloy are Sb-rich inclusions (Fig. 7).

Fig. 7: Micrograph (detail of Fig. 5), unetched, dark field,
