LEAD CAMES OF A STAINED GLASS WINDOW 52583 – PB SB ALLOY – UNKNOWN – SWITZERLAND

Artefact name Lead comes of a stained glass window 52583

Authors Alice Gerber. (Haute École Arc Neuchâtel, Neuchâtel, Neuchâtel, Switzerland)

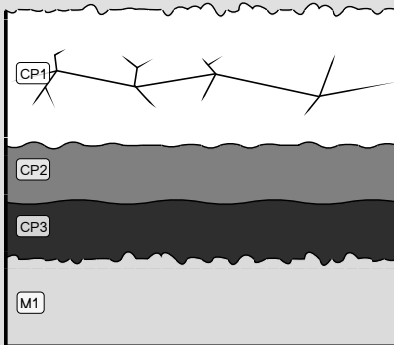
Fig. 4: Stratigraphic representation of the corrosion structure of the lead came observed macroscopically under binocular microscope using the MiCorr application. The characteristics of the strata are only accessible by clicking on the drawing that redirects you to the search tool by stratigraphy representation, Credit HE-Arc CR, A.Gerber.

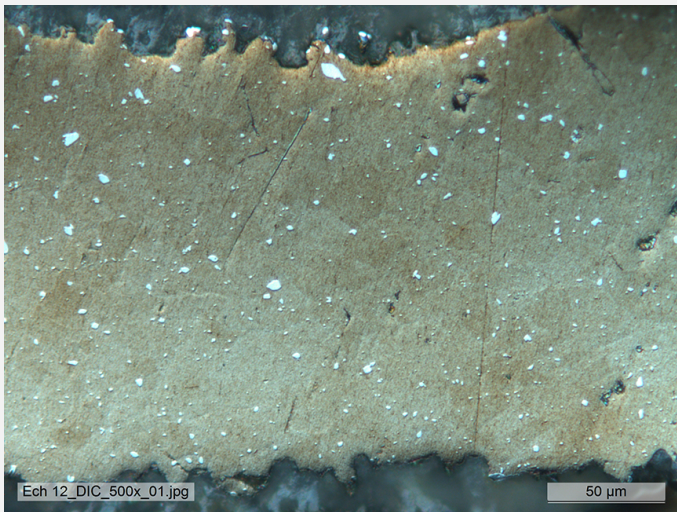
The lead alloy contains approximately 1.5% antimony. The grains of the metal are slightly visible, even without etching. The light-coloured dots in the alloy are Sb-rich inclusions (Fig. 7).

Fig. 7: Micrograph (detail of Fig. 5), unetched, dark field,

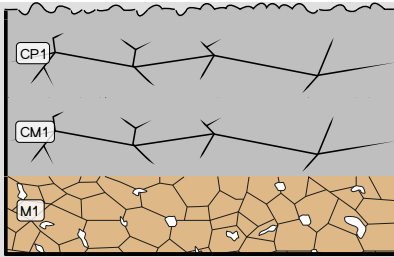
Fig. 10: Stratigraphic representation of the lead came in cross-section (dark field) using the MiCorr application with reference to Fig. 8. The characteristics of the strata are only accessible by clicking on the drawing that redirects you to the search tool by stratigraphy representation, Credit HE-Arc CR, A.Gerber.
