# LEAD CAMES OF A STAINED GLASS WINDOW 52583 – PB SB ALLOY – UNKNOWN – SWITZERLAND

**Artefact name** Lead comes of a stained glass window 52583

**Authors** Alice Gerber. (Haute École Arc Neuchâtel, Neuchâtel, Neuchâtel, Switzerland)

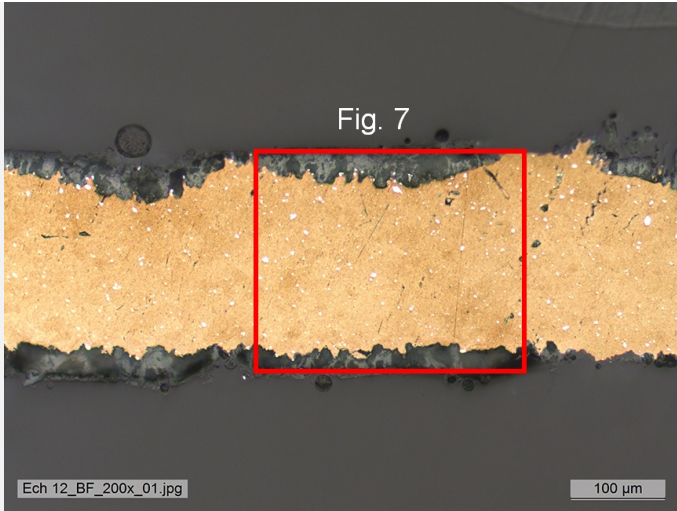
Fig. 5: Micrograph of the cross-section of the corroded lead came with location of Fig. 7, unetched, dark field. The grains of the metal are slightly visible, and the light-coloured dots in the alloy are inclusions,

<b>Description of sample</b>	The sample is a piece of metal taken from the corroded lead came of the stained glass (Fig. 2). This came was replaced during the 2009 restoration. The purpose was to understand why this new metal has been completely corroded in a few years (Fig. 2, 3 and 5), while the historical metal next to it is not affected at all.
<b>Alloy</b>	Pb Sb alloy
<b>Technology</b>	Cast and cold worked
<b>Lab number of sample</b>	None
<b>Sample location</b>	HE-Arc CR, Neuchâtel, Neuchâtel
<b>Responsible institution</b>	HE-Arc CR, Neuchâtel, Neuchâtel
<b>Date and aim of sampling</b>	None
