# SACRIFICIAL KNIFE (TUMI) IVC 24745 – CU ALLOY – UNKNOWN – PERU

**Artefact name** Sacrificial knife (tumi) Ivc 24745

**Authors** Christian. Degriigny (HE-Arc CR, Neuchâtel, Neuchâtel, Switzerland) & Marion. Billot (HE-Arc CR, Neuchâtel, Neuchâtel, Switzerland) & Valentin. Boissonnas (HE-Arc CR, Neuchâtel, Neuchâtel, Switzerland)

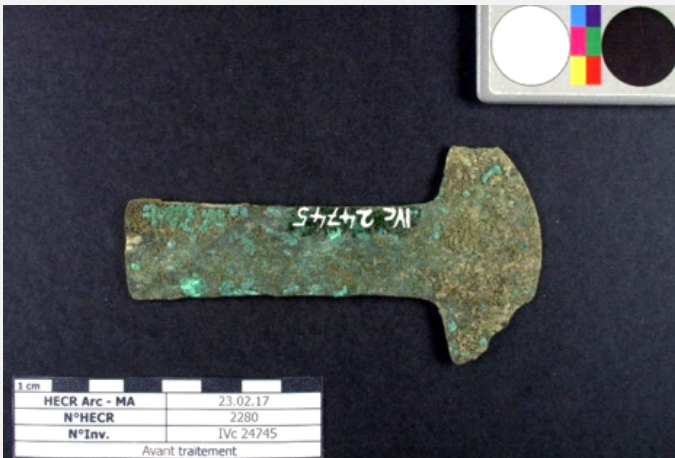
Fig. 1: Sacrificial knife,

<b>Description of the artefact</b>	Sacrificial knife (tumi) covered with green corrosion products and sediments. Semi circular flattened cutting edge. Trapezoidal handle with rectangular section. L = 105 mm; W handle = 25 mm; W blade = 55 mm; T = 1 mm; WT = 18,7 g.
<b>Type of artefact</b>	Sacrificial knife (tumi in vernacular language)
<b>Origin</b>	Probably Cajamarca (Peru), Cajamarca, Cajamarca, Peru
<b>Recovering date</b>	Unknown
<b>Chronology category</b>	Unknown
<b>chronology tpq</b>	<input type="text" value="200"/> A.D. ▼
<b>chronology taq</b>	<input type="text" value="1300"/> A.D. ▼
<b>Chronology comment</b>	None

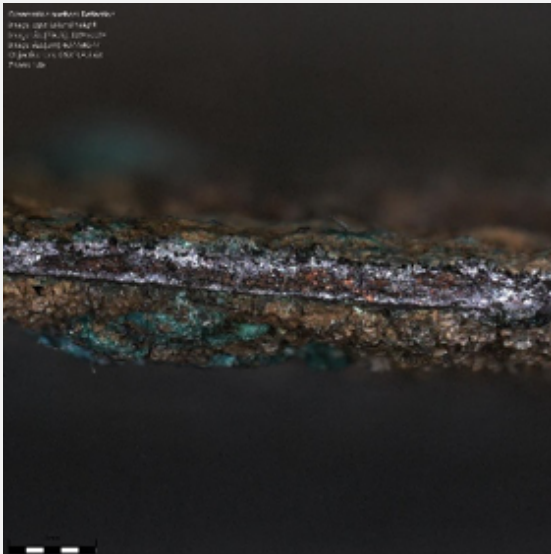
Fig. 3: Detail of the corrosion structure of the fractured cutting edge of the knife. To be related to the schematic stratigraphy of Fig. 6,

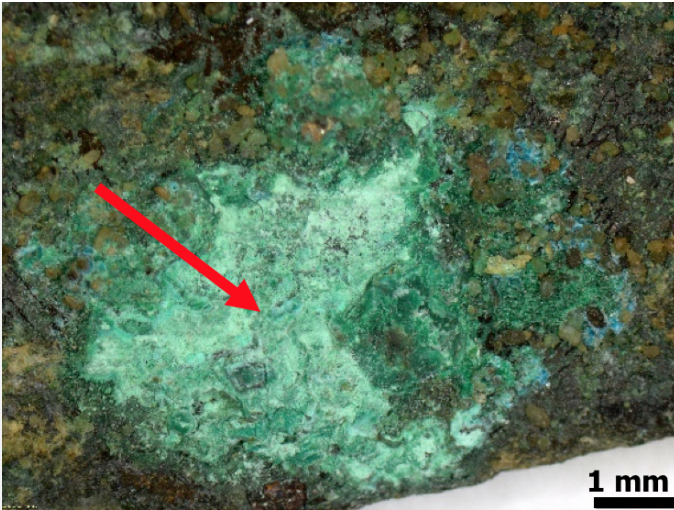
Fig. 4: Detail from Fig. 2 of the sampling area for XRF and XRD analysis,

<b>Description of sample</b>	Invasive sampling was not authorized by the museum. Only one powder sample was taken of the green corrosion product (Fig. 4).
<b>Alloy</b>	Cu Alloy
<b>Technology</b>	Cold worked (laminated)
<b>Lab number of sample</b>	1
<b>Sample location</b>	HE-Arc CR, Neuchâtel, Neuchâtel
<b>Responsible institution</b>	HE-Arc CR, Neuchâtel, Neuchâtel
<b>Date and aim of sampling</b>	02.04.2017, chemical and structural analyses

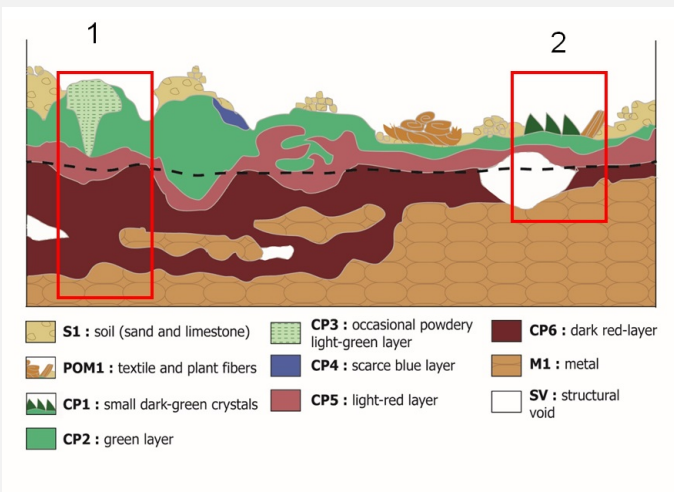
The schematic representation below gives an overview of the corrosion layers encountered on the tumi from a first visual macroscopic observation under binocular microscope.

Fig. 5: Stratigraphic representation of the sacrificial knife by macroscopic observation with indication of corrosion structures 1 and 2 used to build the MiCorr stratigraphy of Fig. 6,

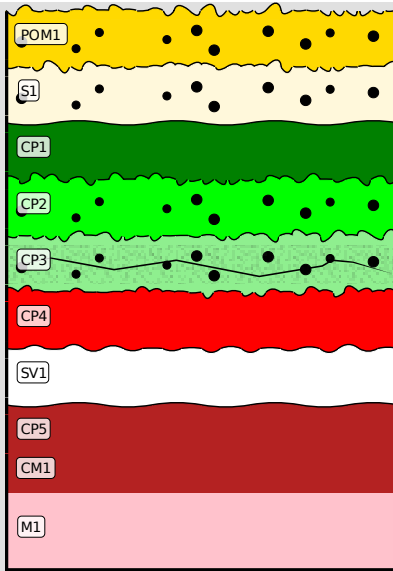
Fig. 6. Stratigraphic representation of the corrosion structure of the knife (combination of corrosion structures 1 and 2 of Fig. 5) observed macroscopically under binocular microscope using the MiCorr application. The characteristics of the strata are only accessible by clicking on the drawing that redirects you to the search tool by stratigraphy representation, Credit HE-Arc CR, M.Billot.

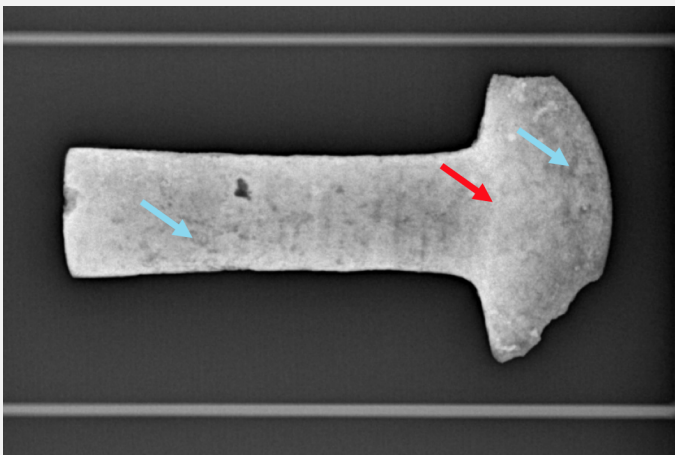
As indicated above, the metal of the knife might be an arsenic-copper alloy. Its manufacturing technique is not known but the X-radiography image seems to indicate that the artefact might have been produced as-cast with internal flaws (Fig. 7). The object has still a lot of remaining metal. Irregularities and different thicknesses are visible and parallel lines show that the knife was hammered. The whiter the area, the thicker the metal is.

Fig. 7: X-ray radiography of the knife. The base of the blade is thicker and is probably as-cast (red arrow). The blue arrows indicate casting flaws or localized corrosion,

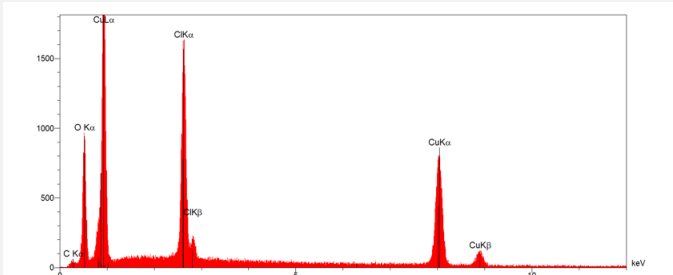
Results from XRF analyses of the non-cleaned metal surface (Table 1) indicate the presence of chlorine. The exogenous elements come from the landfill are mainly Si and Al, certainly associated to aluminosilicates. A sample was taken in the powdered light-green isolated layer (Figs. 2, 4 and 5). Chlorine, copper and oxygen was analysed by EDS-SEM. The presence of a high amount of Cl as well as Cu and O seems to indicate active corrosion (Fig. 8). XRD analysis confirmed the presence of paratacamite often associated to active corrosion (Fig. 9).

Fig. 8: EDS spectrum of a sample of the powdered light-green isolated layer (Fig. 4), Lab of Electronic Microscopy and Microanalysis (Néode),

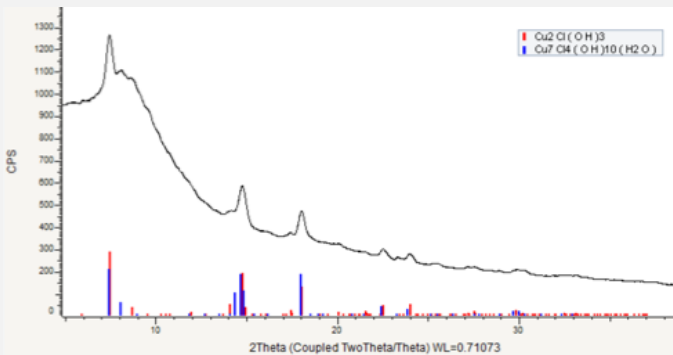
Fig. 9: XRD spectrum of a sample of the powdered light-green isolated layer (Fig. 4), Laboratory of Analytical Chemistry, Empa, HE-Arc,

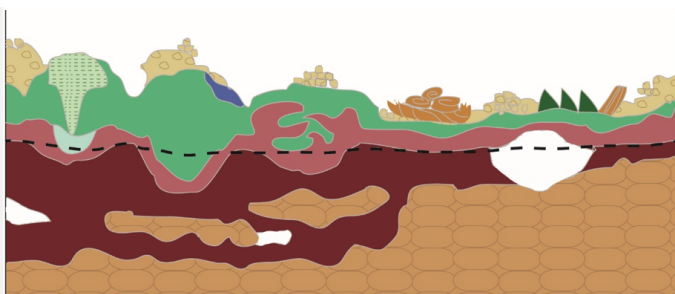
The schematic representation of corrosion layers of Fig. 5 integrating additional information based on the analyses carried out is given in Fig. 10. The limit of the original surface (represented by the dotted line on the figure below) was identified as still present and is located at the interface between CP6 and CP7.

Fig. 10: Improved stratigraphic representation of the tumi from visual observations and analyses,

The limit of the original surface has been altered by the corrosion products but can be found at the interface of CP6 and CP7. This tumi follows the type II corrosion model of L. Robbiola.
