FRAGMENT OF AN AEGIS OF NEITH 1886.305.0096 – LEADED BRONZE

Artefact name Fragment of an Aegis of Neith 1886.305.0096

Authors Line. Pedersen (HE-Arc, Neuchâtel, Neuchâtel, Switzerland) & Christian. Degrigny (HE-Arc CR, Neuchâtel, Neuchâtel, Switzerland) & Valentin. Boissonnas (HE-Arc CR, Neuchâtel, Neuchâtel, Switzerland)

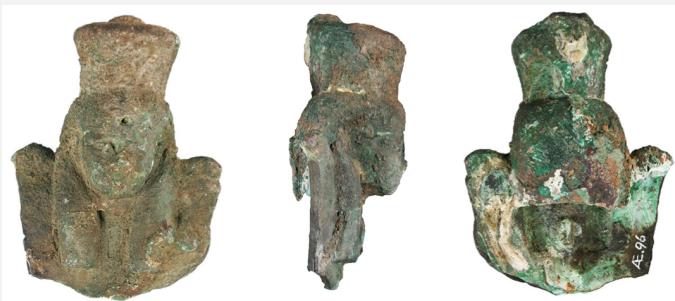
Fig. 1: Fragment of an Aegis of Neith. From left to right: front, side view and back respectively,

Fragment of an aegis surmounted by the head of Neith, the Egyptian goddess of war (Fig. 1). Traces of leaf gilding is still present in certain areas (Fig. 3). The lower part of the collar and the upper part of the crown are broken (Fig. 2 and 4). The surface is covered with a thick and hard, green-brown corrosion crust (Fig. 2, 3 and 4). A cross-section was studied on the lower edge that was broken after excavation. Dimensions: L = 96mm; W = 72mm; T = 40mm; WT = 216g.

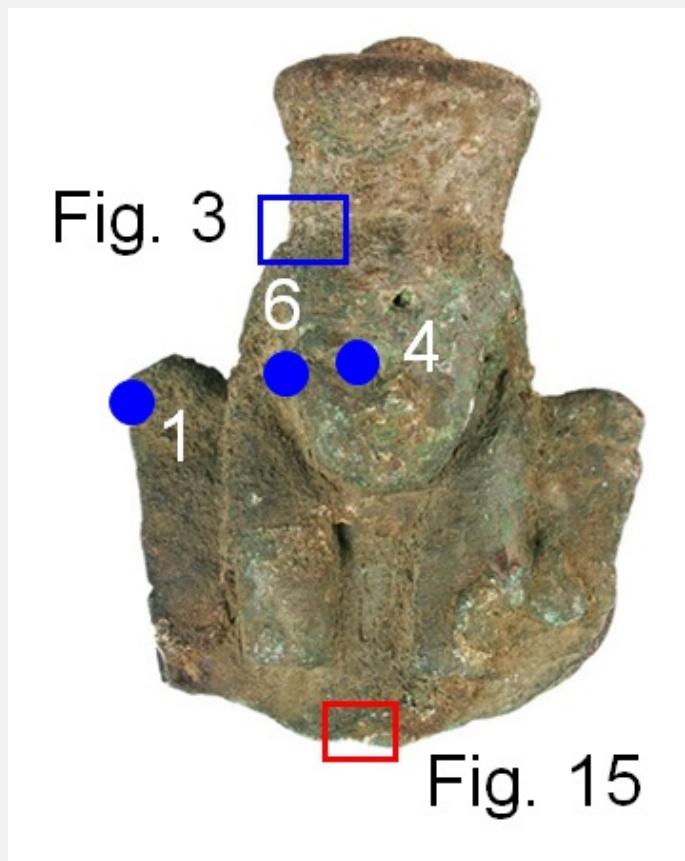
Fig. 2: Front face of the aegis with location of XRF measurements (blue spots), powder sample (red square) and gilding remains on the surface (blue square),

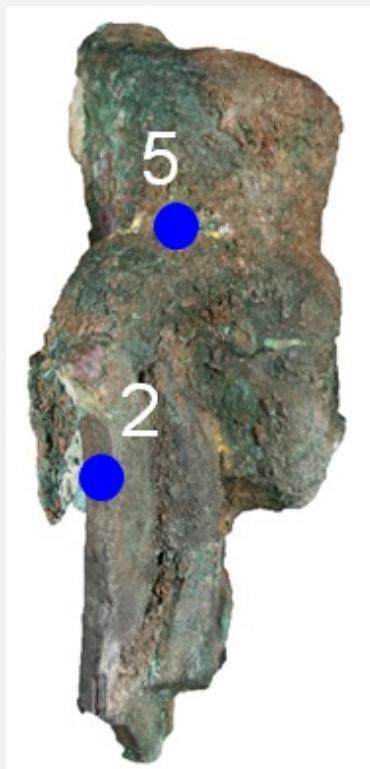
Fig. 4: Side view of the aegis with location of XRF measurements (blue spots),

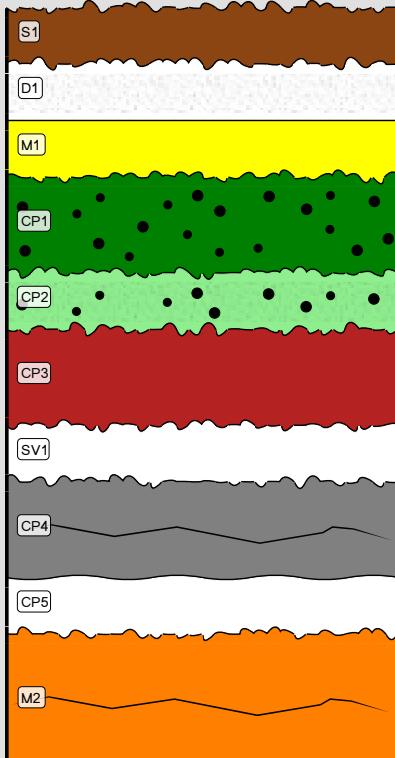
Fig.9: Schematic representation combining stratigraphies 1 and 2 under binocular microscope and using the MiCorr application. The characteristics of the strata are only accessible by clicking on the drawing that redirects you to the search tool by stratigraphy representation, Credit He-Arc CR, L.Pedersen.

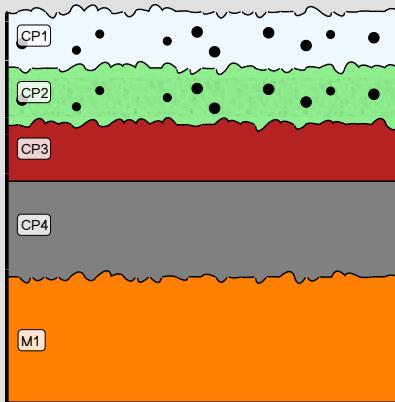
Fig.10: Schematic representation of stratigraphy 3 under binocular microscope and using the MiCorr application. CP1 is CP6 in Fig. 8. The characteristics of the strata are only accessible by clicking on the drawing that redirects you to the search tool by stratigraphy representation, Credit He-Arc CR, L. Pedersen.

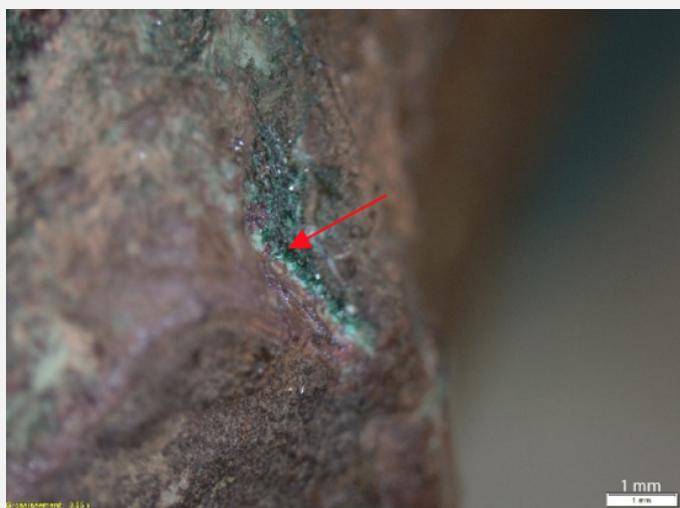
Fig. 13: Observation of the dark green corrosion product,

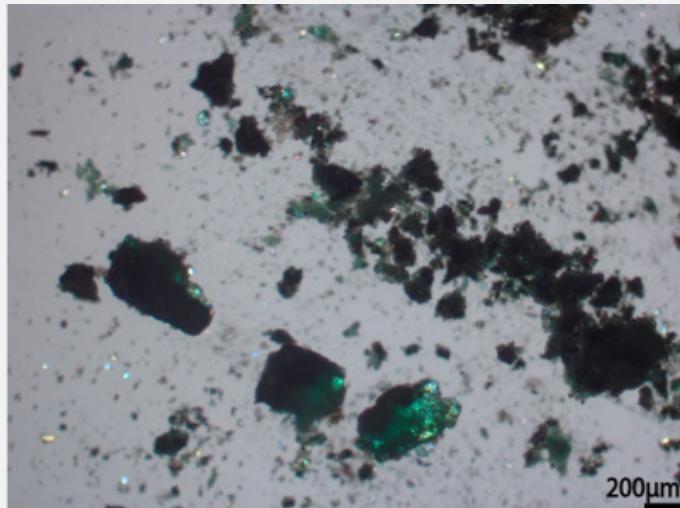
Fig. 14: Dark green corrosion product identified as paratacamite, atacamite $\text{Cu}_2\text{Cl}(\text{OH})_3$ by XRD. Microscopic examination under polarized light,

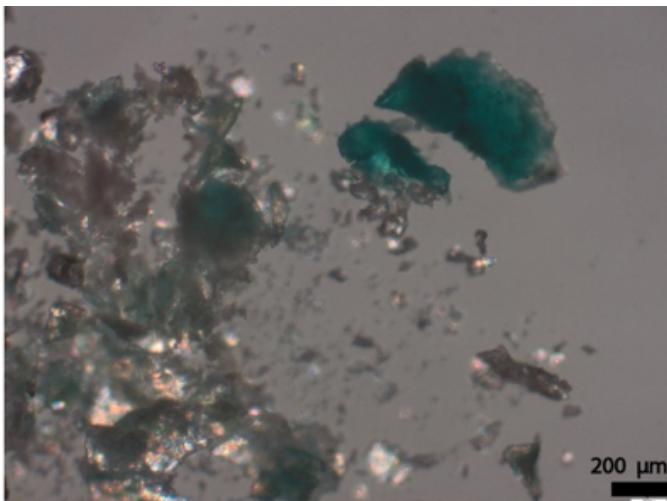
Fig. 18: Light blue corrosion product identified as chalconatronite $\text{Na}_2\text{Cu}(\text{CO}_3)_2 \cdot 3\text{H}_2\text{O}$ by XRD. Microscopic examination under polarized light,
