FRAGMENT OF AN AEGIS OF NEÏTH 1886.305.0096 – LEADED BRONZE

Artefact name	Fragment of an Aegis of Neïth 1886.305.0096
Authors	Line. Pedersen (HE-Arc, Neuchâtel, Neuchâtel, Switzerland) & Christian. Degriigny (HE-Arc CR, Neuchâtel, Neuchâtel, Switzerland) & Valentin. Boissonnas (HE-Arc CR, Neuchâtel, Neuchâtel, Switzerland)
Url	/artefacts/1270/

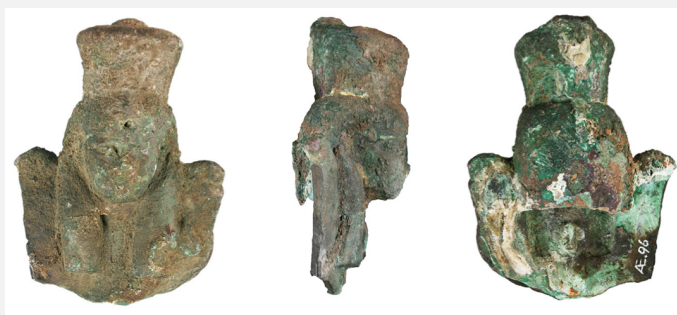
Fig. 1: Fragment of an Aegis of Neïth. From left to right: front, side view and back respectively,

Description of the artefact	Fragment of an aegis surmounted by the head of Neith, the Egyptian goddess of war (Fig. 1). Traces of leaf gilding is still present in certain areas (Fig. 3). The lower part of the collar and the upper part of the crown are broken (Fig. 2 and 4). The surface is covered with a thick and hard, green-brown corrosion crust (Fig. 2, 3 and 4). A cross-section was studied on the lower edge that was broken after excavation. Dimensions: L = 96mm; W = 72mm; T = 40mm; WT = 216g.
Type of artefact	sculpture
Origin	ancient Egypt
Recovering date	Purchased at the end of the 19th, probably from the art market. Date of excavation unknown.
Chronology category	None
chronology tpq	<input type="text"/> ---- ▼
chronology taq	<input type="text"/> ---- ▼
Chronology comment	
Burial conditions / environment	Unknown

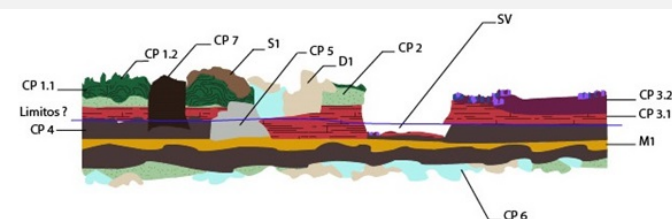
Captions	Colour, aspect, hardness and cohesion
S1	Brown, matte, can be scratched with scalpel blade but remains cohesive.
D1	White shiny deposit, powdery when shaved with scalpel.
CP1.1	Dark green corrosion layer, lumpy and matte, thick, hardly scratched by a scalpel blade, cohesive and compact.
CP1.2	Minor stratum of CP1.1. Dark green crystals appearing on the surface of the artefact. Easily scratched by a scalpel blade.
CP2	Light green corrosion layer, matte and thick in some places, powdery under the action of a scalpel blade. Sometimes located directly on CP4.
CP3.1	Red corrosion layer, lumpy and matte, thick, sometimes hard and sometimes powdery under the action of a scalpel blade.
CP3.2	Minor stratum of CP3.1. Purple with blue-purple crystals, hard and cohesive.
CP3.3	Minor stratum of CP3.1. Purple with blue-purple crystals, hard and cohesive.
Limitos	Interface of the limit of the original surface. Shiny, straight, black, manufacturing traces.

CP4	Dark grey with red or green reflection. Shiny, hard, straight, dense and with traces of engraving and possible inlays.
CP5	Isolated white stratum: waxy and very soft.
CP6	Light blue stratum, chalky. Isolated on the exterior surface and extends on the interior surface.
CP7	Isolated black stratum, very hard, straight and shiny.
SV:	Void in CP4, resulting in loss of the limitos. Presence of CP1.2 crystals inside the void.
Structural Void	
M1	Yellow stratum with metallic sheen, dense and hardly scratched by scalpel blade.

Fig. 7: Preliminary stratigraphy 2, corresponding to the back face of the aegis and interior (below part). S = soil, D = deposit, M = metal, CP = corrosion products, SV = structural void,

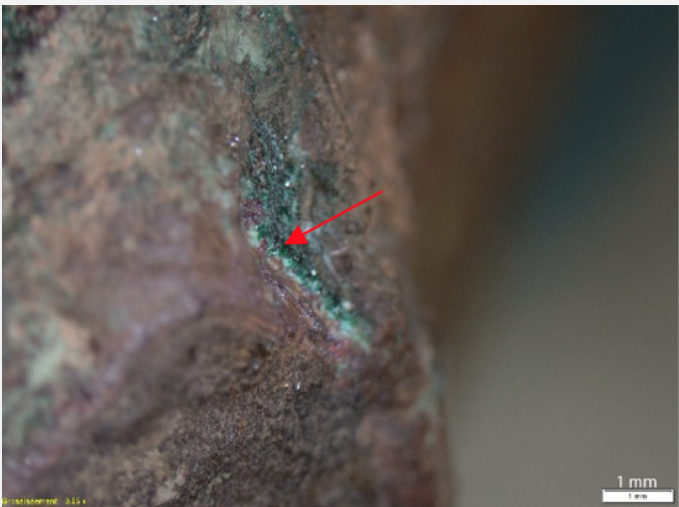
Fig. 13: Observation of the dark green corrosion product,

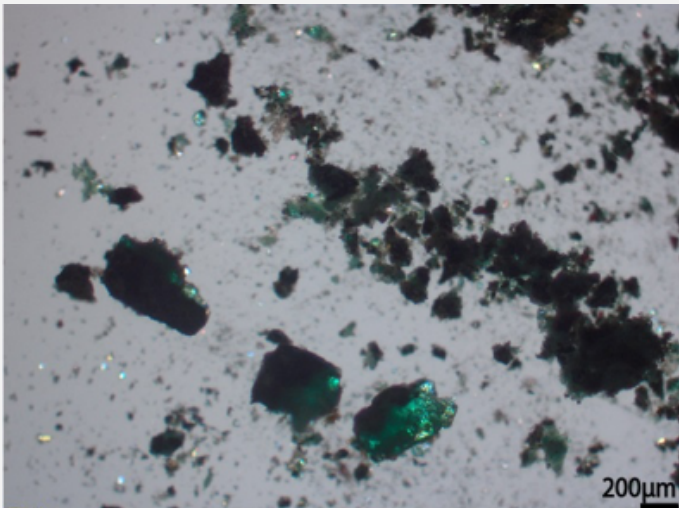
Fig. 14: Dark green corrosion product identified as paratacamite, atacamite Cu2Cl(OH)3 by XRD. Microscopic examination under polarized light,

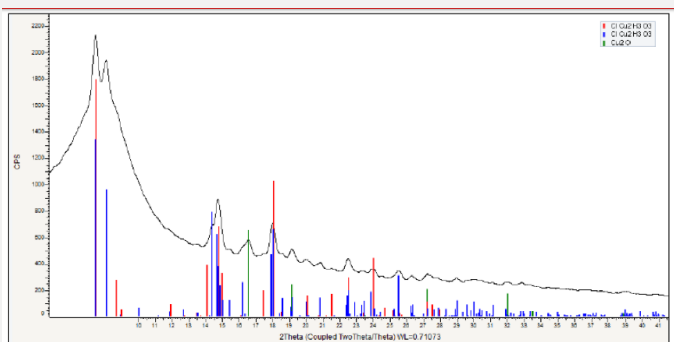
Fig. 21: XRD spectrum of the sample of the dark green corrosion product showing the presence of atacamite and paratacamite ($\text{Cu}_2\text{Cl}(\text{OH})_3$) as major compound and cuprite (Cu_2O) as minor compound,

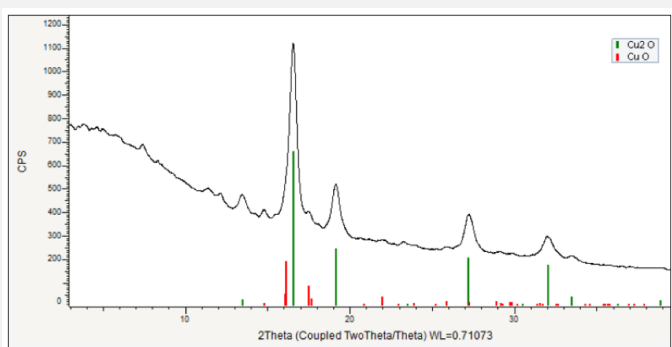
Fig. 24: XRD spectrum of the sample from the dark red corrosion product showing the presence of cuprite (Cu_2O) as major compound and tenorite (CuO) as minor compound,
