RING SMRA 16-17285-01 - CU ALLOY - ROMAN TIMES - SWITZERLAND

Artefact name	Ring SMRA 16-17285-01
Authors	Christian. Degrigny (HE-Arc CR, Neuchâtel, Neuchâtel, Switzerland) & Naima. Gutknecht (HE-Arc CR, Neuchâtel, Neuchâtel, Switzerland) & Valentina. Valbi (Laboratoire Métallurgie et Culture LMC-IRAMAT-CNRS-UTBM, Belfort, Franche-Comté, France)
Url	/artefacts/1276/

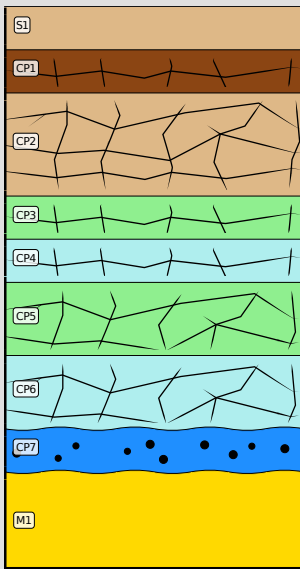
Fig. 5: Stratigraphic representation of the corrosion structure of the ring observed macroscopically under binocular using the MiCorr application with reference to Fig. 4. The characteristics of the strata, such a discontinuity, are accessible by clicking on the drawing that redirects you to the search tool by stratigraphy representation, Credit HE-Arc CR, N.Gutknecht.

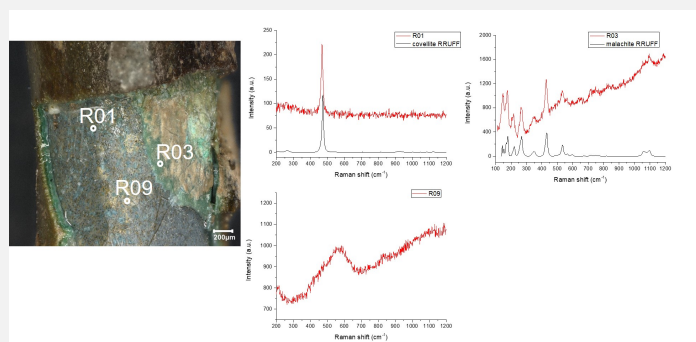
It was not possible to sample this artefact. Therefore, μ -Raman point analyses were performed on the surface of the object in an area where different strata of corrosion products were exposed, as shown in Fig. 6 in a micrograph taken by optical microscopy. The surface of the object appears brown (CP1). It covers a green stratum (CP5) and a blue/golden one (CP7 and M1) with black spots in it. The R01 analysis point was performed on one of the blackspots observed in the blue stratum and can be identified as covellite (CuS) by comparison with a reference spectrum. Point analyses performed on the blue (CP7) and golden stratum showed a spectrum with a large peak at around 560 cm^{-1} (R09) that can be identified as nanocassiterite (SnO_2) by comparison with the work of Ospitali et al. 2012. The R03 point analysis was performed on the green stratum (CP5) and is identified as malachite ($\text{Cu}_2(\text{CO}_3)(\text{OH})_2$) by comparison with a reference spectrum.

Fig. 6: Raman points of analysis on the surface of the object and Raman spectra obtained for R01 (together with the covellite reference spectrum RRUFFID=R060306), R03 (together with the malachite reference spectrum RRUFFID=R050508) and R09,

The ring is a tin bronze probably with some lead. The identification of nanocassiterite as the most internal CP shows a phenomenon of decuprification typical of bronze corrosion, accompanied by the formation of copper hydroxycarbonate as a more external CP. The dark inclusions observed in the CP7 and identified as covellite are likely to be residuals of copper sulfide inclusions from the metal microstructure.
