RING SMRA 16-17285-01 – CU ALLOY – ROMAN TIMES – SWITZERLAND

Artefact name	Ring SMRA 16-17285-01
Authors	Christian. Degriigny (HE-Arc CR, Neuchâtel, Neuchâtel, Switzerland) & Naima. Gutknecht (HE-Arc CR, Neuchâtel, Neuchâtel, Switzerland) & Valentina. Valbi (Laboratoire Métallurgie et Culture LMC-IRAMAT-CNRS-UTBM, Belfort, Franche-Comté, France)
Url	/artefacts/1276/

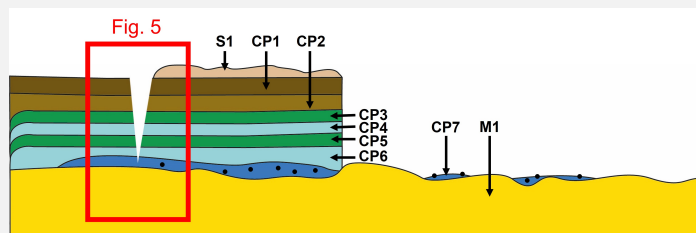
Fig. 4: Stratigraphic representation of the corrosion structure of the ring by macroscopic and binocular observation with indication of the corrosion structure used to build the MiCorr stratigraphy of Fig. 5 (red rectangular),

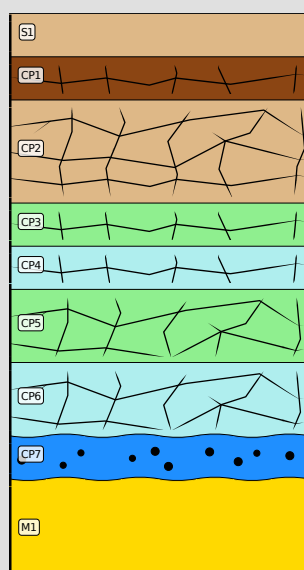
Fig. 5: Stratigraphic representation of the corrosion structure of the ring observed macroscopically under binocular using the MiCorr application with reference to Fig. 4. The characteristics of the strata, such a discontinuity, are accessible by clicking on the drawing that redirects you to the search tool by stratigraphy representation, Credit HE-Arc CR, N.Gutknecht.

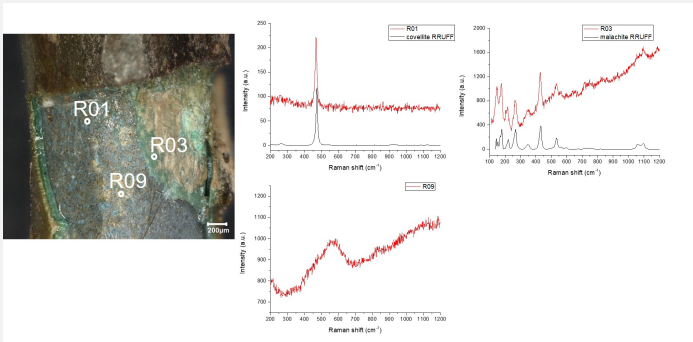
It was not possible to sample this artefact. Therefore, μ -Raman point analyses were performed on the surface of the object in an area where different strata of corrosion products were exposed, as shown in Fig. 6 in a micrograph taken by optical microscopy. The surface of the object appears brown (CP1). It covers a green stratum (CP5) and a blue/golden one (CP7 and M1) with black spots in it. The R01 analysis point was performed on one of the blackspots observed in the blue stratum and can be identified as covellite (CuS) by comparison with a reference spectrum. Point analyses performed on the blue (CP7) and golden stratum showed a spectrum with a large peak at around 560 cm^{-1} (R09) that can be identified as nanocassiterite (SnO_2) by comparison with the work of Ospitali et al. 2012. The R03 point analysis was performed on the green stratum (CP5) and is identified as malachite ($\text{Cu}_2(\text{CO}_3)(\text{OH})_2$) by comparison with a reference spectrum.

Fig. 6: Raman points of analysis on the surface of the object and Raman spectra obtained for R01(together with the covellite reference spectrum RRUFFID=R060306), R03 (together with the malachite reference spectrum RRUFFID=R050508) and R09,

The ring is a tin bronze probably with some lead. The identification of nanocassiterite as the most internal CP shows a phenomenon of decuprification typical of bronze corrosion, accompanied by the formation of copper hydroxycarbonate as a more external CP. The dark inclusions observed in the CP7 and identified as covellite are likely to be residuals of copper sulfide inclusions from the metal microstructure.
