# RING SMRA 16-17285-01 - CU ALLOY - ROMAN TIMES - SWITZERLAND

**Artefact name** Ring SMRA 16-17285-01

**Authors** Christian. Degrigny (HE-Arc CR, Neuchâtel, Neuchâtel, Switzerland) & Naima. Gutknecht (HE-Arc CR, Neuchâtel, Neuchâtel, Switzerland) & Valentina. Valbi (Laboratoire Métallurgie et Culture LMC-IRAMAT-CNRS-UTBM, Belfort, Franche-Comté, France)

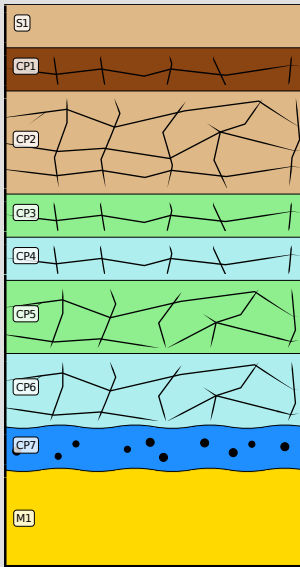
Fig. 5: Stratigraphic representation of the corrosion structure of the ring observed macroscopically under binocular using the MiCorr application with reference to Fig. 4. The characteristics of the strata, such a discontinuity, are accessible by clicking on the drawing that redirects you to the search tool by stratigraphy representation, Credit HE-Arc CR, N.Gutknecht.
