RING SMRA 16-17285-01 - CU ALLOY - ROMAN TIMES - SWITZERLAND

Artefact name Ring SMRA 16-17285-01

Authors Christian. Degrigny (HE-Arc CR, Neuchâtel, Neuchâtel, Switzerland) & Naima. Gutknecht (HE-Arc CR, Neuchâtel, Neuchâtel, Switzerland) & Valentina. Valbi (Laboratoire Métallurgie et Culture LMC-IRAMAT-CNRS-UTBM, Belfort, Franche-Comté, France)

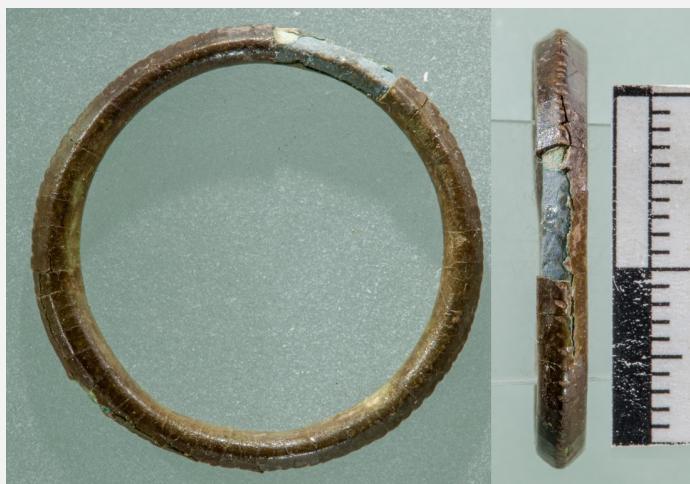
Fig. 1: Ring (face A and side views).

Ring with a faceted cross-section and decorated with ridges on the outside. Its original shape seems to be preserved although the brown corrosion structure is heavily cracked and even has a large lacuna on face A (Fig. 1). Diameter (external) = 2.6cm and weight = 2.5g.

Flaking of the surface was observed before the drying of the object, hence the consolidation with paraloid B72.

Cleaning of soil with ethanol and consolidation with resin paraloid B72 in ethyl acetate. Drying at 50°C.

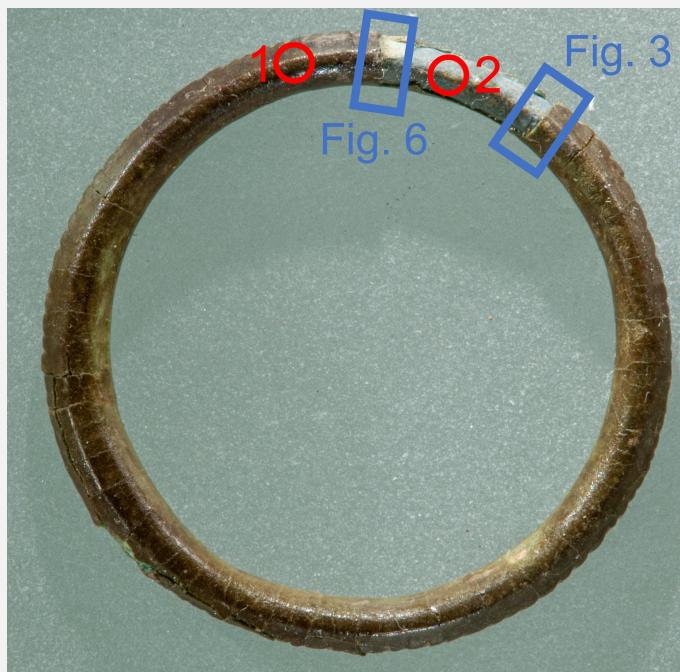
Fig. 2: Location of XRF analyses (red circles), Fig. 3 (blue square) and Fig. 6 (Raman spectroscopy (blue square) on face A,

XRF analysis was carried out without sampling. For point 1, all strata (soil, corrosion products, and metal) are analyzed at the same time. As for point 2, the analysis was performed where corrosion layers flaked. Therefore, it reflects better the metal composition. The metal is presumably a copper-tin alloy with some lead, while the Si, Fe, Al and P are probably coming from the burial environment. The higher amount of tin on point 1 (with corrosion layers) than on point 2 (corrosion structure flaked, metal visible) is a strong indicator of tin enrichment on the corrosion layers. The presence of chlorine could not be revealed.

Table 2: Chemical composition analysed with handled XRF at the surface of the ring for two representative points shown in Fig.2. The results are rounded up to the nearest whole number (n.d.: below the detection limit), UR-Arc CR.

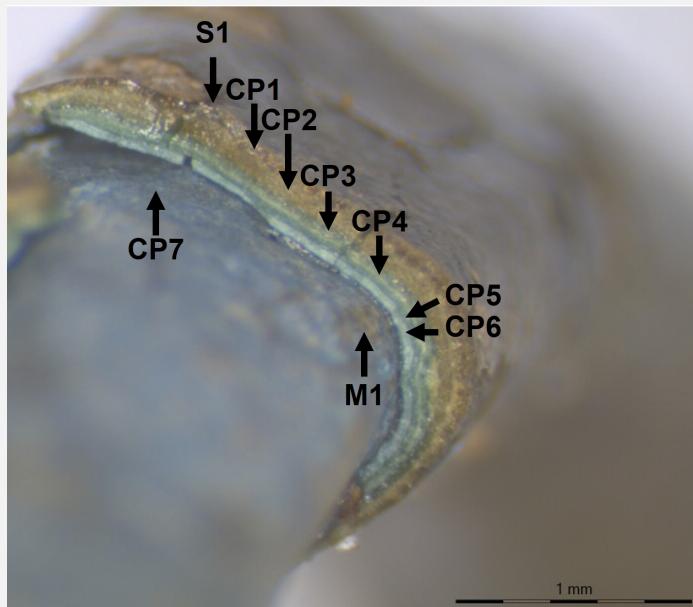
Fig. 3: Description of the corrosion structure,

The schematic representation below gives an overview of the corrosion structure encountered on the ring from a first visual macroscopic observation. There are cracks through CP1 to CP6 that generate the flaking of the layers.

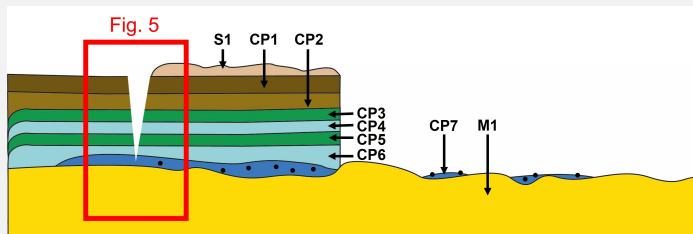
Fig. 4: Stratigraphic representation of the corrosion structure of the ring by macroscopic and binocular observation with indication of the corrosion structure used to build the MiCorr stratigraphy of Fig. 5 (red rectangular).

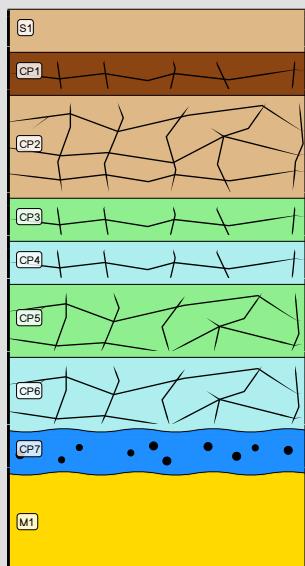
Fig. 5: Stratigraphic representation of the corrosion structure of the ring observed macroscopically under binocular using the MiCorr application with reference to Fig. 4. The characteristics of the strata, such as a discontinuity, are accessible by clicking on the drawing that redirects you to the search tool by stratigraphy representation, Credit HE-Arc CR, N.Gutknecht.

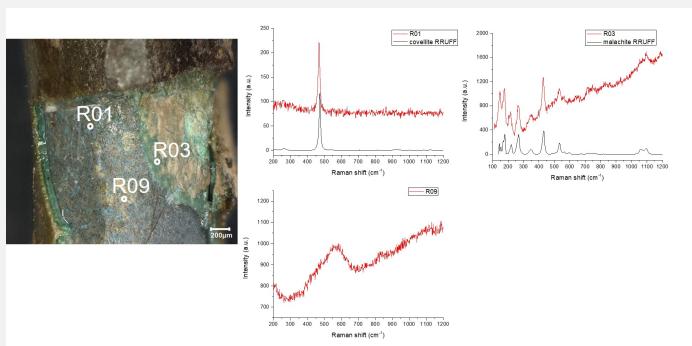
It was not possible to sample this artefact. Therefore, μ -Raman point analyses were performed on the surface of the object in an area where different strata of corrosion products were exposed, as shown in Fig. 6 in a micrograph taken by optical microscopy. The surface of the object appears brown (CP1). It covers a green stratum (CP5) and a blue/golden one (CP7 and M1) with black spots in it. The R01 analysis point was performed on one of the black spots observed in the blue stratum and can be identified as covellite (CuS) by comparison with a reference spectrum. Point analyses performed on the blue and golden stratum showed a spectrum with a large peak at around 560 cm⁻¹ (R09) that can be identified as nanocassiterite (SnO₂) by comparison with the work of Ospitali et al. 2012. The R03 point analysis was performed on the green stratum (CP5) and is identified as malachite (Cu₂(CO₃)(OH)₂) by comparison with a reference spectrum.

Fig. 6: Raman points of analysis on the surface of the object and Raman spectra obtained for R01 (together with the covellite reference spectrum RRUFFID=R060306), R03 (together with the malachite reference spectrum RRUFFID=R050508) and R09,

The ring is a tin bronze probably with some lead. The identification of nanocassiterite as the most internal CP shows a phenomenon of decuprification typical of bronze corrosion, accompanied by the formation of copper hydroxycarbonate as a more external CP. The dark inclusions observed in the CP7 and identified as covellite are likely to be residuals of copper sulfide inclusions from the metal microstructure.
